MINNESOTA STATE CAPITOL  
HISTORIC STRUCTURES REPORT  
VOLUME 2.1

SITE DEVELOPMENT AND CONDITIONS

MINNESOTA STATE CAPITOL  
HISTORIC STRUCTURES REPORT  
VOLUME 2.2.2

GROUND FLOOR SPACE INVENTORY AND CONDITIONS

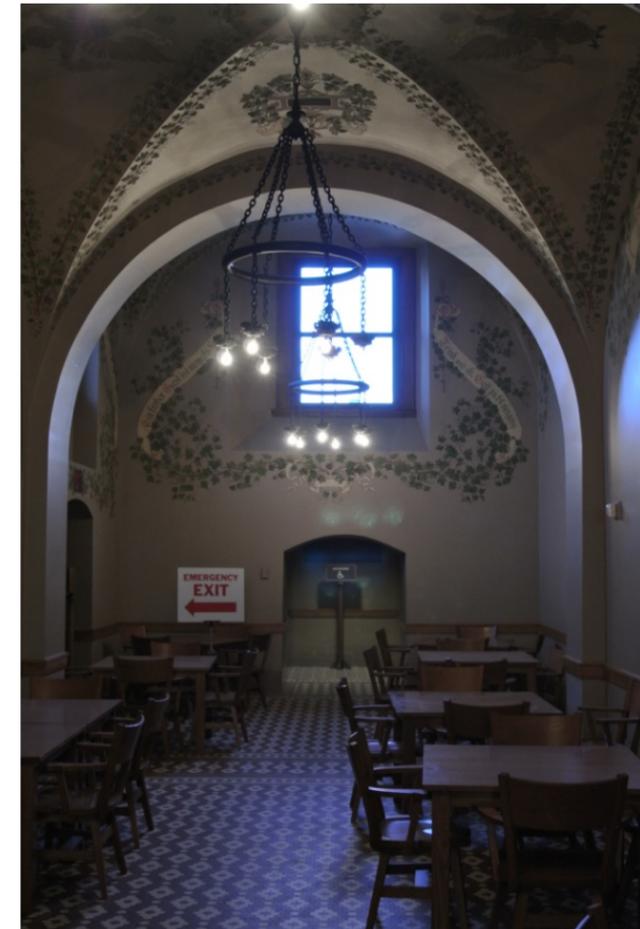
Building Element:	Description:	Condition of Material:
Floor	Tile	Original, Intact
Walls	Plaster	Intact, Restored
Ceiling/Cornice	Plaster vaults with decorative painting	Intact/Restored
Doors/Frame:	Doors are all new	Not original
Hardware	ADA Hardware	Not original, replica
Light Fixtures	Chandelliers	Intact/Restored
Artwork	Decorative painting	Original, Restored
Mechanical	Metal decorative Grilles	Intact, probably not original
Trim	Plaster/Oak	Intact, Restored

Rathskeller with its original tile floor, oak trim, and restored decorative paintings on the ceiling.

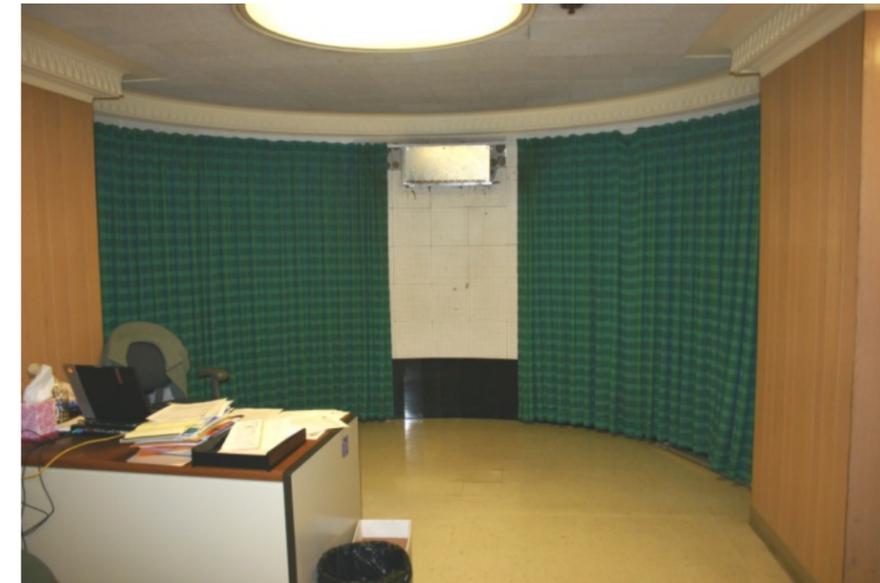
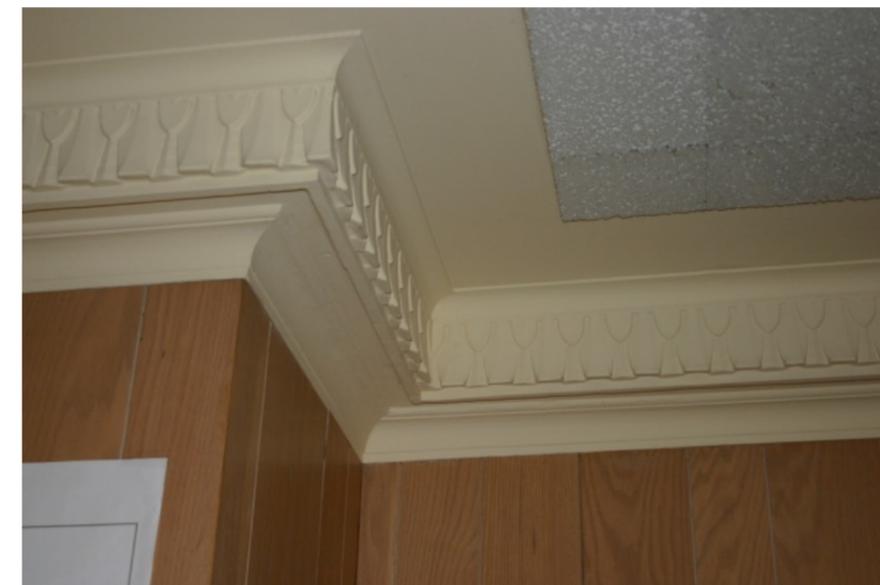
The fabric of the Governor's Dining Room has been entirely covered up or destroyed by modern additions. It is now used as a press room. Remaining items of interest are the door knobs and hardware, which have an interesting Art Deco motif, and a chrome finish. They do not match the prevailing original hardware in any way.

Building Element:	Description:	Condition of Material:
Floor	Synthetic tile	Intact/not original
Walls	CMU, wood paneling	Not original
Ceiling/Cornice	ACT/Faux plaster	Intact
Doors/Frame:	Doors are all new	Not original
Hardware	1930s chrome finished	Original to 1935
Light Fixtures	Ceiling mounted	Not original
Artwork	Mural	Original to 1935
Mechanical	Plain metal grilles	Not original
Trim	Faux plaster	Not original

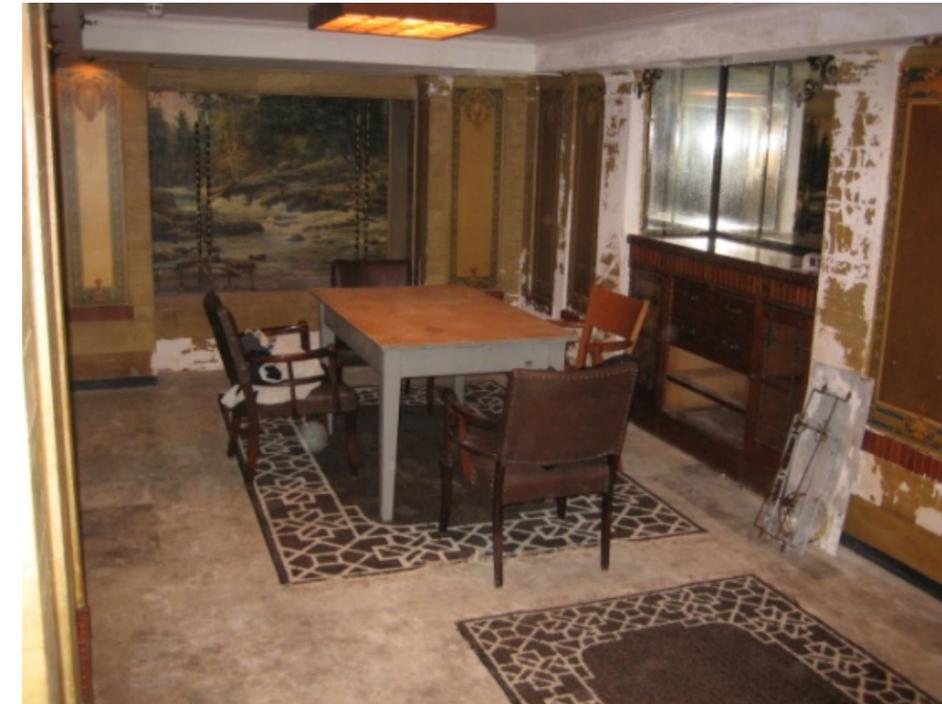
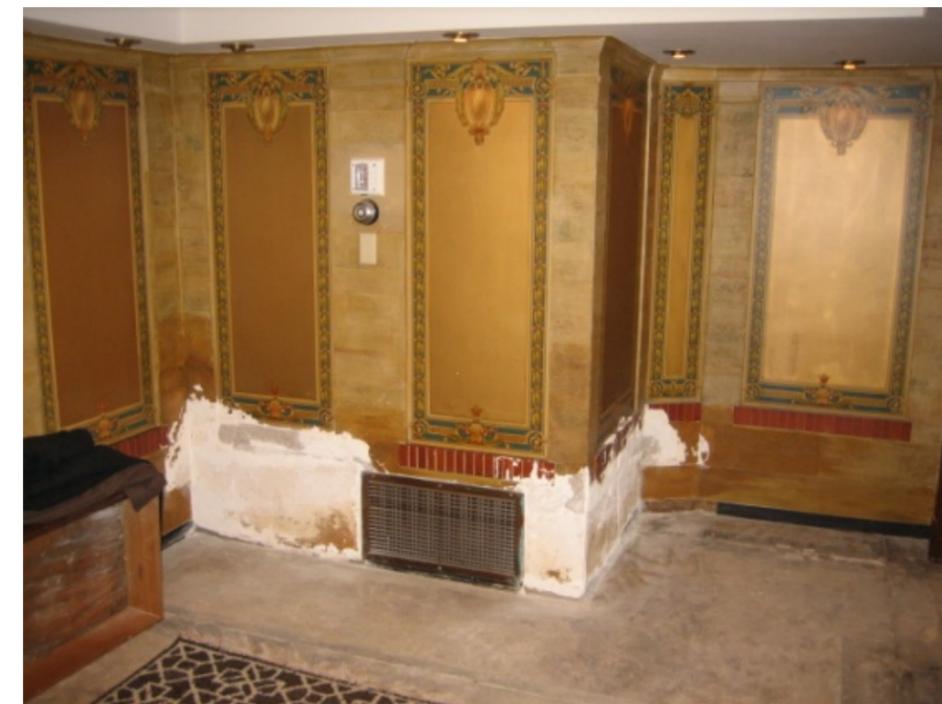
The Justice's Dining Room has been extensively damaged, both by renovations and water damage.

Original built-in furniture and artwork remain, but have all been damaged by water.

Building Element:	Description:	Condition of Material:
Floor	Concrete	Water damaged
Walls	Plaster	Water damaged
Ceiling/Cornice	ACT/Faux plaster	Destroyed
Doors/Frame:	Wood	Intact
Hardware	Cast iron, neogothic	Not original
Light Fixtures	Ceiling mounted	Water damaged
Artwork	Mural, decorative paint	Water damaged
Mechanical	Plain metal grilles	Not original
Trim	Plaster	Water damaged

2006 Maintenance: Plant Management cleans and disinfects the Supreme Court Justice’s Dining room in the Capitol. The walls are scrapped down to free any loose plaster. The carpet (non-original) is removed and disposed of. The walls, built in cabinetry and original chairs are cleaned with Fosters 40-80 to kill any active mold growth.

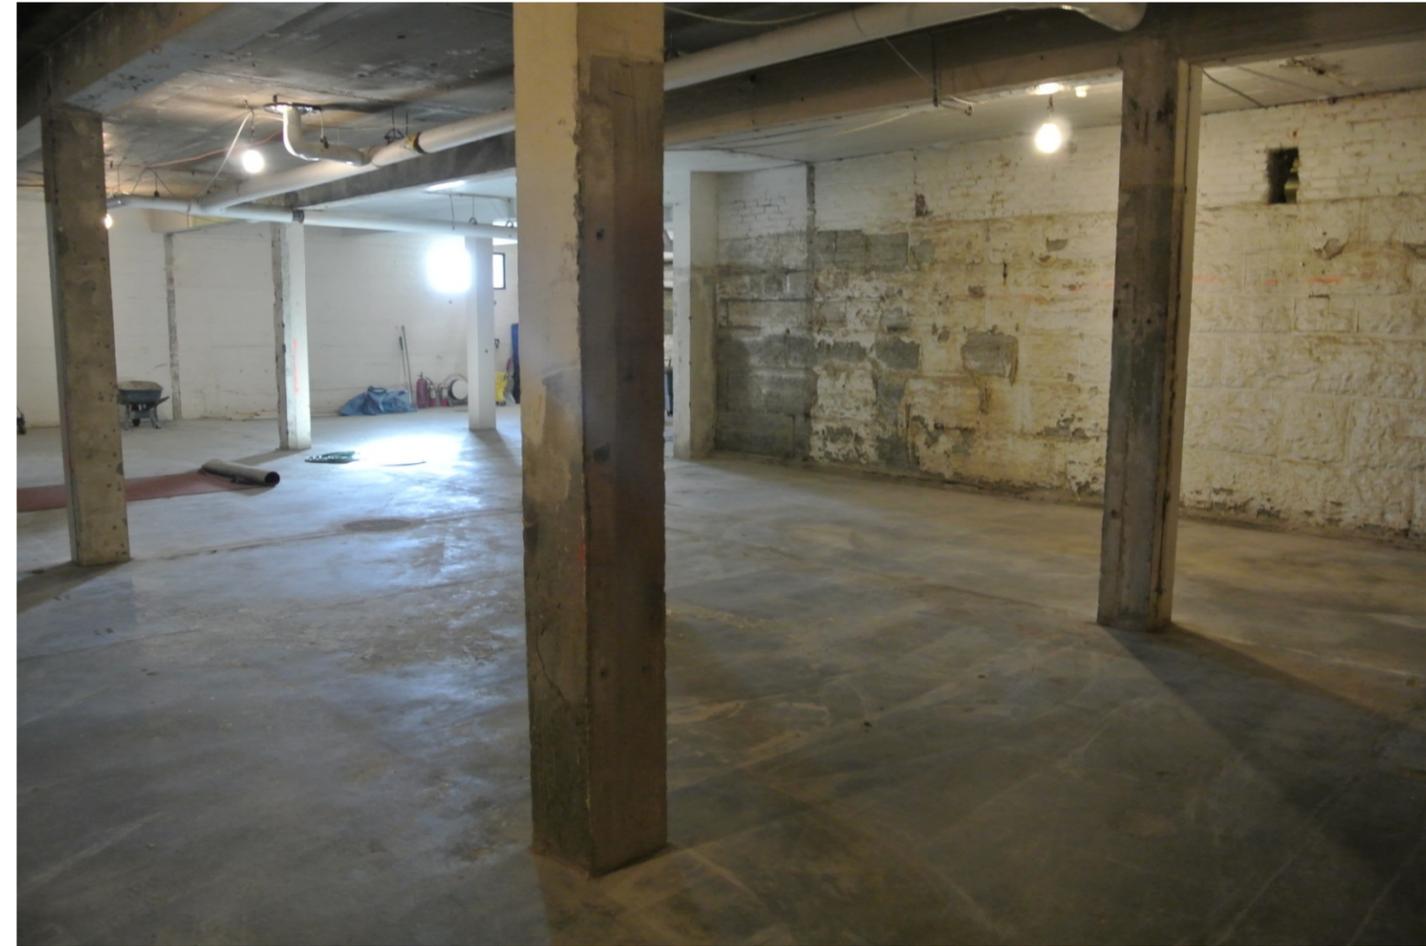
These areas were mostly House offices. In this photo, taken after demolition, the raw concrete floor, columns and ceiling can be seen. In the background, Blue Limestone foundation walls, with brick infill above. Note also the terrace level window that allows some natural light into this space.

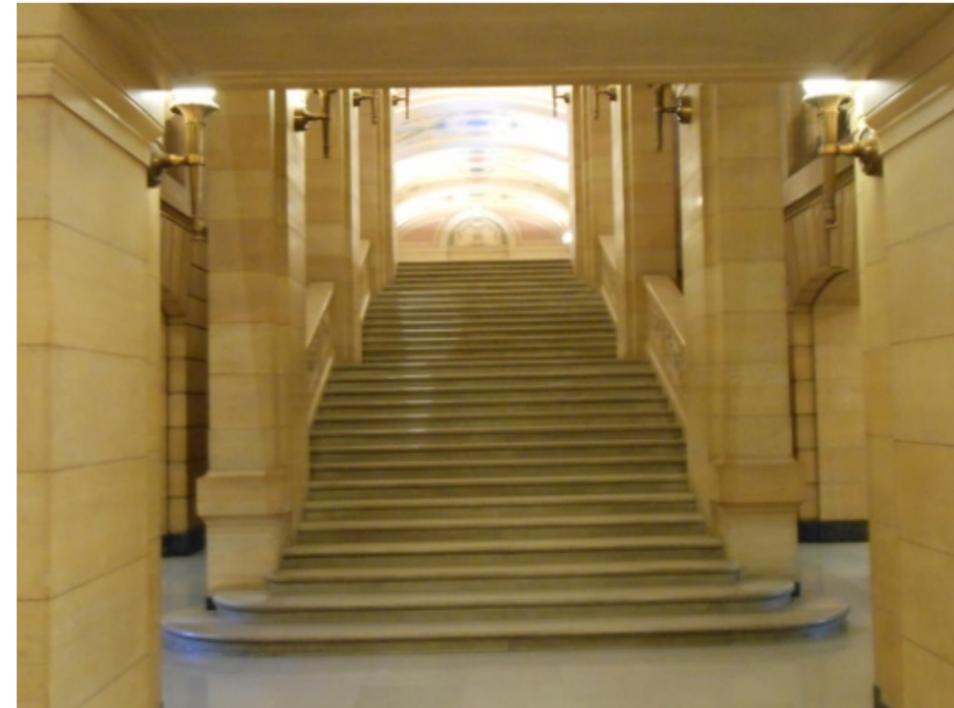
Same as above with the exception of missing floor candelabra. Original door to MHS reading room filled in, and new lighting. See significant alterations.

Building Element:	Description:	Condition of Material:
Floor	Joliet Limestone floor, Marble treads.	Intact, Original
Walls	Kasota Stone/Plaster	Intact, Original
Ceiling/Cornice	Plaster, skylight	Intact, Original
Doors/Frame:	Wood, see door section	Some removed, covered with plaster.
Hardware	Brass Lever	Original knobs replaced in ADA upgrade. Replicas
Light Fixtures	Historic Torcheres, uplights	Torcheres original, though not in original locations/uplights not
Artwork	Decorative Plaster painting/Portraits	Restored/Not original
Mechanical	Bronze decorative grilles	Intact, Original
Trim	Plaster/Stone	Intact, Original

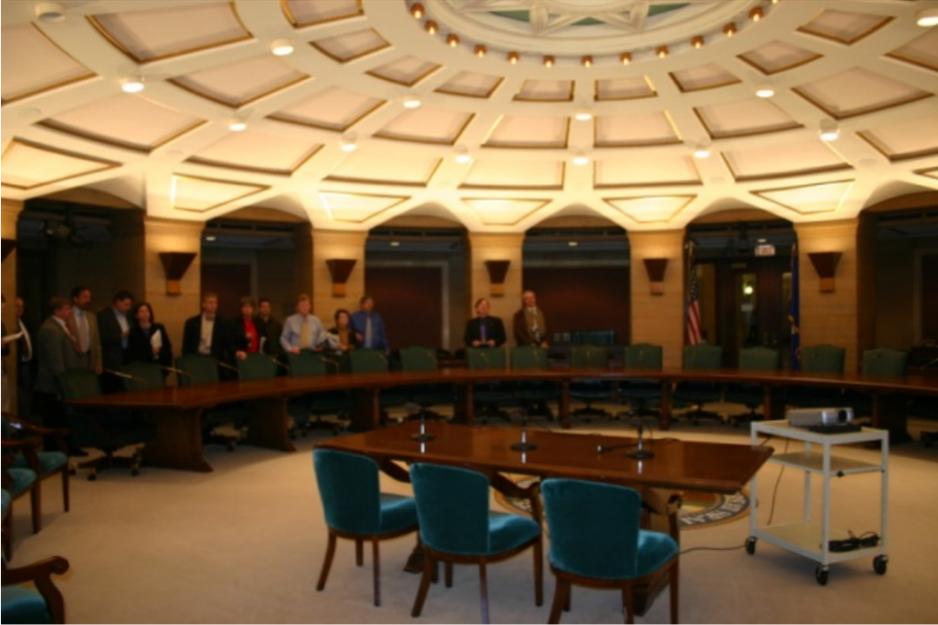
Meeting room. New carpet floor, acoustic ceiling, and original ceiling decoration visible

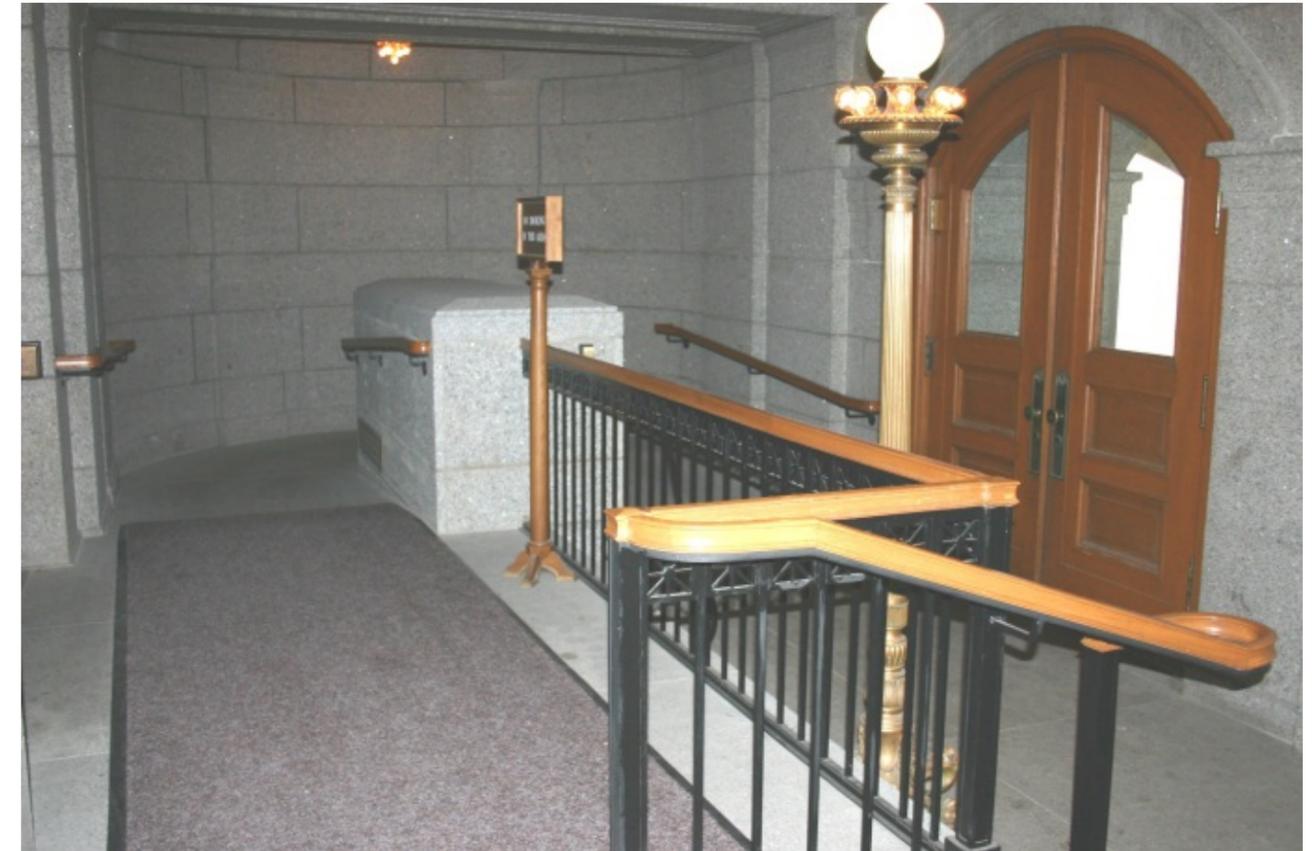
The Vestibule and Porte Couchere are the primary accessible entry on the South side of the Capitol. Symmetrical ramps were added to the vestibule, and additional ramps were added outside under the shelter of the Porte Couchere. The handrails are not original. Of the three sets of exterior doors, only the central pair function as the others have been blocked on the exterior by the ADA ramp added in 2000.

South Entry Vestibule. Note semicircular ramp.

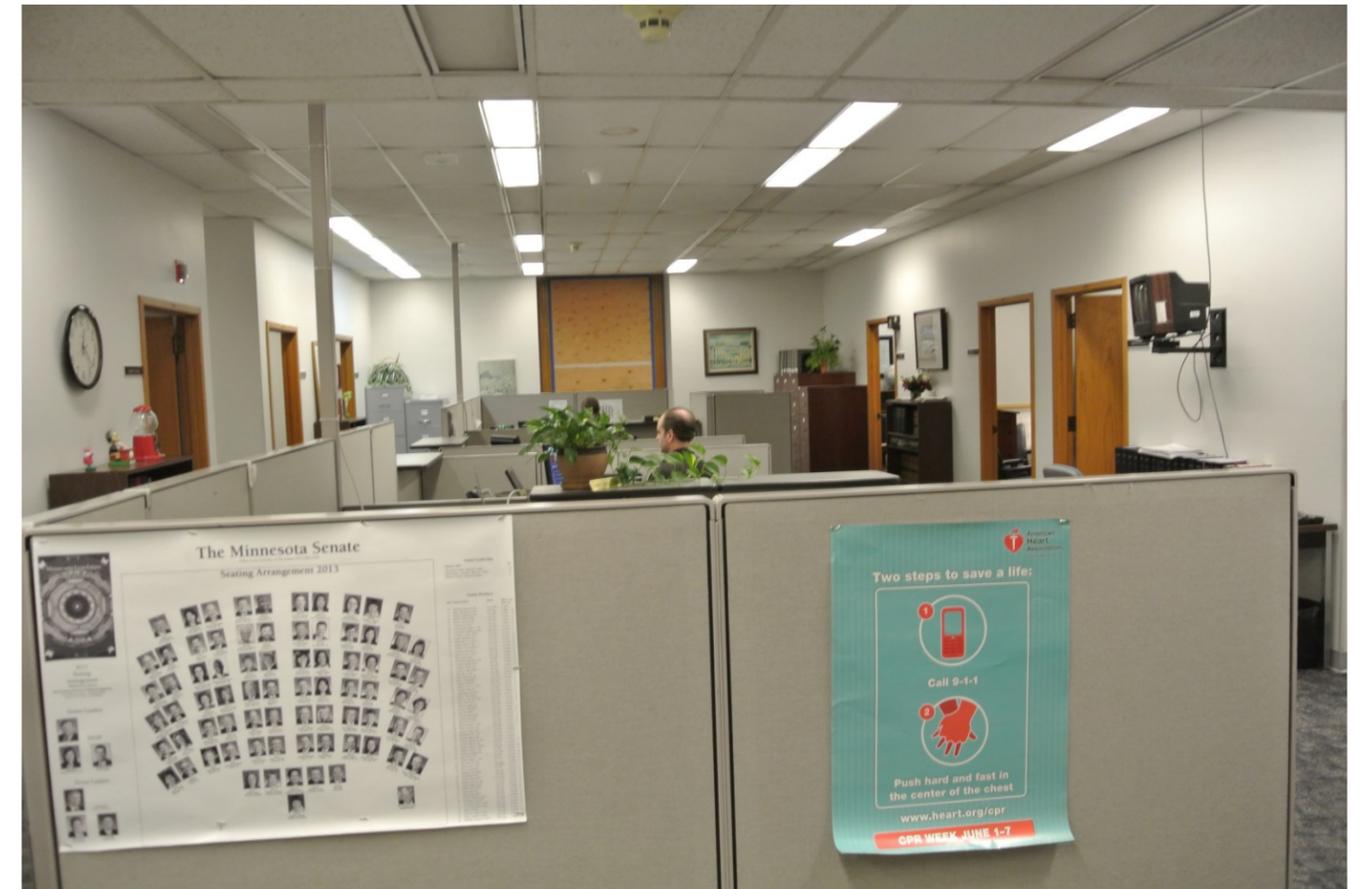
Original Counter was removed. Guastavino tile remains above the ACT ceiling in the corridor. Hangers for the ACT have caused some damage. Marble floor may remain under carpet. Its condition is unknown. Other surfaces may be damaged by the addition of new walls and systems. Extent unknown until demolition occurs.

Building Element:	Description:	Condition of Material:
Floor	Concrete, Marble/carpet	Destroyed, Unknown?
Walls	Plaster/VWC	Modified
Ceiling/Cornice	Guastavino/ACT	Unknown
Doors/Frame:	Not original	Not original
Hardware	Brass Lever	Not original or replica
Light Fixtures	Lay in fixtures	Not Original
Artwork	None	None
Mechanical	Not original	Not original
Trim	Wood	Not original

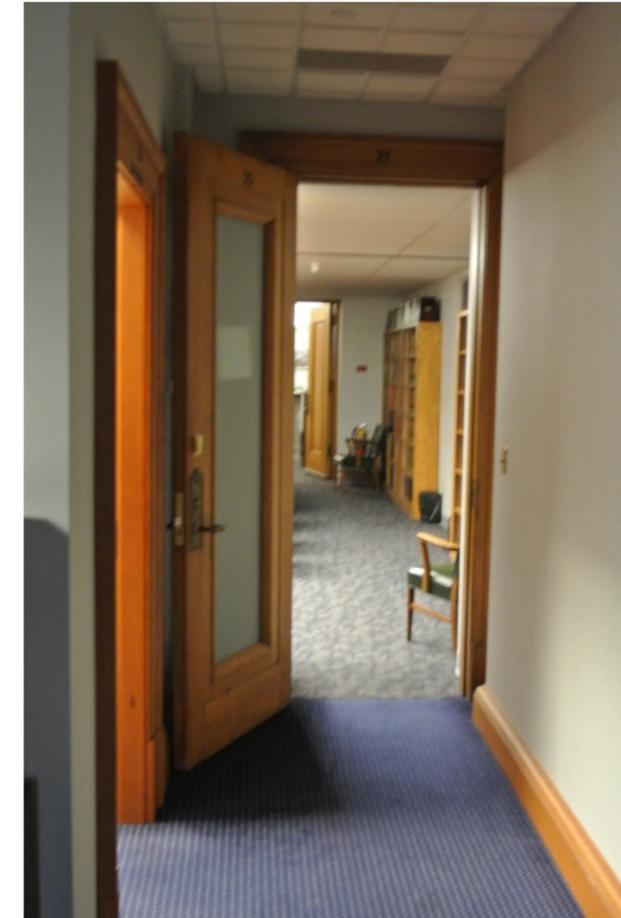
Building Element:	Description:	Condition of Material:
Floor	Concrete/carpet	Destroyed
Walls	Plaster/VWC	Modified
Ceiling/Cornice	Plaster/ACT	Unknown
Doors/Frame:	Original doors intact, most doors not original	Modified
Hardware	Brass Lever	ADA lever on original doors. Other doors non replica levers
Light Fixtures	Lay in fixtures	Not Original
Artwork	None	None
Mechanical	Not original	Not original
Trim	Wood	Not original

Original door to Education offices.  
Conference room beyond was  
originally the West Vestibule.

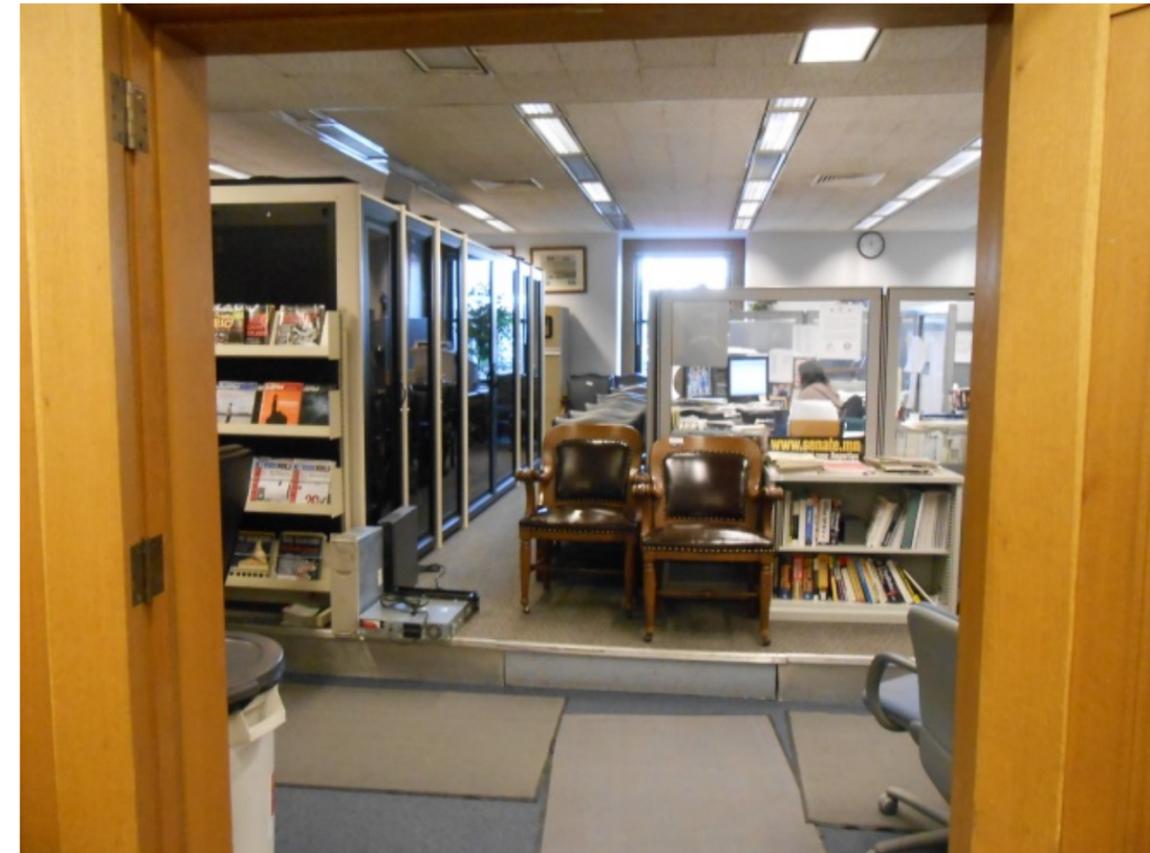
Building Element:	Description:	Condition of Material:
Floor	Concrete/access flooring/carpet	Destroyed
Walls	Plaster/paint	Original partitions removed, new added.
Ceiling/Cornice	Plaster/ACT	Condition of original ceiling above ACT unknown
Doors/Frame:	Original wood at corridor, remainder newer	Modified
Hardware	Replica ADA levers at original doors only.	Not original
Light Fixtures	Wall mounted uplights	Not Original
Artwork	None	None
Mechanical	Ceiling distribution	Not original
Trim	Wood	Not original

Computer room. note raised floor.

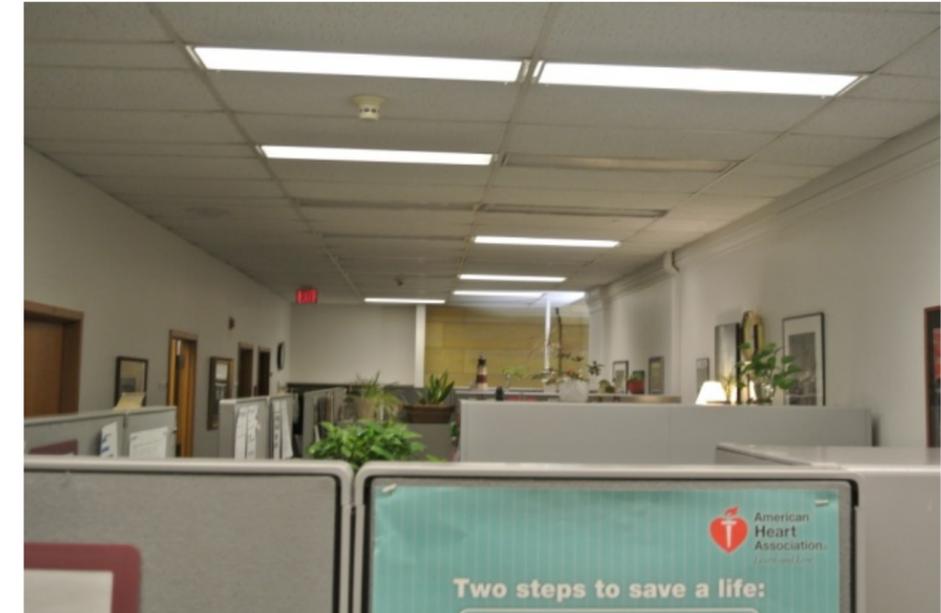
Building Element:	Description:	Condition of Material:
Floor	Joliet Limestone/carpet	Unknown beneath carpet
Walls	Plaster/VWC	Modified, new walls added, walls covered with new treatment
Ceiling/Cornice	Guastavino vault/ACT	Condition of original ceiling above ACT unknown
Doors/Frame:	Original wood at corridor, remainder newer	Modified
Hardware	Replica ADA levers at original doors only.	Not original
Light Fixtures	Wall mounted uplights	Not Original
Artwork	None	None
Mechanical	Not original	Not original
Trim	Wood	Not original

The tile vaults in the former hall are concealed above ACT. Some original stone wall finish visible in background

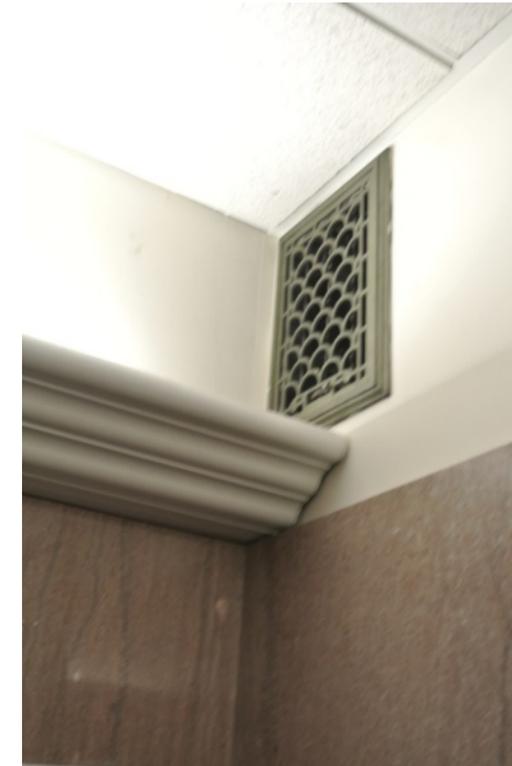
Historic grille and stone with later acoustic ceiling and uplights
