Minnesota State Capitol Exterior Stone Repair Project

Presentation to CAAPB, SHPO, MHS and
DOA Representatives
December 19, 2012

2012 (Phase 1): Stone Repair Trials and Mock-up Evaluation

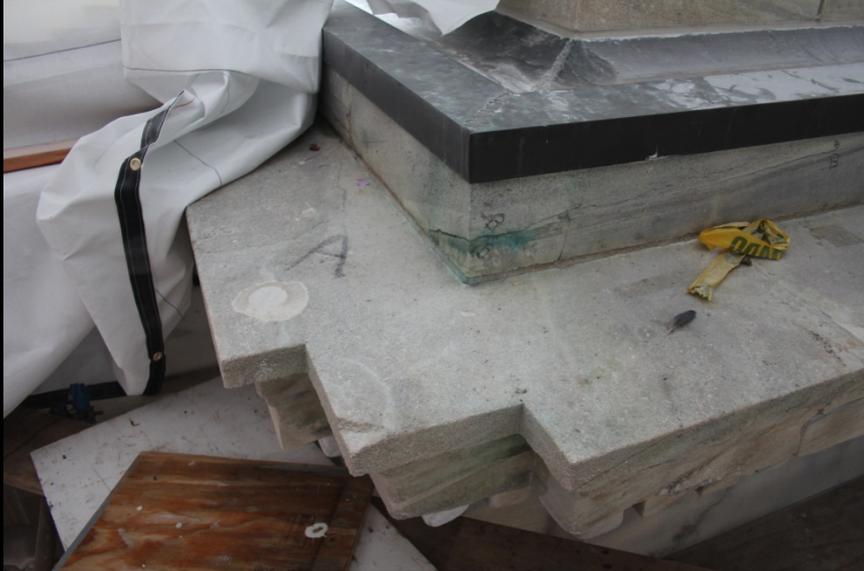
East elevator cornice (top view) – identified in 2010 as possible life safety concern

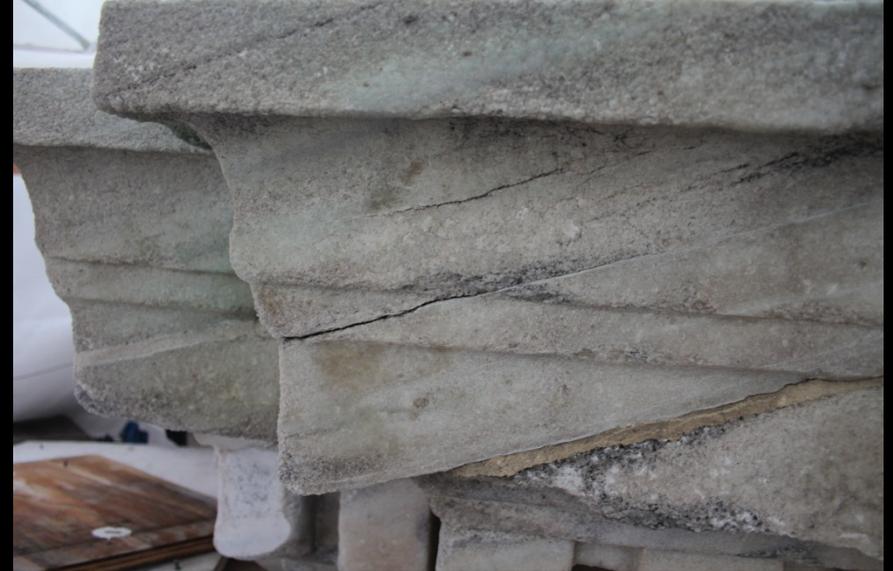
East elevator cornice (side view) – vein erosion and diagonal cracking

- The east elevator has been subjected to long term water infiltration from above.
- Back-up masonry is saturated and never completely dries.
- Brick and stone show evidence of freeze/thaw damage.
- Stone anchors are corroded and embedded.
- Freeze/thaw expansion is causing several units to shift outward.

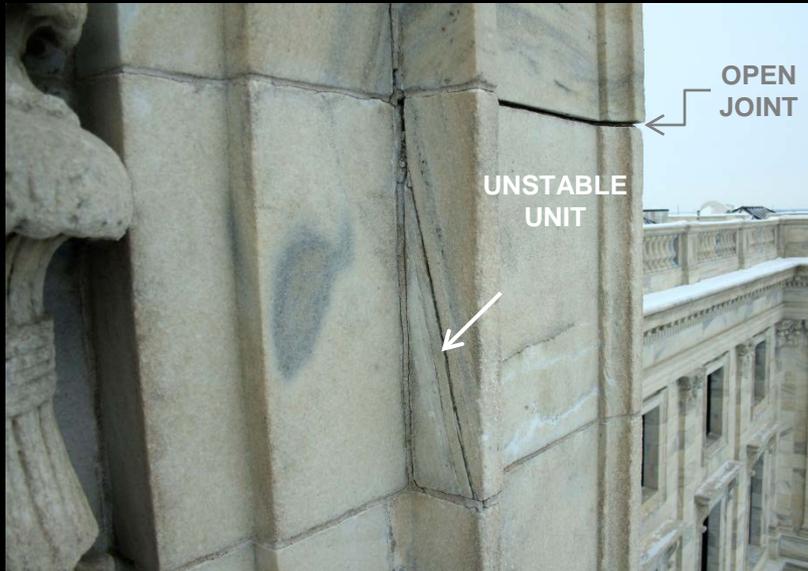
East elevator pilaster (side view) – identified in 2010 as life safety item

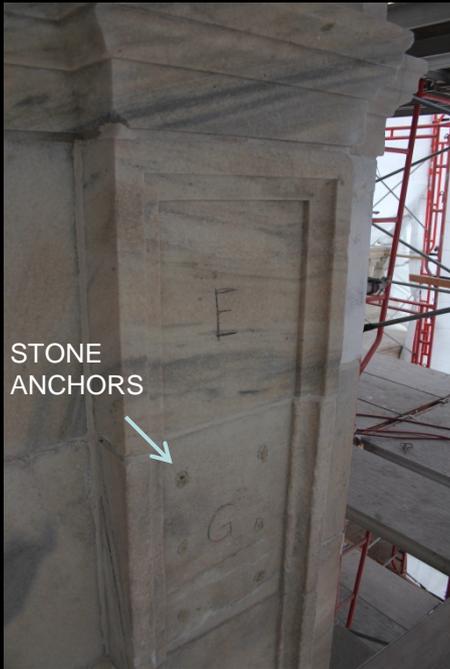
East elevator pilaster– emergency repairs 2010

- + Unit is secure for now
- + Original material remains in place
- + Visually unobtrusive
- Brick back-up deterioration is not addressed
- Material is still compromised
- Stone will continue to deteriorate
- Frequent inspection is required

- Option A – Minimal intervention. **Original stone is retained**. Emergency repair remains in place as is.
- Option B- Aggressive intervention. **Original stone is replaced** with new material to match existing.

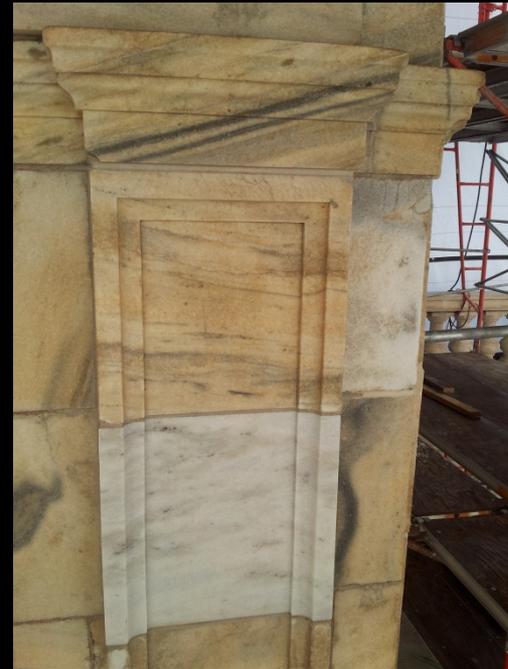
East elevator pilaster - unit replacement 2011

- + Satisfies all criteria
- New stone stands out against adjacent weathered material (may be non-issue when building is cleaned)
- * Affords better protection for historic material below

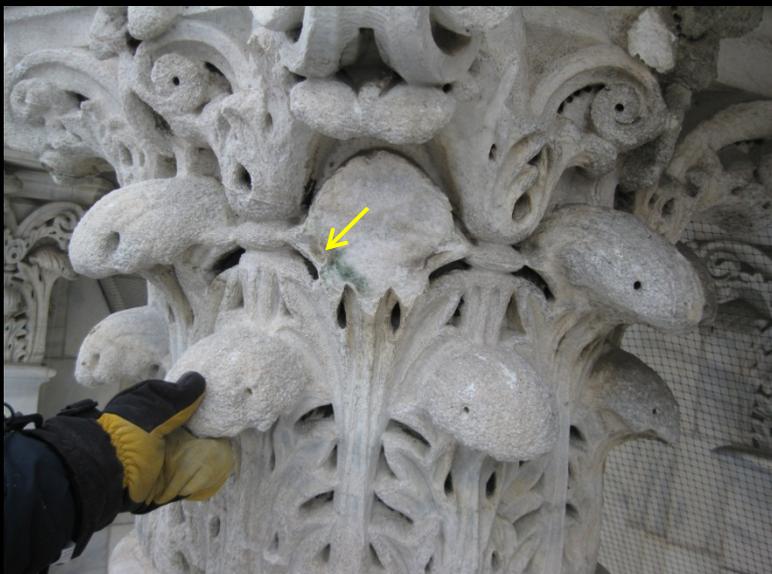
West Façade column capital – missing and unstable acanthus leaves

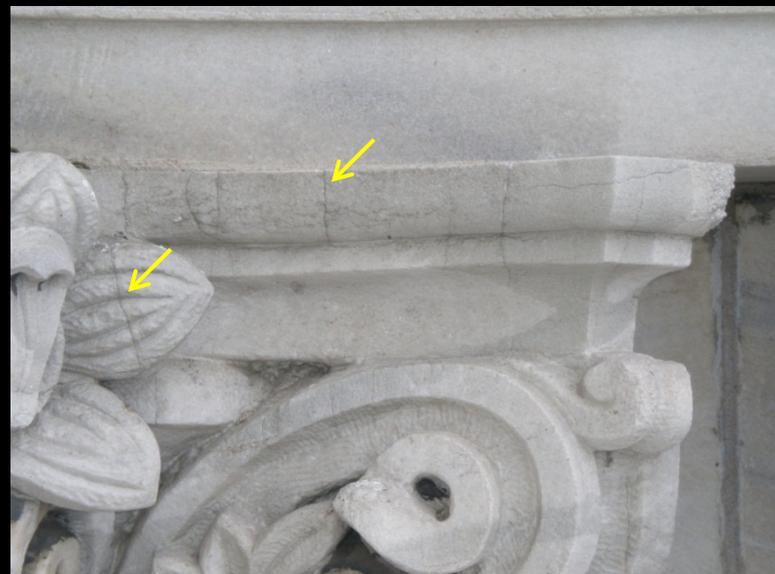
North Façade pilaster capital – Micro-fractures and minor cracking

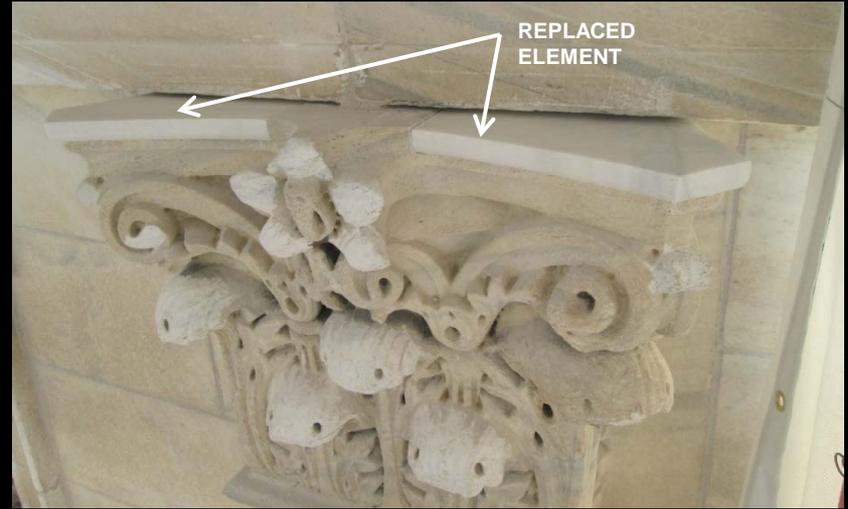
Option C (field revisions)

Note: Deep deterioration required more extensive removal of original material than was originally assumed.

- + Historic material is retained as much as possible
- + Improved water management and surface protection
- Weathered material is interspersed with fresh stone

- Option C – Moderate-high intervention. Eroded surfaces are **smoothed & carved**. Unstable elements are **removed and replaced**.

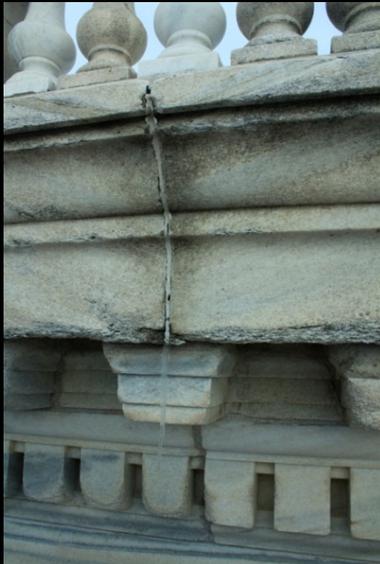
South cornice fascia w/ failed joint

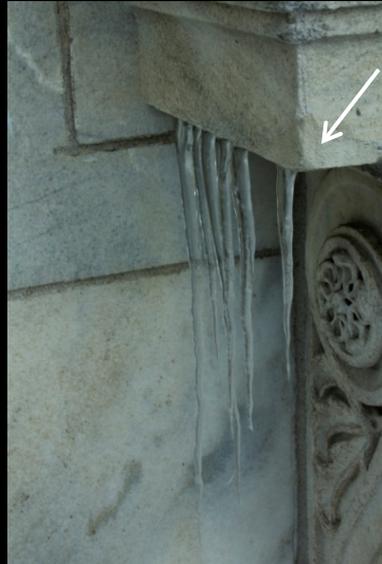
South window hood drip edge
(previous patch repair at corner)

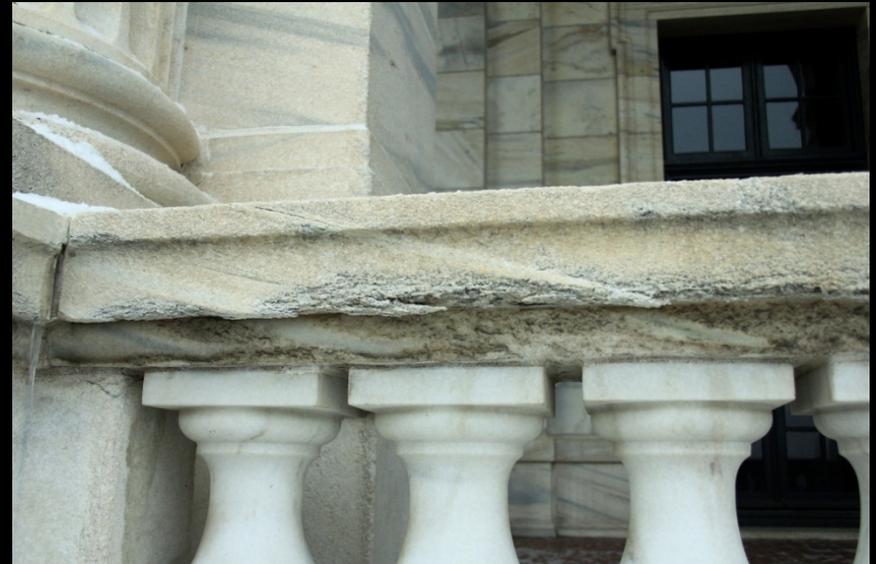
South loggia balustrade rail cap. Balusters were replaced several years ago

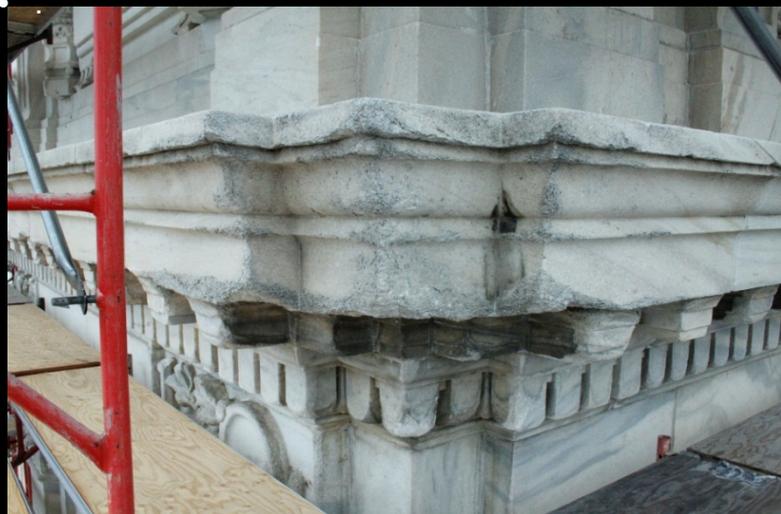
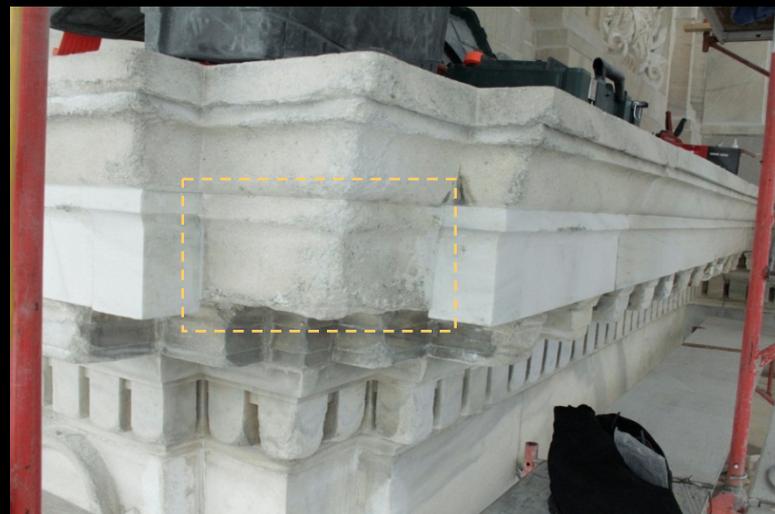
Note: Inside corner (shown dashed) is scheduled for future replacement

- + Original material is left in place to the greatest extent possible.
- + New work is integrated with existing material at logical breaks, recesses or changes in profile
- Weathered material is left in place above new work, deterioration will continue at a different (faster) pace than new material
- Removal of sound material is sometimes required to maximize performance, provide visual consistency and/or preserve character

- Option A – Aggressive Intervention. Damaged material is **removed** and **restored** with new stone Dutchman replacement.
- Option B – Cementitious patch repairs are no longer acceptable in these locations. Previous patch repairs may actually have accelerated damage to adjacent stone.

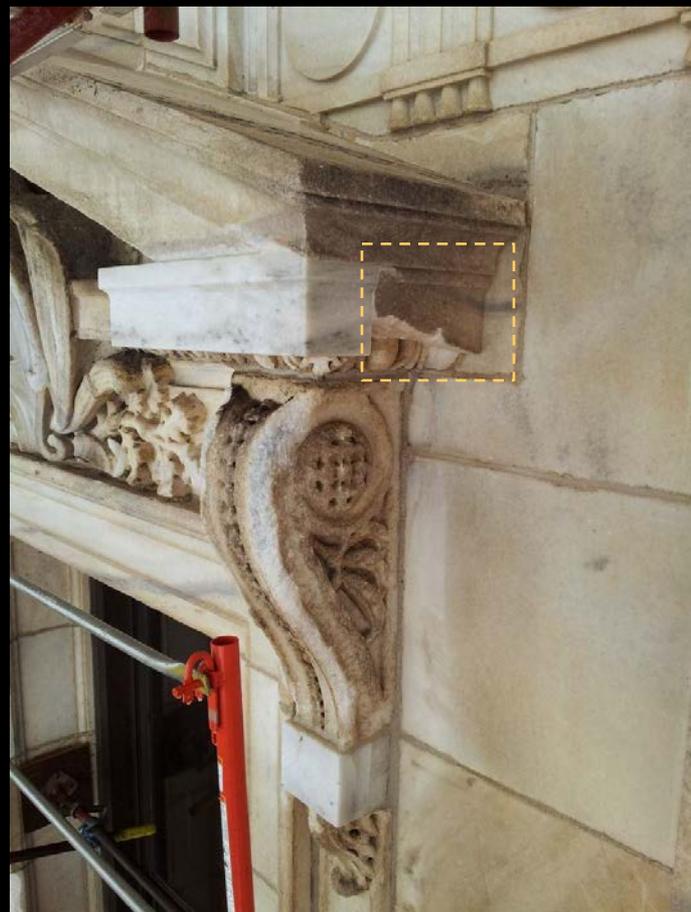
Note: Deterioration was more extensive than initially assumed. The entire length of the return will be replaced in the future (area shown dashed)

- Option A – Aggressive Intervention. Damaged material is **removed** and **restored** with new stone Dutchman replacement.
- Option B – Cementitious patch repairs are no longer acceptable in these locations. Previous patch repairs may actually have accelerated damage to adjacent stone.

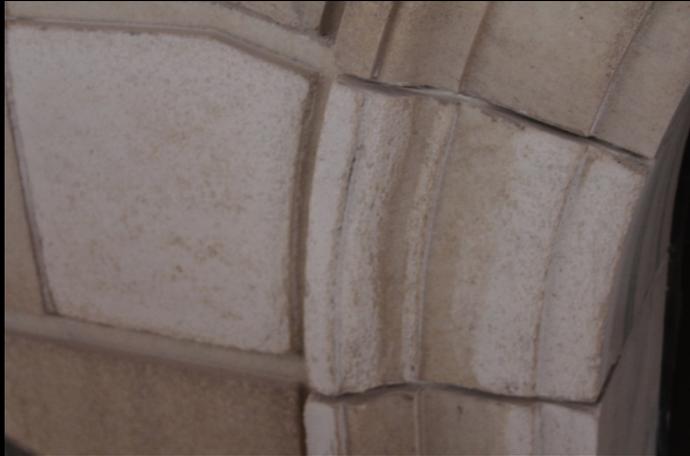
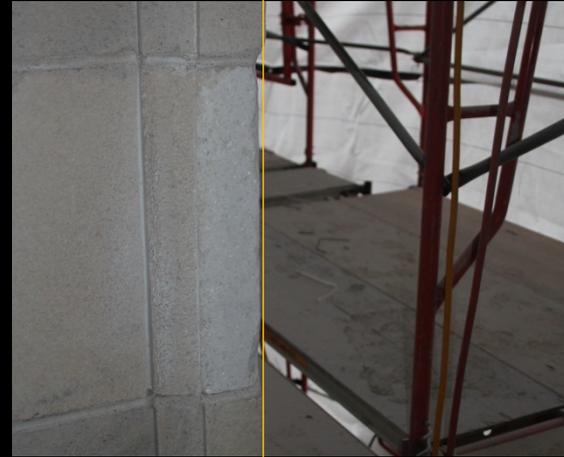
Nearly ¼” of surface material has been removed which is noticeable when viewed from the side

- Option A – Protect. Mild grinding and smoothing of weathered surfaces to improve water runoff. Margins are re-carved and trued uniformly to an established line.
- Option B – Aggressive grinding and smoothing of weathered surface. Surface deterioration is removed to sound stone and surfaces are re-carved and blended to transition to adjacent material.

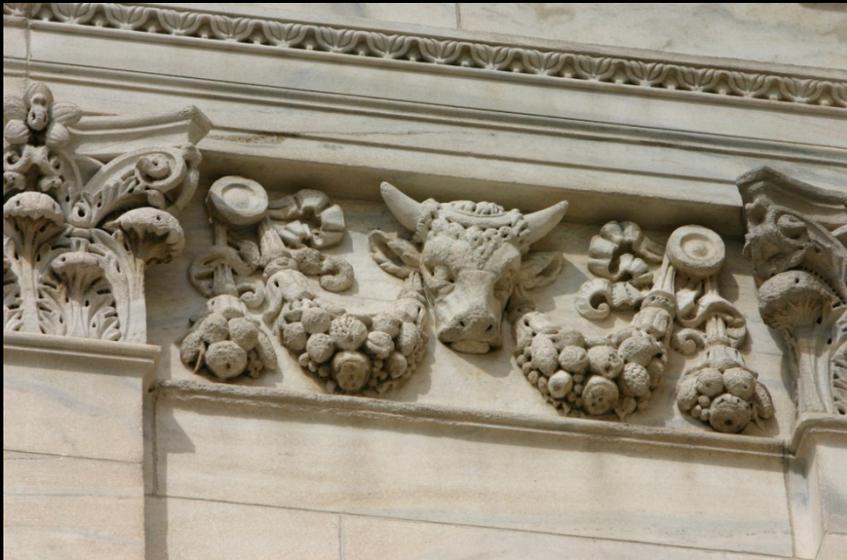
East elevator – east façade high relief detail

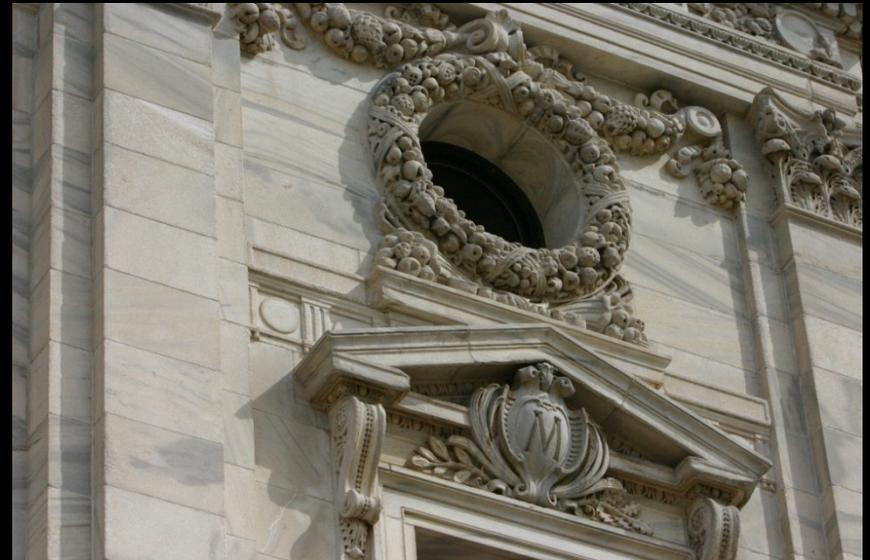
East elevator – south façade high relief detail

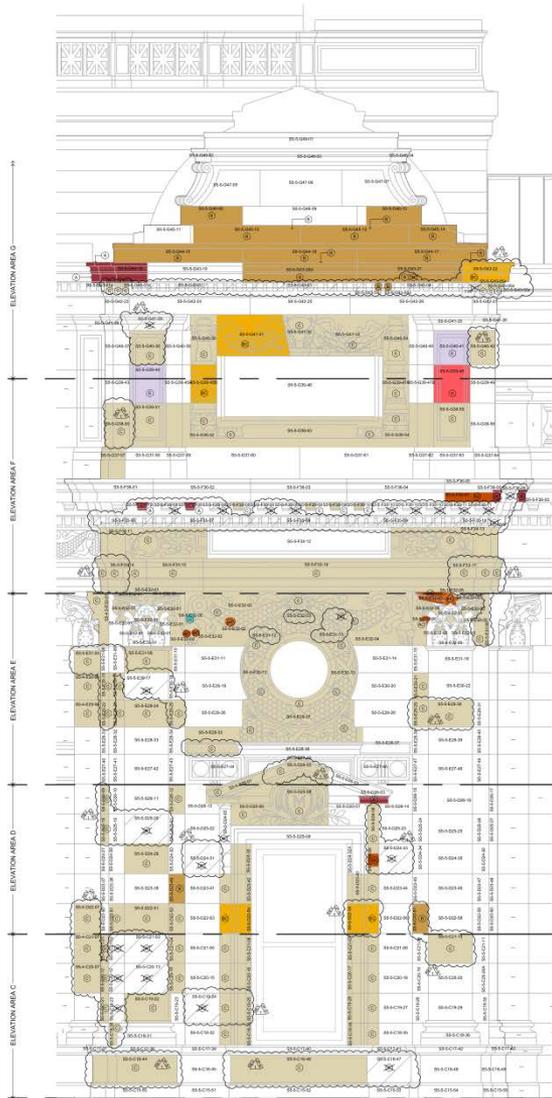
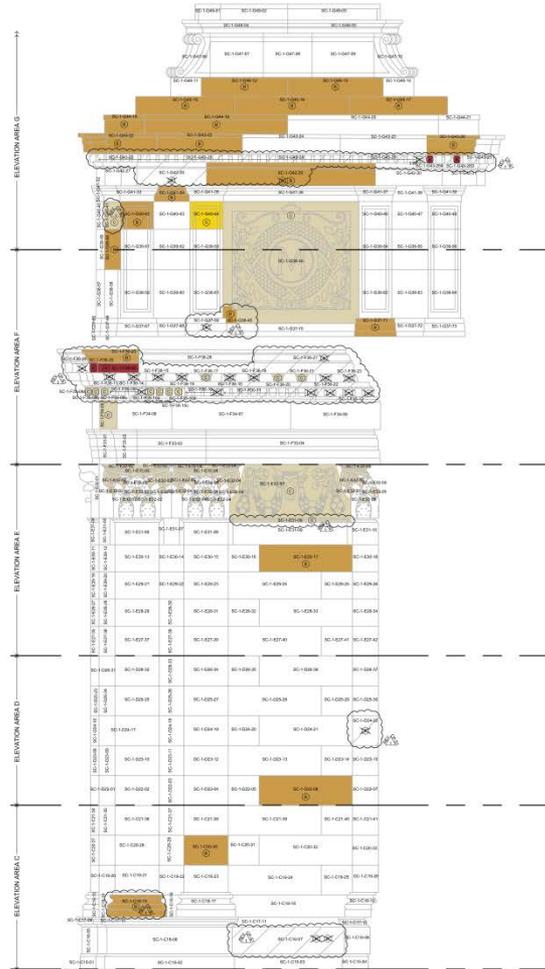
EAST ELEVATOR TOWER ELEVATIONS (DUTCHMAN REPAIRS)
CP-S1
A445

1 EAST ELEVATOR TOWER SOUTH ELEVATION BAY S5-5, SECTIONS C THROUGH G

2 EAST ELEVATOR TOWER EAST ELEVATION BAY S5, SECTIONS C THROUGH G
