# **Requirement Detail Report**

**By Asset Name and Priority**

**State Capital Building (01)**

**Asset Name:** State Capitol Building  
**Asset Number:** 1

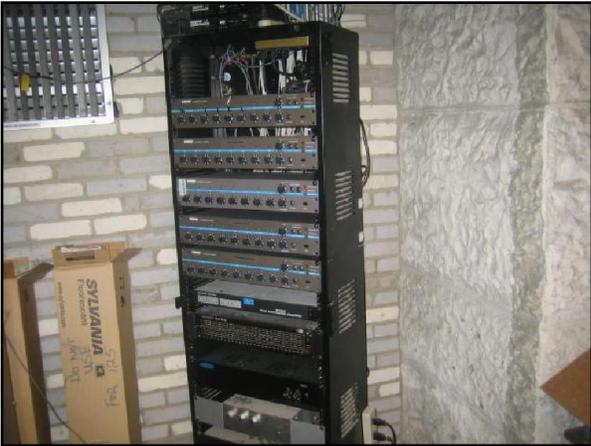
The amplifier serving Room G15 is aged and beyond its useful life in accordance with BOMA (2003) recommendations. The unit is located in Room B36.

Audio Systems - Amplifier Beyond Rated Life - Room B36  
 Audio Systems - Amplifier Beyond Rated Life - Room B36

Replace the aged amplifier located in Room B36. Unit counts for budget purposes only. Actual counts may vary.

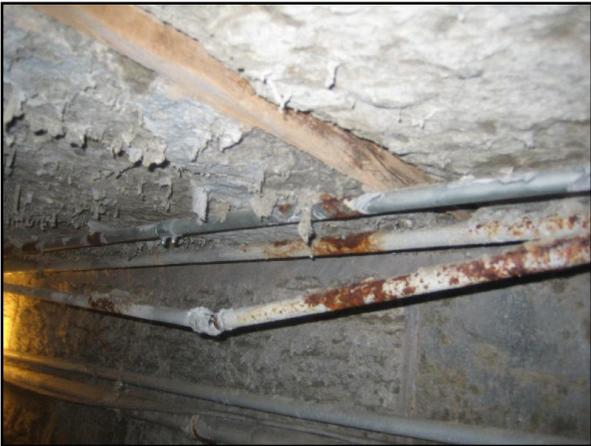
Electrical conduits located on the exterior wall at the South Entrance and in the Ground Floor storage units at the South Entrance are rusted and starting to deteriorate. Conduits in the Basement Tunnel B34A are completely rusted in half exposing the interior wiring. There are also two junction box covers missing in B34A.

Branch Wiring - Conduits Rusted and Deteriorated - Room B34A  
 Branch Wiring - Conduits Rusted and Deteriorated - Room B34A

Replace the rusted conduits on the exterior wall at the South Entrance, in the Ground Floor storage units at the South Entrance, and in the Basement Tunnel B34A. Replace missing junction box covers in B34A.

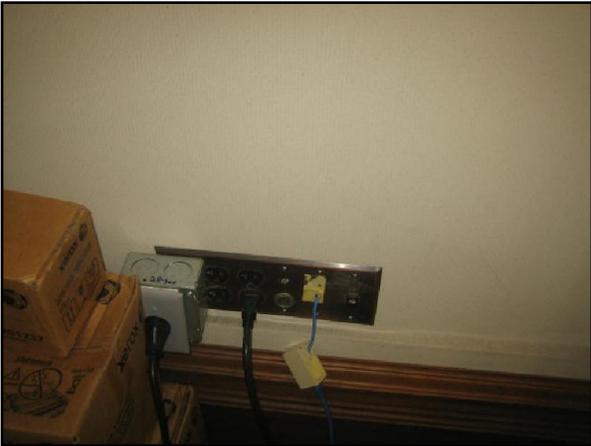
There is a surface mounted junction box and receptacle improperly mounted to a flush mount multiple outlet faceplate in Room 355 in violation of NFPA 70 (2005) Articles 110.3(B) and 110.12.

Branch Wiring - Improper Installation - Room 355  
Branch Wiring - Improper Installation - Room 355

Remove the improperly mounted junction box and receptacle outlet in Room 355 and provide new proper installation. Replace the damaged flush mount faceplate.

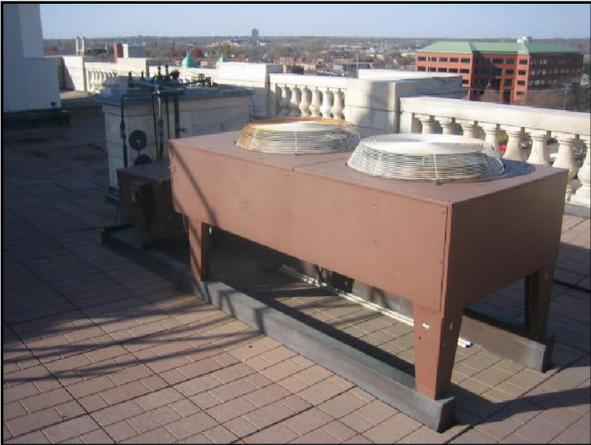
Receptacle outlets are not installed in accessible locations or within 25 feet of all HVAC units on the roof for use by workers servicing the equipment in violation of NFPA 70 (2005) Article 210.63.

Branch Wiring – Outlets Not Installed at HVAC Units

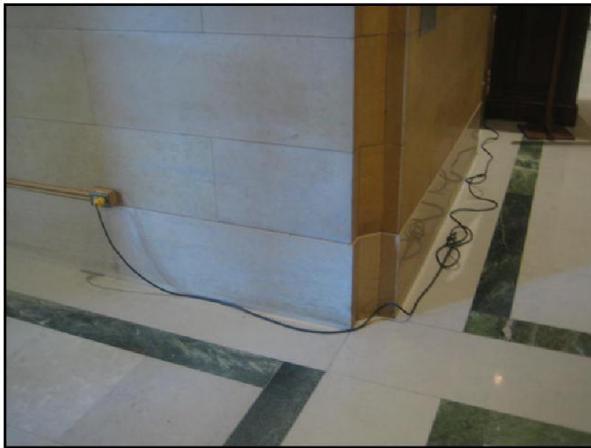
A bronze post lamp located on the second floor at the SE corner of the Rotunda is wired with an extension cord in violation of NFPA 70 (2005) Article 400.8(1).

Bronze Lamp Post - Wired With Extension Cord

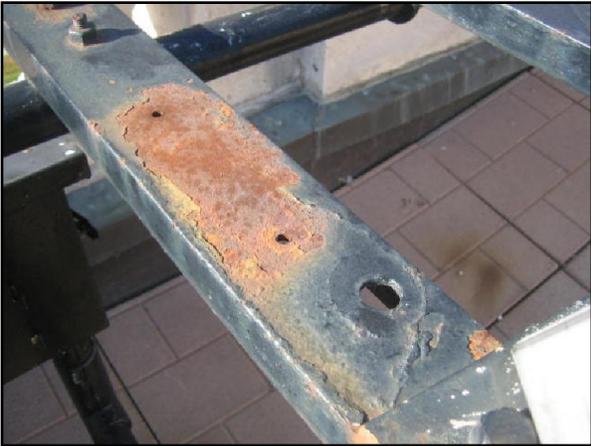
Steel frames on the roof supporting building floodlights are starting to show signs of age with paint peeling and steel supports starting to rust.

Building Floodlights - Luminaire Supports on Roof Starting to Rust  
 Building Floodlights - Luminaire Supports on Roof Starting to Rust

Remove all rust and repaint the steel supports on the roof supporting building floodlights.

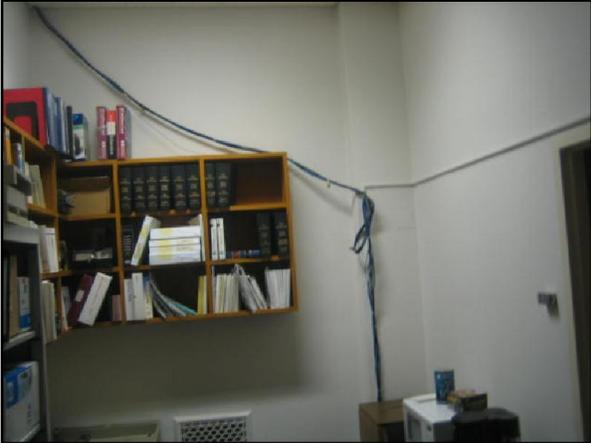
Communications wiring in Room 215 and 218 is hanging from the ceiling without any support and or installed exposed around door frames and baseboard molding in violation of NFPA 70 (2005) Article 800.24.

Communication Wiring - Improperly Installed - Room 215/218  
 Communication Wiring - Improperly Installed - Room 215/218

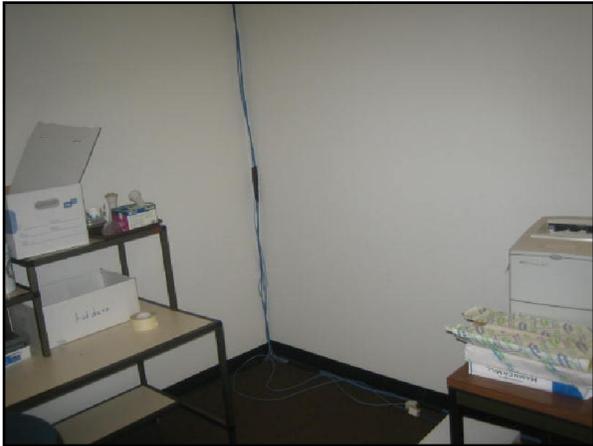
Communications wiring in Room 317A/B/C is laying on the floor in violation of NFPA 70 (2005) Article 800.24.

Communication Wiring - Improperly Installed - Room 317  
 Communication Wiring - Improperly Installed - Room 317

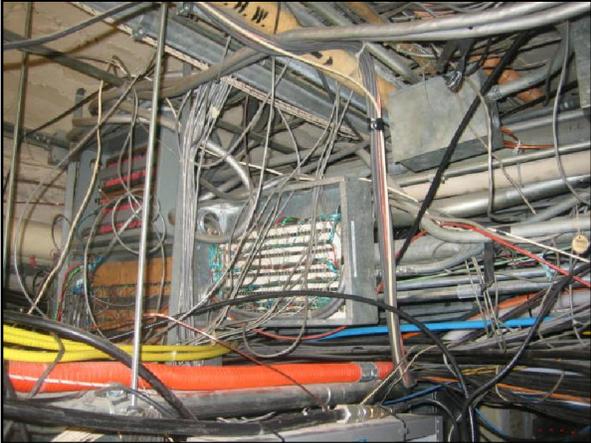
Communications wiring in Room B31 is poorly installed with lack of proper supports in violation of NFPA 70 (2005) Articles 800.24, 300.4(D) and 300.11.

Communication Wiring - Poor Installation - Room B31

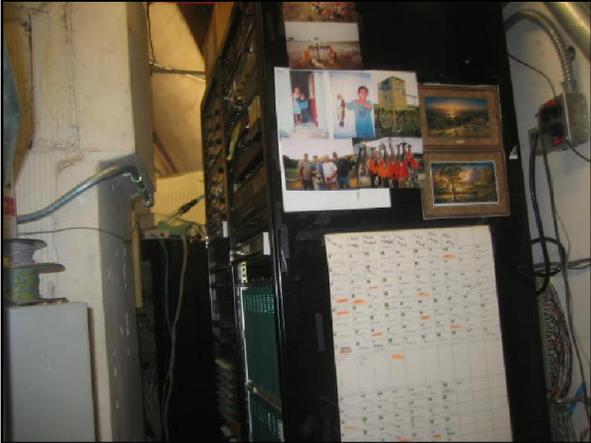
The computer servers located in the closet off of Room 214 are installed such that working space about the equipment is insufficient for personnel to service the equipment in violation of NFPA 70 (2005) Article 110.26.

Computer Servers - Insufficient Working Space - Room 214  
 Computer Servers - Insufficient Working Space - Room 214

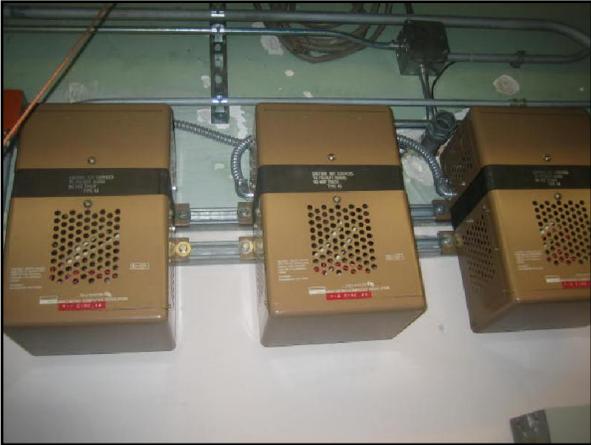
Note: During the 2010 assessment, it could not be determined what the regulators were connected to. The regulators are extremely loud and should be replaced as soon as possible or removed if no longer required.

Electrical Power Distribution - Computer Regulators Renewal  
 Electrical Power Distribution - Computer Regulators Renewal

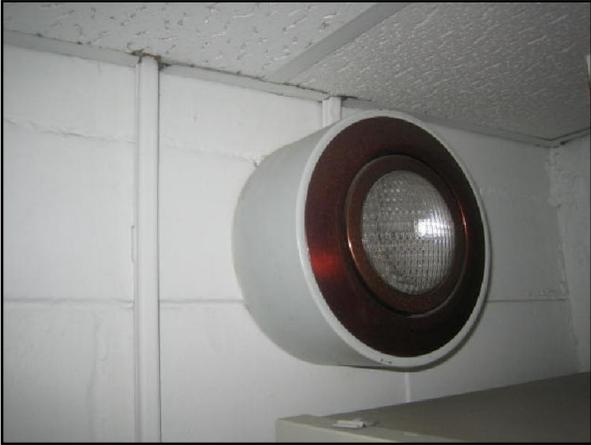
Emergency lighting is not provided for all means of egress throughout the building in violation of NFPA 101 (2006) Section 7.9. Existing emergency lighting consists of a minimal number of aged low voltage units in various areas of the building. Per maintenance personnel, during power outages, emergency lighting is inadequate with many areas and floors left in the dark.

Emergency Lighting - Inadequate  
 Emergency Lighting - Inadequate

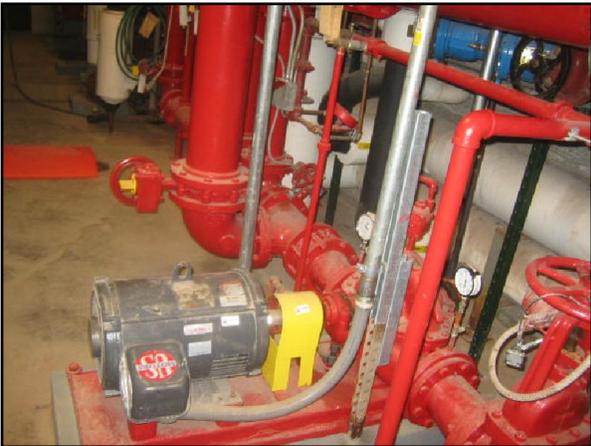
Fire Pump – Circuit Conductors Not Fire Rated  
 Fire Pump – Circuit Conductors Not Fire Rated

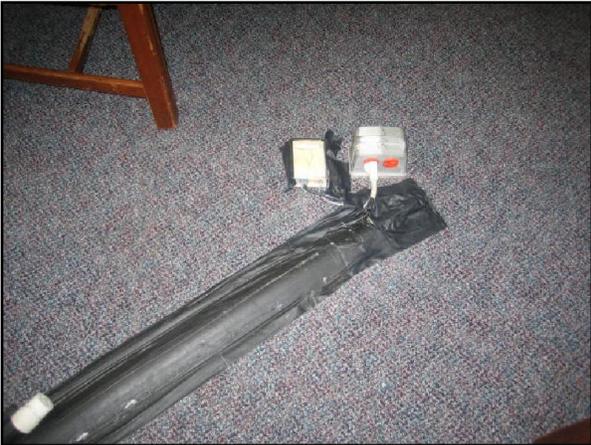
Floor Duct - Floor Raceway Outlets Improperly Located  
 Floor Duct - Floor Raceway Outlets Improperly Located

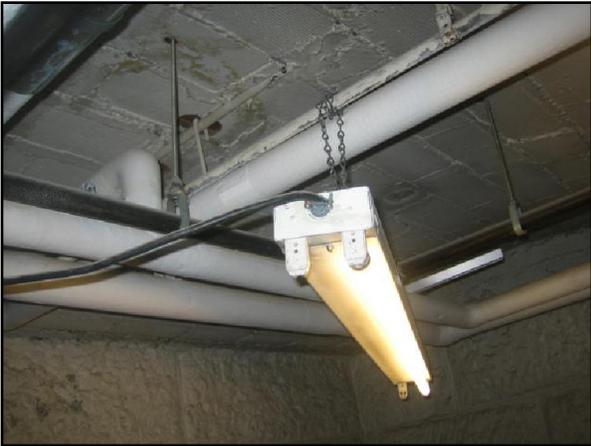
Fluorescent Lighting - Wired With Extension Cord - Room B60  
 Fluorescent Lighting - Wired With Extension Cord - Room B60

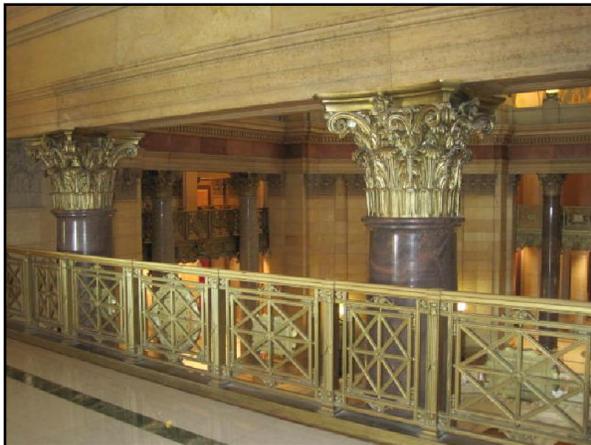
Guardrails - Non-Compliant Heights - Rotunda - Third Floor

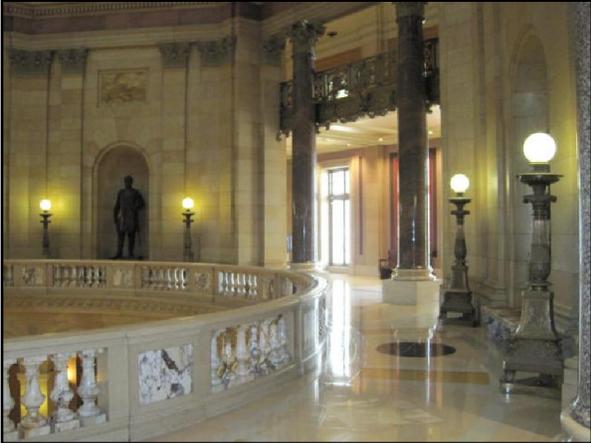
Guardrails - Non-Compliant Heights - Rotunda and Stair Galleries - Second Floor

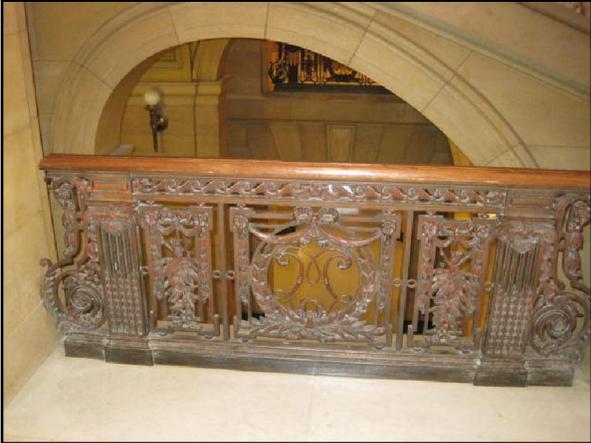
Guardrails - Non-Compliant Heights - Stair Galleries - First Floor

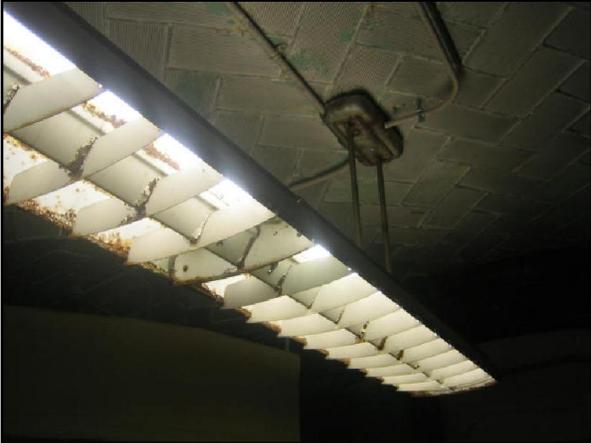
Lighting and Branch Wiring - Beyond Rated Life - Room G21A

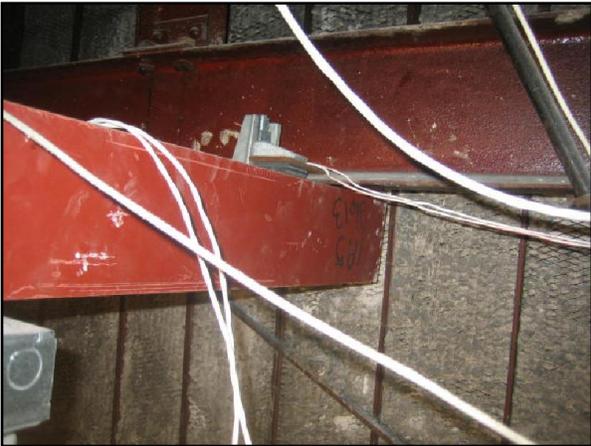
Local Area Networks – Communications Wiring Improperly Supported - Attic  
 Local Area Networks – Communications Wiring Improperly Supported - Attic

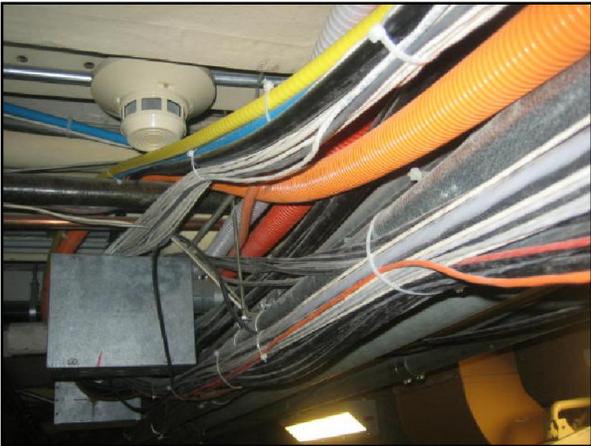
Local Area Networks – Communications Wiring Improperly Supported - Basement Corridor  
 Local Area Networks – Communications Wiring Improperly Supported - Basement Corridor

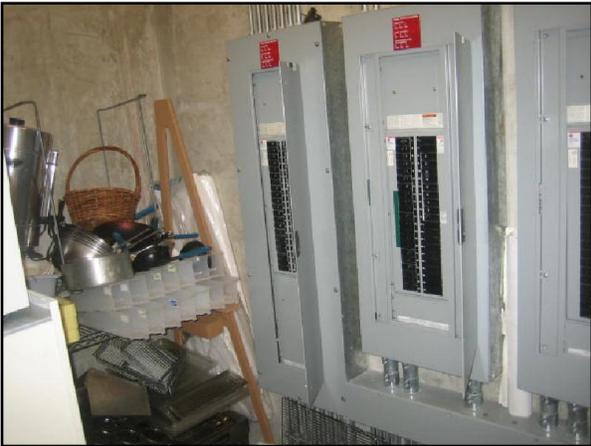
Panelboards – Inadequate Working Space - Basement  
 Panelboards – Inadequate Working Space - Basement

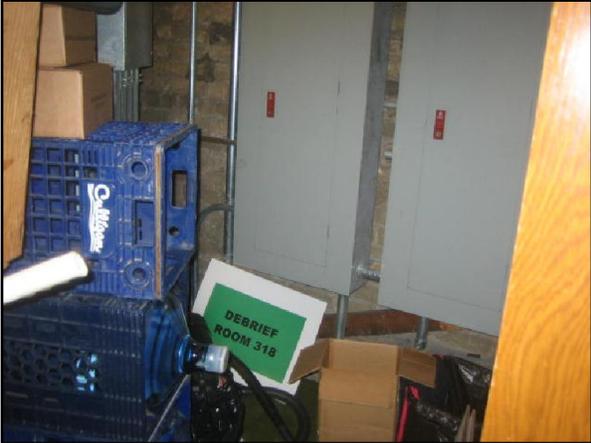
Panelboards – Inadequate Working Space - Second Floor  
 Panelboards – Inadequate Working Space - Second Floor

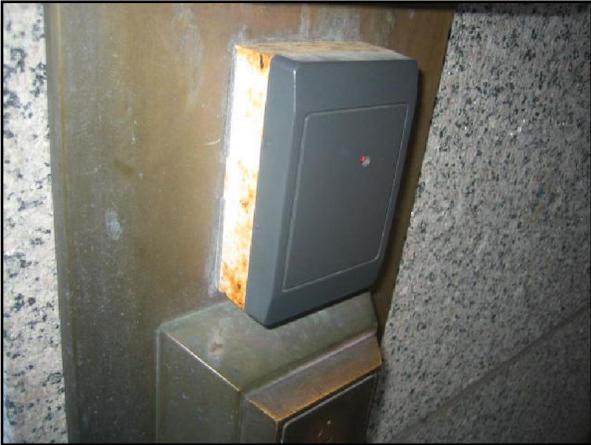
Access Control - Exterior Back Boxes Rusted  
 Access Control - Exterior Back Boxes Rusted

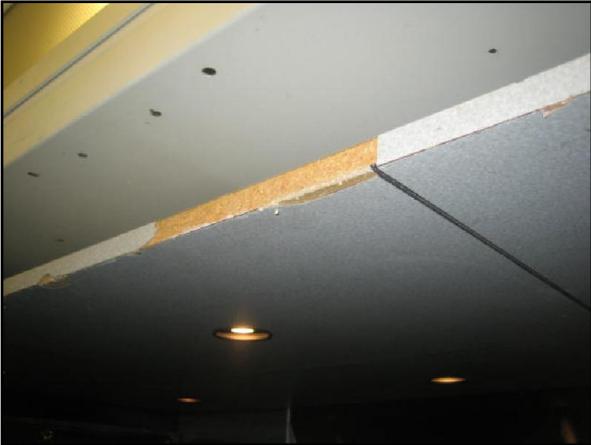
Elevator Cab #3 - Damaged Ceiling and Floor  
Elevator Cab #3 - Damaged Ceiling and Floor

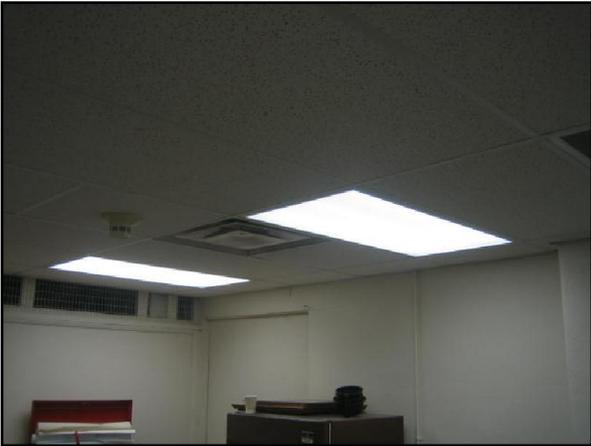
Fluorescent Lighting - Approaching Rated Life  
 Fluorescent Lighting - Approaching Rated Life

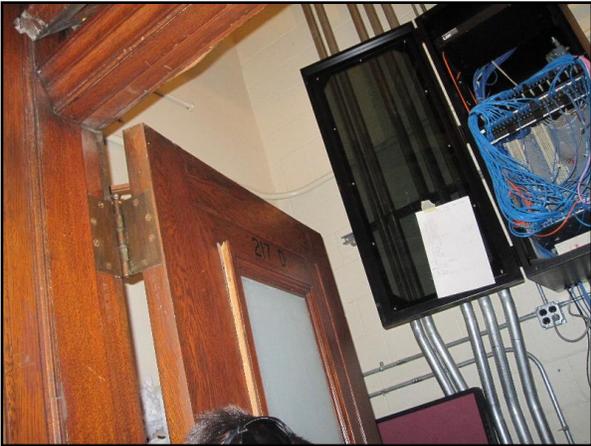
Tel / Data Room - Cooling Inadequate  
 Tel / Data Room - Cooling Inadequate

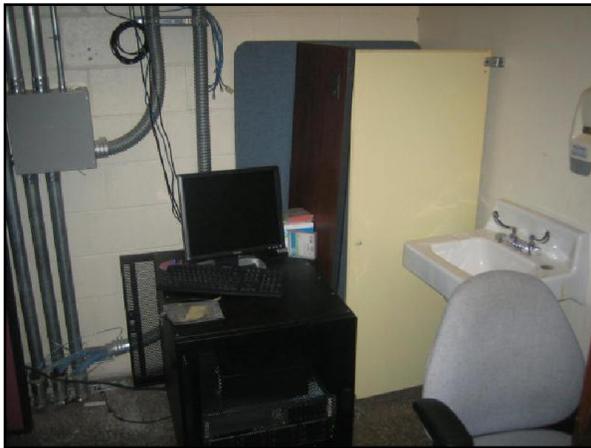
Computer Servers - Poor Location - Room 217D

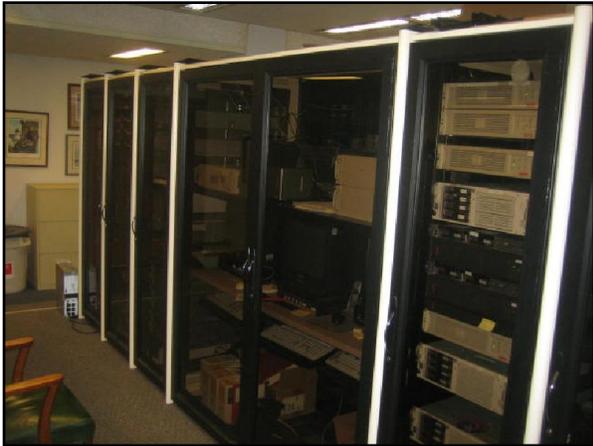
Computer Servers - Poor Location - Room G38  
 Computer Servers - Poor Location - Room G38

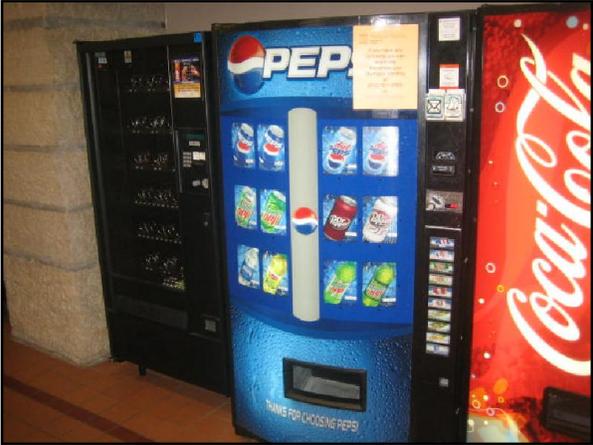
Branch Wiring - Outlets at Vending Machines Not GFCI Type - Cafeteria  
 Branch Wiring - Outlets at Vending Machines Not GFCI Type - Cafeteria

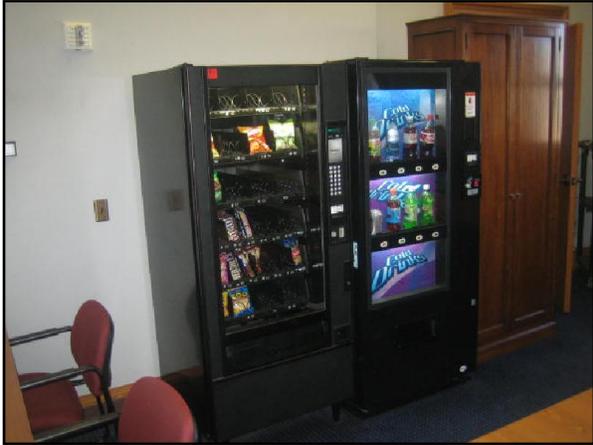
Branch Wiring - Outlets at Vending Machines Not GFCI Type - Room 315

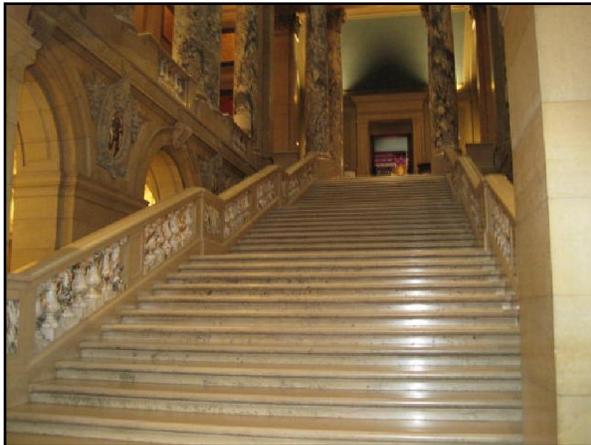
Interior Stairs - Missing or Non-Compliant Handrails - East Monumental Stairs

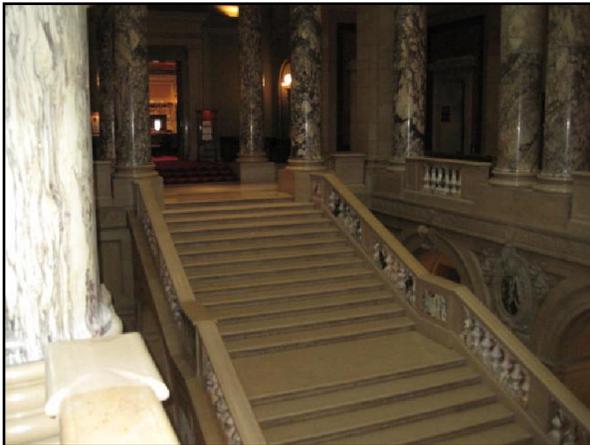
Interior Stairs - Missing or Non-Compliant Handrails - West Monumental Stairs
