Phase I Environmental Site Assessment

Ainsworth Engineered LLC
Grand Rapids OSB Plant
502 County Road 63
Grand Rapids, MN 55744

Project #20-002

June 1, 2009

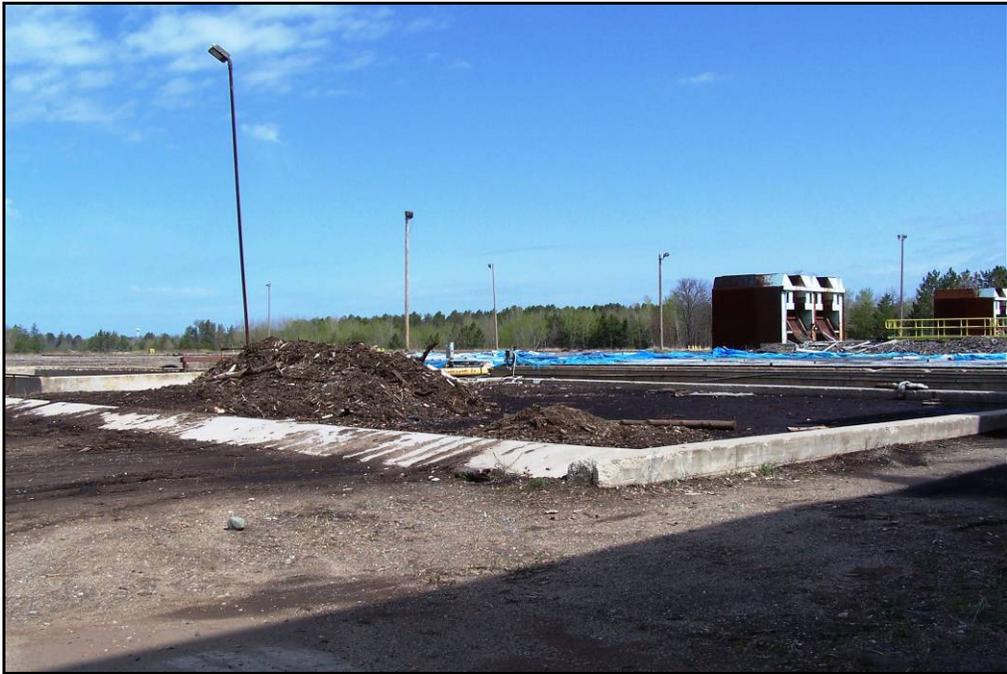
Periodically, log-conditioning ponds were drained and cleaned in order to perform repairs and maintenance on the log chain system. The soil and other organic material removed during this cleaning process was placed on a large concrete dewatering pad for further disposal. The process water was collected in a small sump and pumped back into the log pond system. Dewatered solids were tested as part of the waste stream characterization. Test data going back to 1993 supports that the pond soil is not a hazardous waste, but has been classified as petroleum-contaminated soil. This material has been disposed of by transporting it to a licenses composting facility, where the petroleum products break down and then the soil can be used as landfill cover or for other similar topsoil purposes. Occasionally, soil would have to be relocated from the dewatering pad prior to sending it off site, In these instances, the material was placed on impermeable liners and bermed to prevent any ground water contamination. The 2006 aerial photograph (Figure 6) shows one such storage application just to the west of the manufacturing buildings and north of logyard D. As of December 2008, there is approximately 150 yd³ of pond on the dewatering pad and in the bottom of the overflow pond pending disposal. This material has been tested and will require composting (photograph 3).

Photograph 3: Pond Soil on Dewatering Pad (Section 6.1.3.2.)

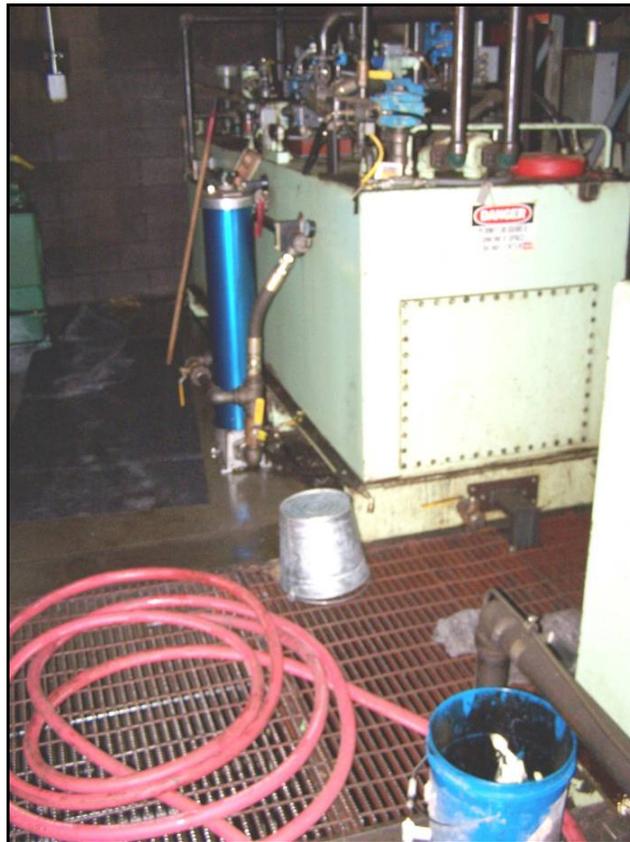
- Standing oil in the concrete containment area under the press hydraulic system is indicative of a material threat of a petroleum release into the ground,
- Standing oil and water are present in the mobile equipment shop floor drain sump. This space is unheated and a frozen sump could crack and release petroleum products into the ground.

Photograph 4: Oil at Press Hydraulic System (Section 6.1.4)

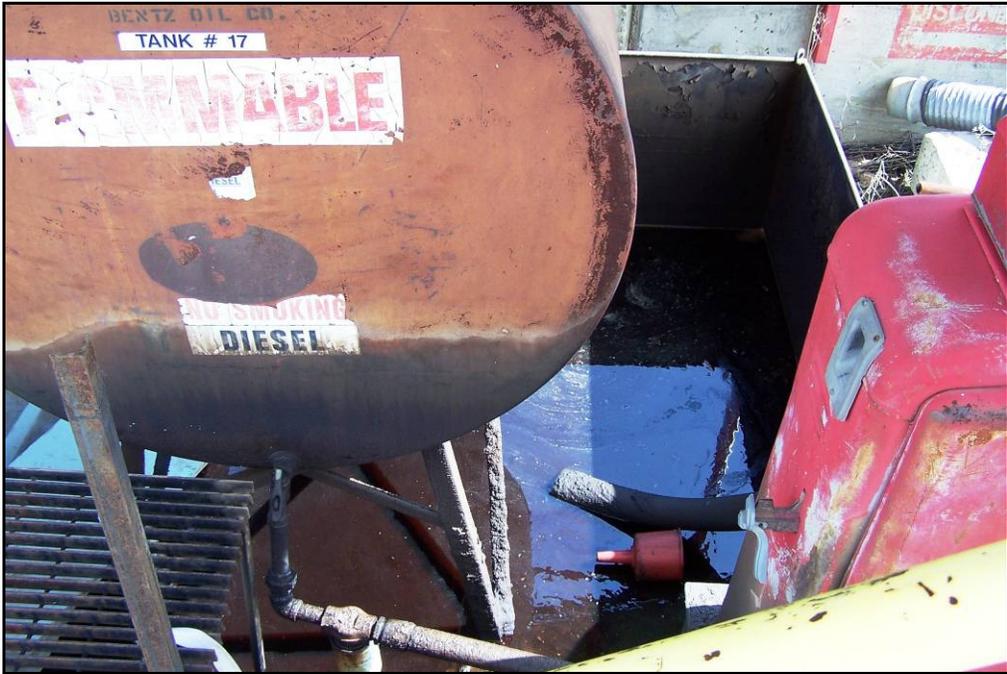
- The existing aboveground storage tank and pump associated with mobile equipment refueling. Refueling occurred on unpaved surfaces, there have been past spills inside the secondary containment area and having an uncoated steel containment in direct contact with unpaved soil are all conditions indicative of a material threat of petroleum releases into the ground from this activity.

The only storage tank located outside a building is a 585 gallon diesel fuel tank used for weekend filling of logyard mobile equipment. This tank includes steel secondary containment area that is set directly on unpaved soil and a roof to minimize rainwater accumulation within the containment area. The pump and all associated piping is above ground and the area is protected from inadvertent damage by large concrete blocks placed near the containment. Refueling from this diesel tank occurs on an unpaved surface (photograph 6). There was a mixture of water and petroleum in the containment area as of May 2009 (photograph 7).

Photograph 7: Diesel Refueling Station Containment (Section 6.1.4)

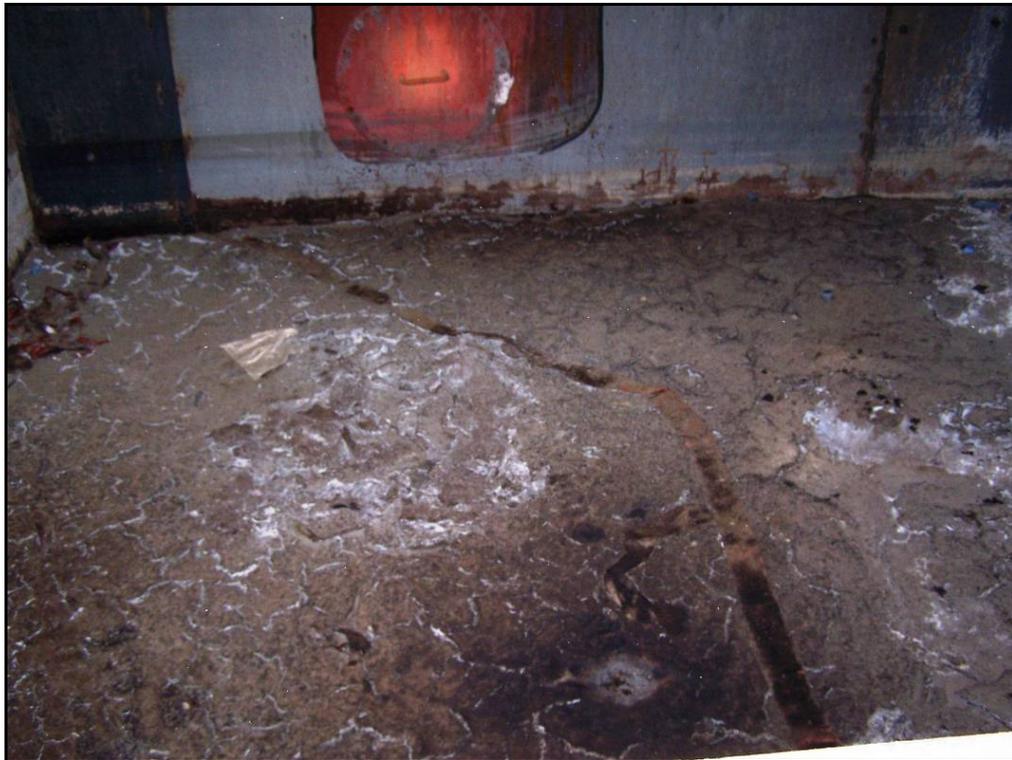
- The presence of dried caustic soda and wood dust inside that specific secondary containment area indicated product remained in the containment long enough for the water to evaporate from the solution. This is a condition indicative of a material threat of a hazardous substance release into the soil or groundwater.

The caustic soda solution storage tank is located within one of the buildings and has a secondary containment area that will hold more than the tank's capacity. As of May 2009, there was approximately 3" of dried residue within the containment. The residue appears to be a combination of wood dust and dried sodium hydroxide solution. The residue was dried and cracked, indicating that the material had been in the containment long enough for any liquids to evaporate (photograph 8).

Photograph 8: WESP Caustic Tank Secondary Containment (Section 6.1.4)

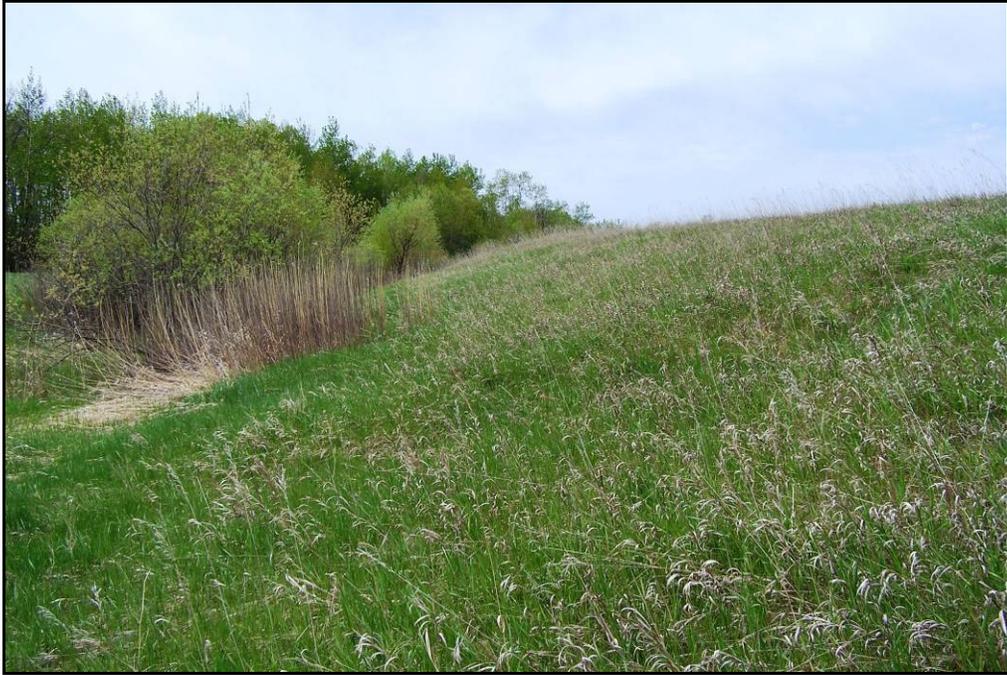
There is a closed, capped, bark filled landfill (SW-853) on the Subject Property. Located south of the manufacturing buildings, this area is visible by comparing the 1975 and 1991 aerial photographs (Figures 6 and 7 respectively). The landfill cover had typically been mowed once per year to maintain a vegetative cover. This was not completed in 2007, 2008 or yet in 2009. I physically inspected the landfill cap over the summers of 2007, 2008 and as recently as May 15, 2009. The cap appeared to be in adequate condition at the times of inspection (photograph 9).

Photograph 9: Closed Bark Landfill, South Edge Vegetation (Section 6.1.5)

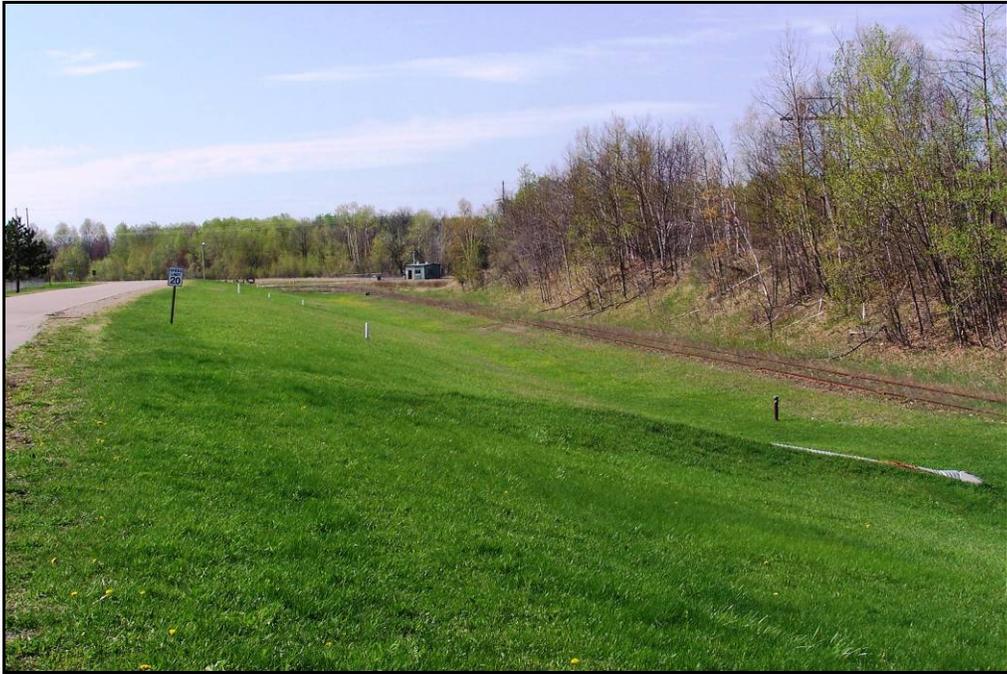
The facility installed three new septic system drain fields in October 2004, as the original drain fields failed performance inspections required at the time of the facility sale from Potlatch to Ainsworth. System #1 is a small system serving a bathroom at the southeast corner of the shipping area (photograph 12). System #2 is another small drain field serving the wood scale house at the north entrance to the Subject Property (photograph 13). Septic system #3 is the main drain field for the facility and is located west of the log truck entrance road between the road and railroad tracks, directly west of the original drain field location (photograph 14).

Photograph 14: Septic Drain field #3 for Manufacturing Area (Section 6.1.7.1)

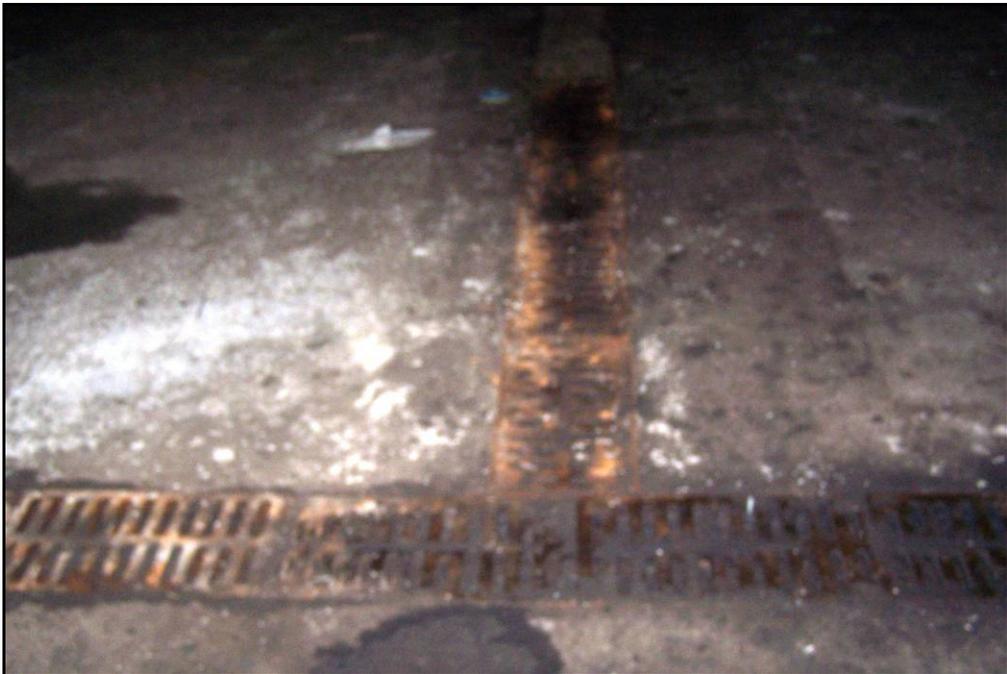
Photograph 16: Mobile equip shop floor trench (Section 6.1.7.2)

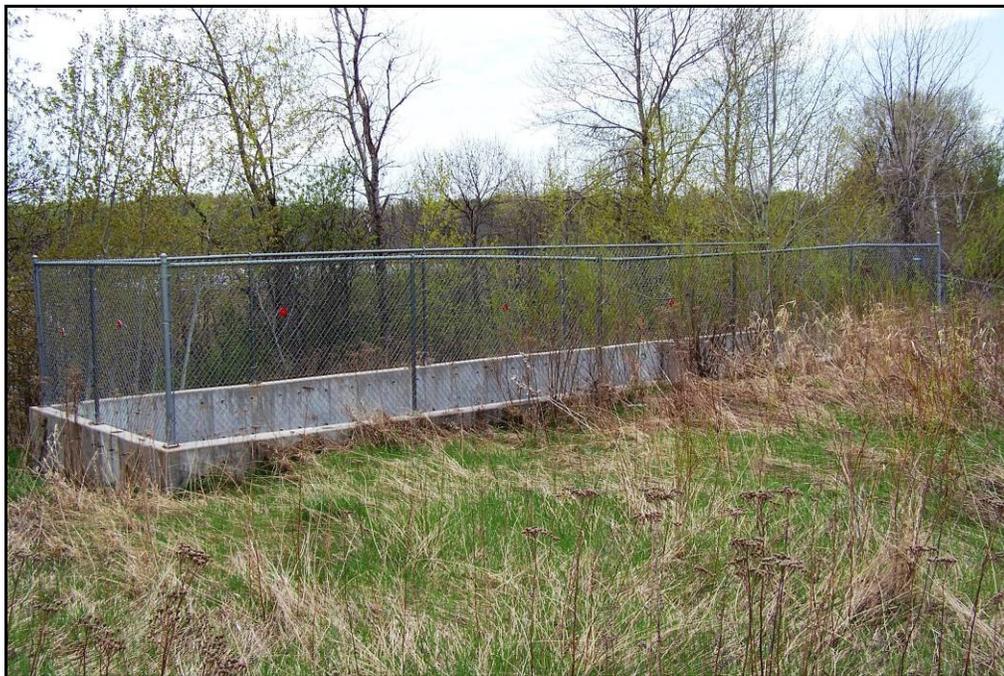
The Subject Property has a system of culverts and open ditches to route surface storm water away from buildings and manufacturing areas. All surface water eventually drains into the Mississippi River or infiltrates into groundwater. There is one structural feature that directly relate to stormwater management, a large concrete containment basin on the east side of the Subject Property connected to an underground stormwater pipe collecting any water from an area between the main manufacturing buildings. This feature includes two open chambers separated by a wooden weir to dissipate any energy and allow suspended solids to settle before eventually discharging via an open ditch filled with riprap into the eastern wetland and eventually the Mississippi River (photographs 18, 19).

Photograph 18: Stormwater detention basin (Section 6.1.8)

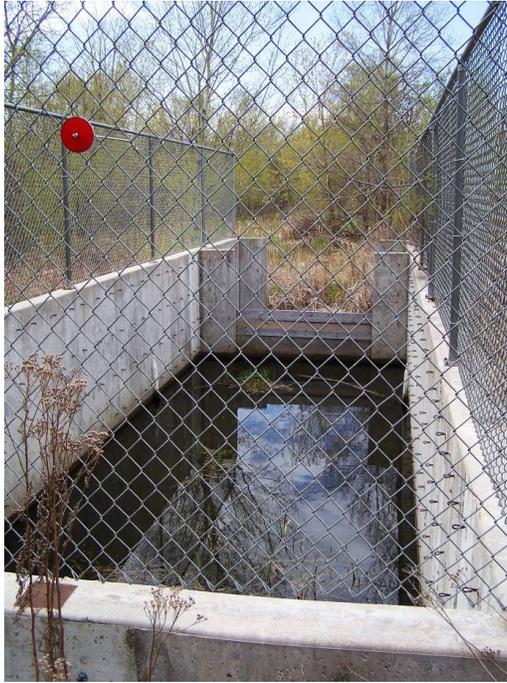
Photograph 19: SW detention basin interior (Section 6.1.8)
