MINNESOTA STATE CAPITOL
HISTORIC STRUCTURES REPORT
VOLUME 2.2.3

FIRST FLOOR SPACE INVENTORY AND CONDITIONS

Section 2.2.3
 First Floor Conditions Assessment
 Historic Structures Report

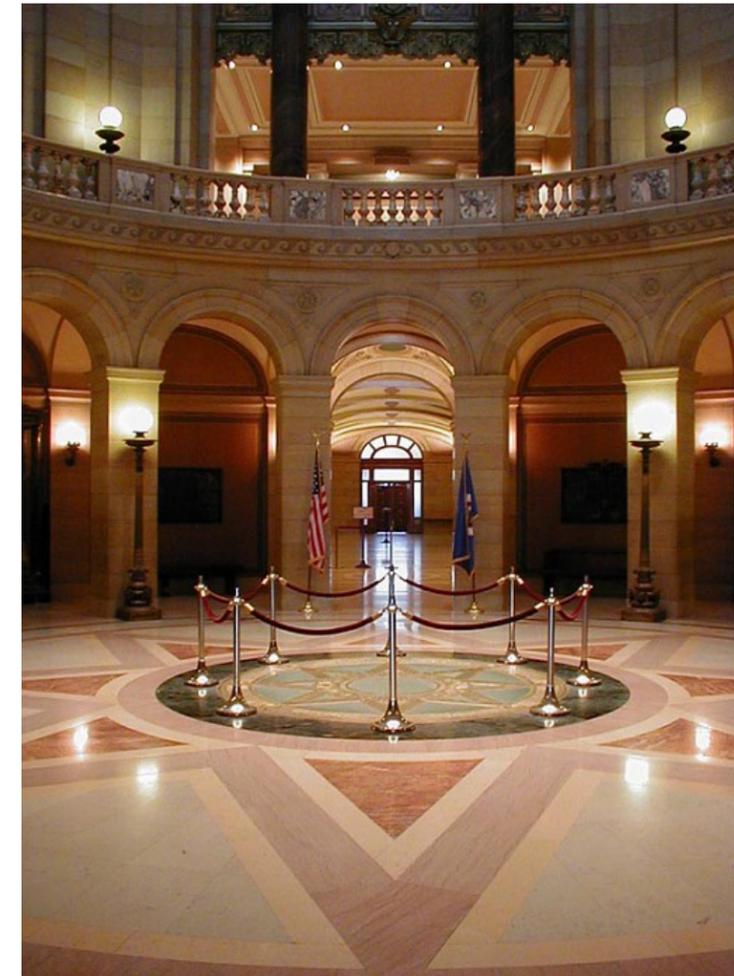
Rotunda
F150
Treatment Level: 1

Same as above with the exception of paint colors. Plaster panels are painted light brown with stenciled border. Green, dark brown and brown floral motif stenciling between gold border line trim. Lunettes follow the same color scheme with line trim. Ceiling of the side aisle is painted buff. Five original settees set against plaster panels. See significant alterations for additions to rotunda.

Building Element:	Description:	Condition of Material:
Floor	Joliet Limestone, various marble	Intact
Walls	Kasota Stone/Plaster	Intact
Ceiling/Cornice	Plaster/paint	Intact
Doors/Frame:	None	None
Hardware	None	None
Light Fixtures	Candel and wall mounted fixtures	Intact/Restored
Artwork	Extensive	Intact
Mechanical	Bronze decorative Grilles	Intact
Trim	Plaster/stone	Intact

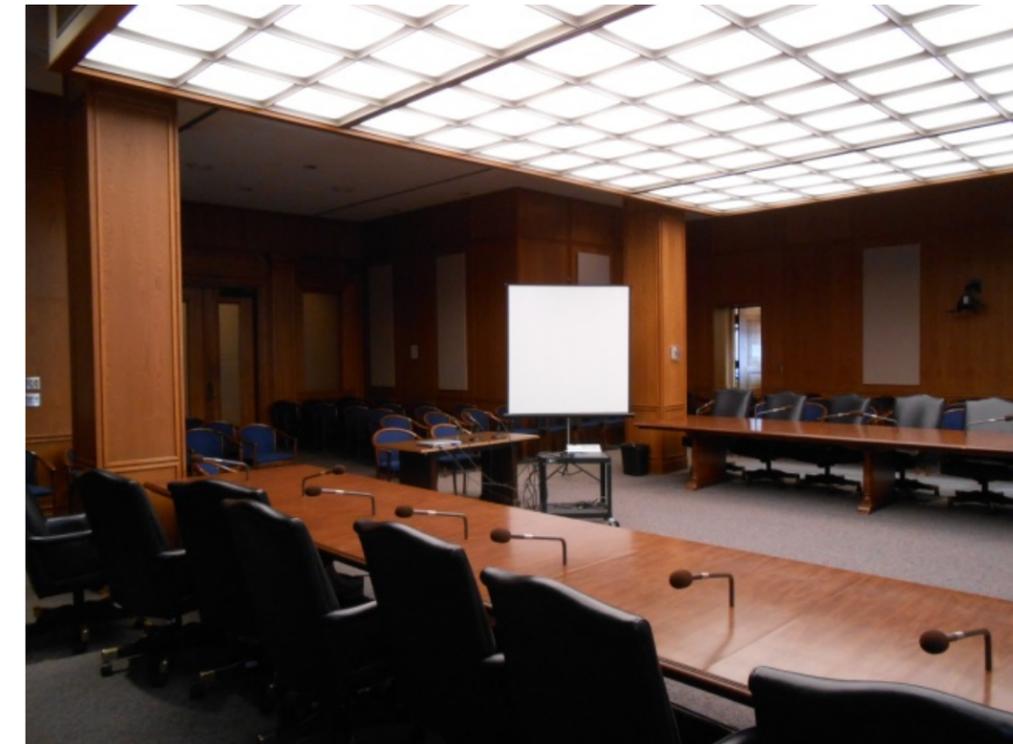
Hearing Room, paneling, ceiling not original. Original oak trim around entry door.

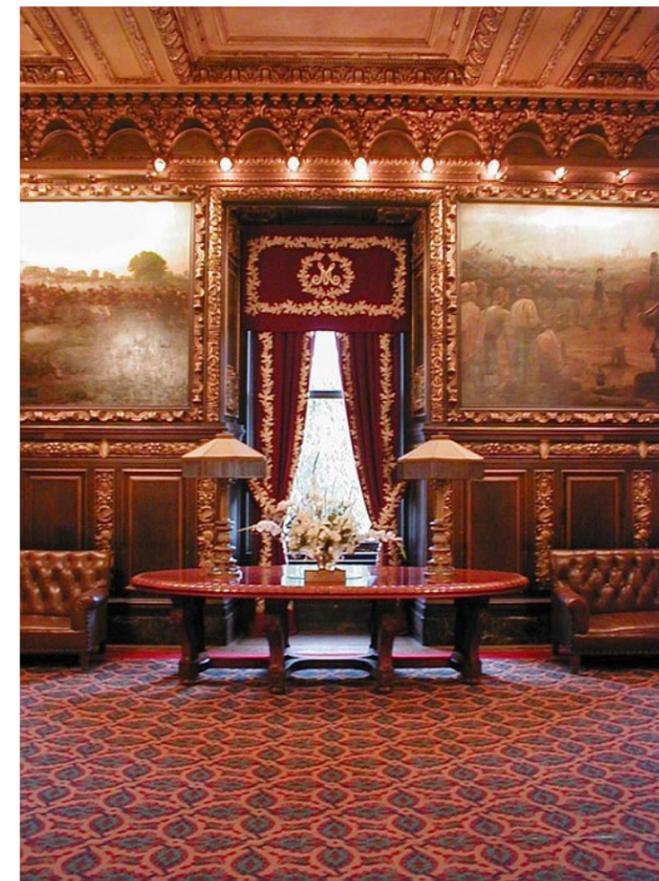
Building Element:	Description:	Condition of Material:
Floor	Inlaid mahogany, with period replica carpet	Water damage to floor near windows
Walls	Mahogany panels and plaster	Intact
Ceiling/Cornice	Decorative Plaster	Intact
Doors/Frame:	Wood, see door section	Intact, some have worn gilding
Hardware	Original knobs and ADA levers	See door section
Light Fixtures	Historic Chandelier, non historic spot lighting	intact
Artwork	Large framed paintings, ornamental scrollwork, gilded carvings	Intact
Mechanical	Cast iron decorative Grilles	Intact
Trim	Mahogany	Intact

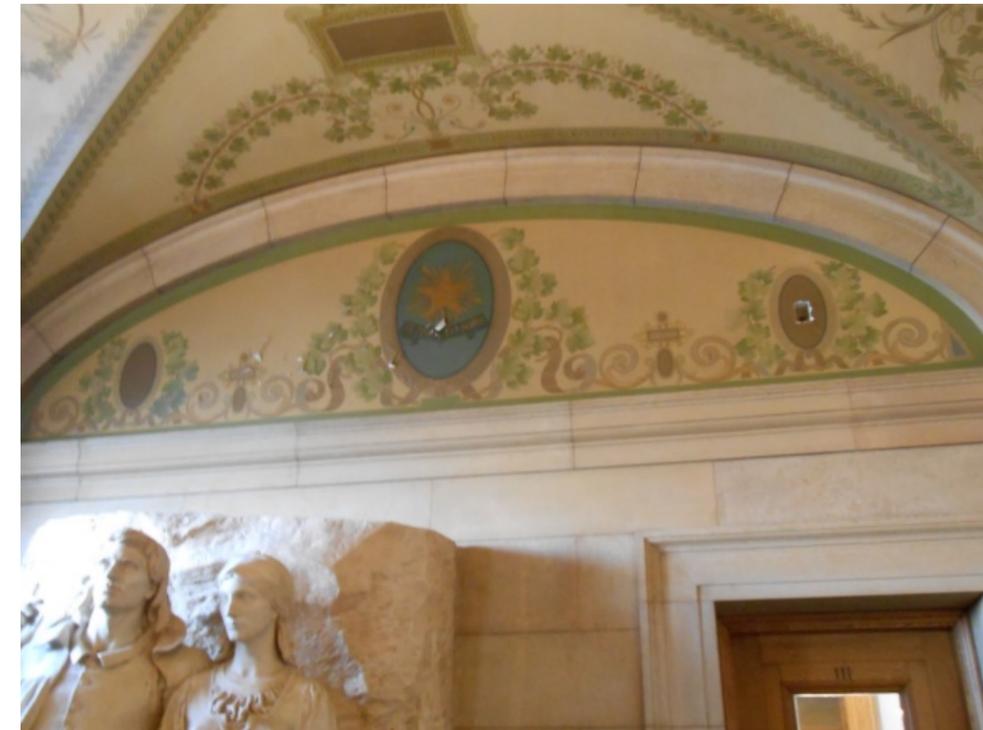
The North Entry is closed to the public when the Legislature is not in session. It is not ADA accessible. miscellaneous stone patching required. Small areas of plaster damage at ground level throughout corridor.

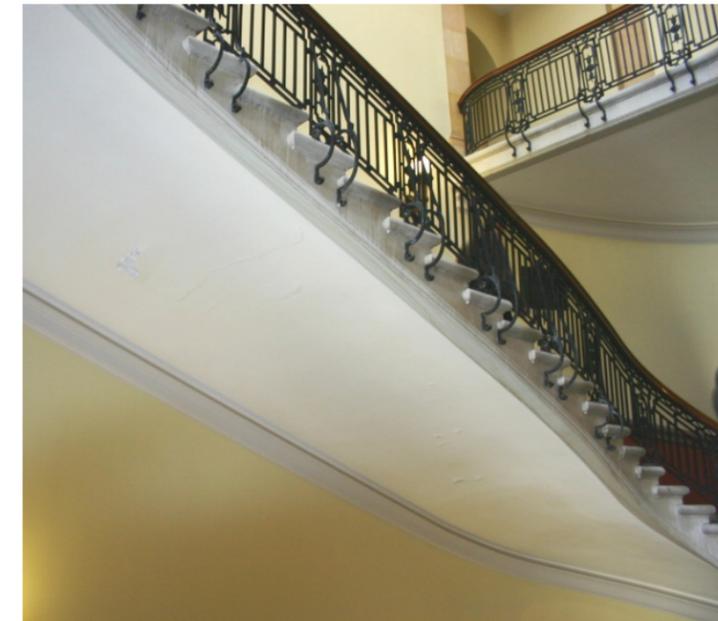
This distinctive stair, also called the ‘House Stair,’ is canilevered from the walls using a Guastavino tile system. Largely intact, some of the treads show signs of deterioration, and damage is described on the floor most appropriate to its location.

Building Element:	Description:	Condition of Material:
Floor	Marble treads	Some wear, unevenness
Walls	Plaster with tenn. Marble handrail	Intact
Ceiling/Cornice	Plaster with decorative painting	Some plaster damage on underside of stair
Doors/Frame:	Openings cased with marble, no doors	Intact, see stone section
Hardware		
Light Fixtures	Historic Torcheres and wall mounted uplights	Original
Artwork	Ornate skylight	intact
Mechanical	Bronze decorative Grilles	Intact
Trim	Marble	Intact
