**State of
Minnesota
Department of
Human Services
Saint Peter
Regional
Treatment Center**

MASTER PLAN REPORT

October 30, 2009

**Architect, Structural,
Mechanical, Electrical
Engineer
BKV Group
222 North Second Street
Minneapolis, Minnesota
55401**

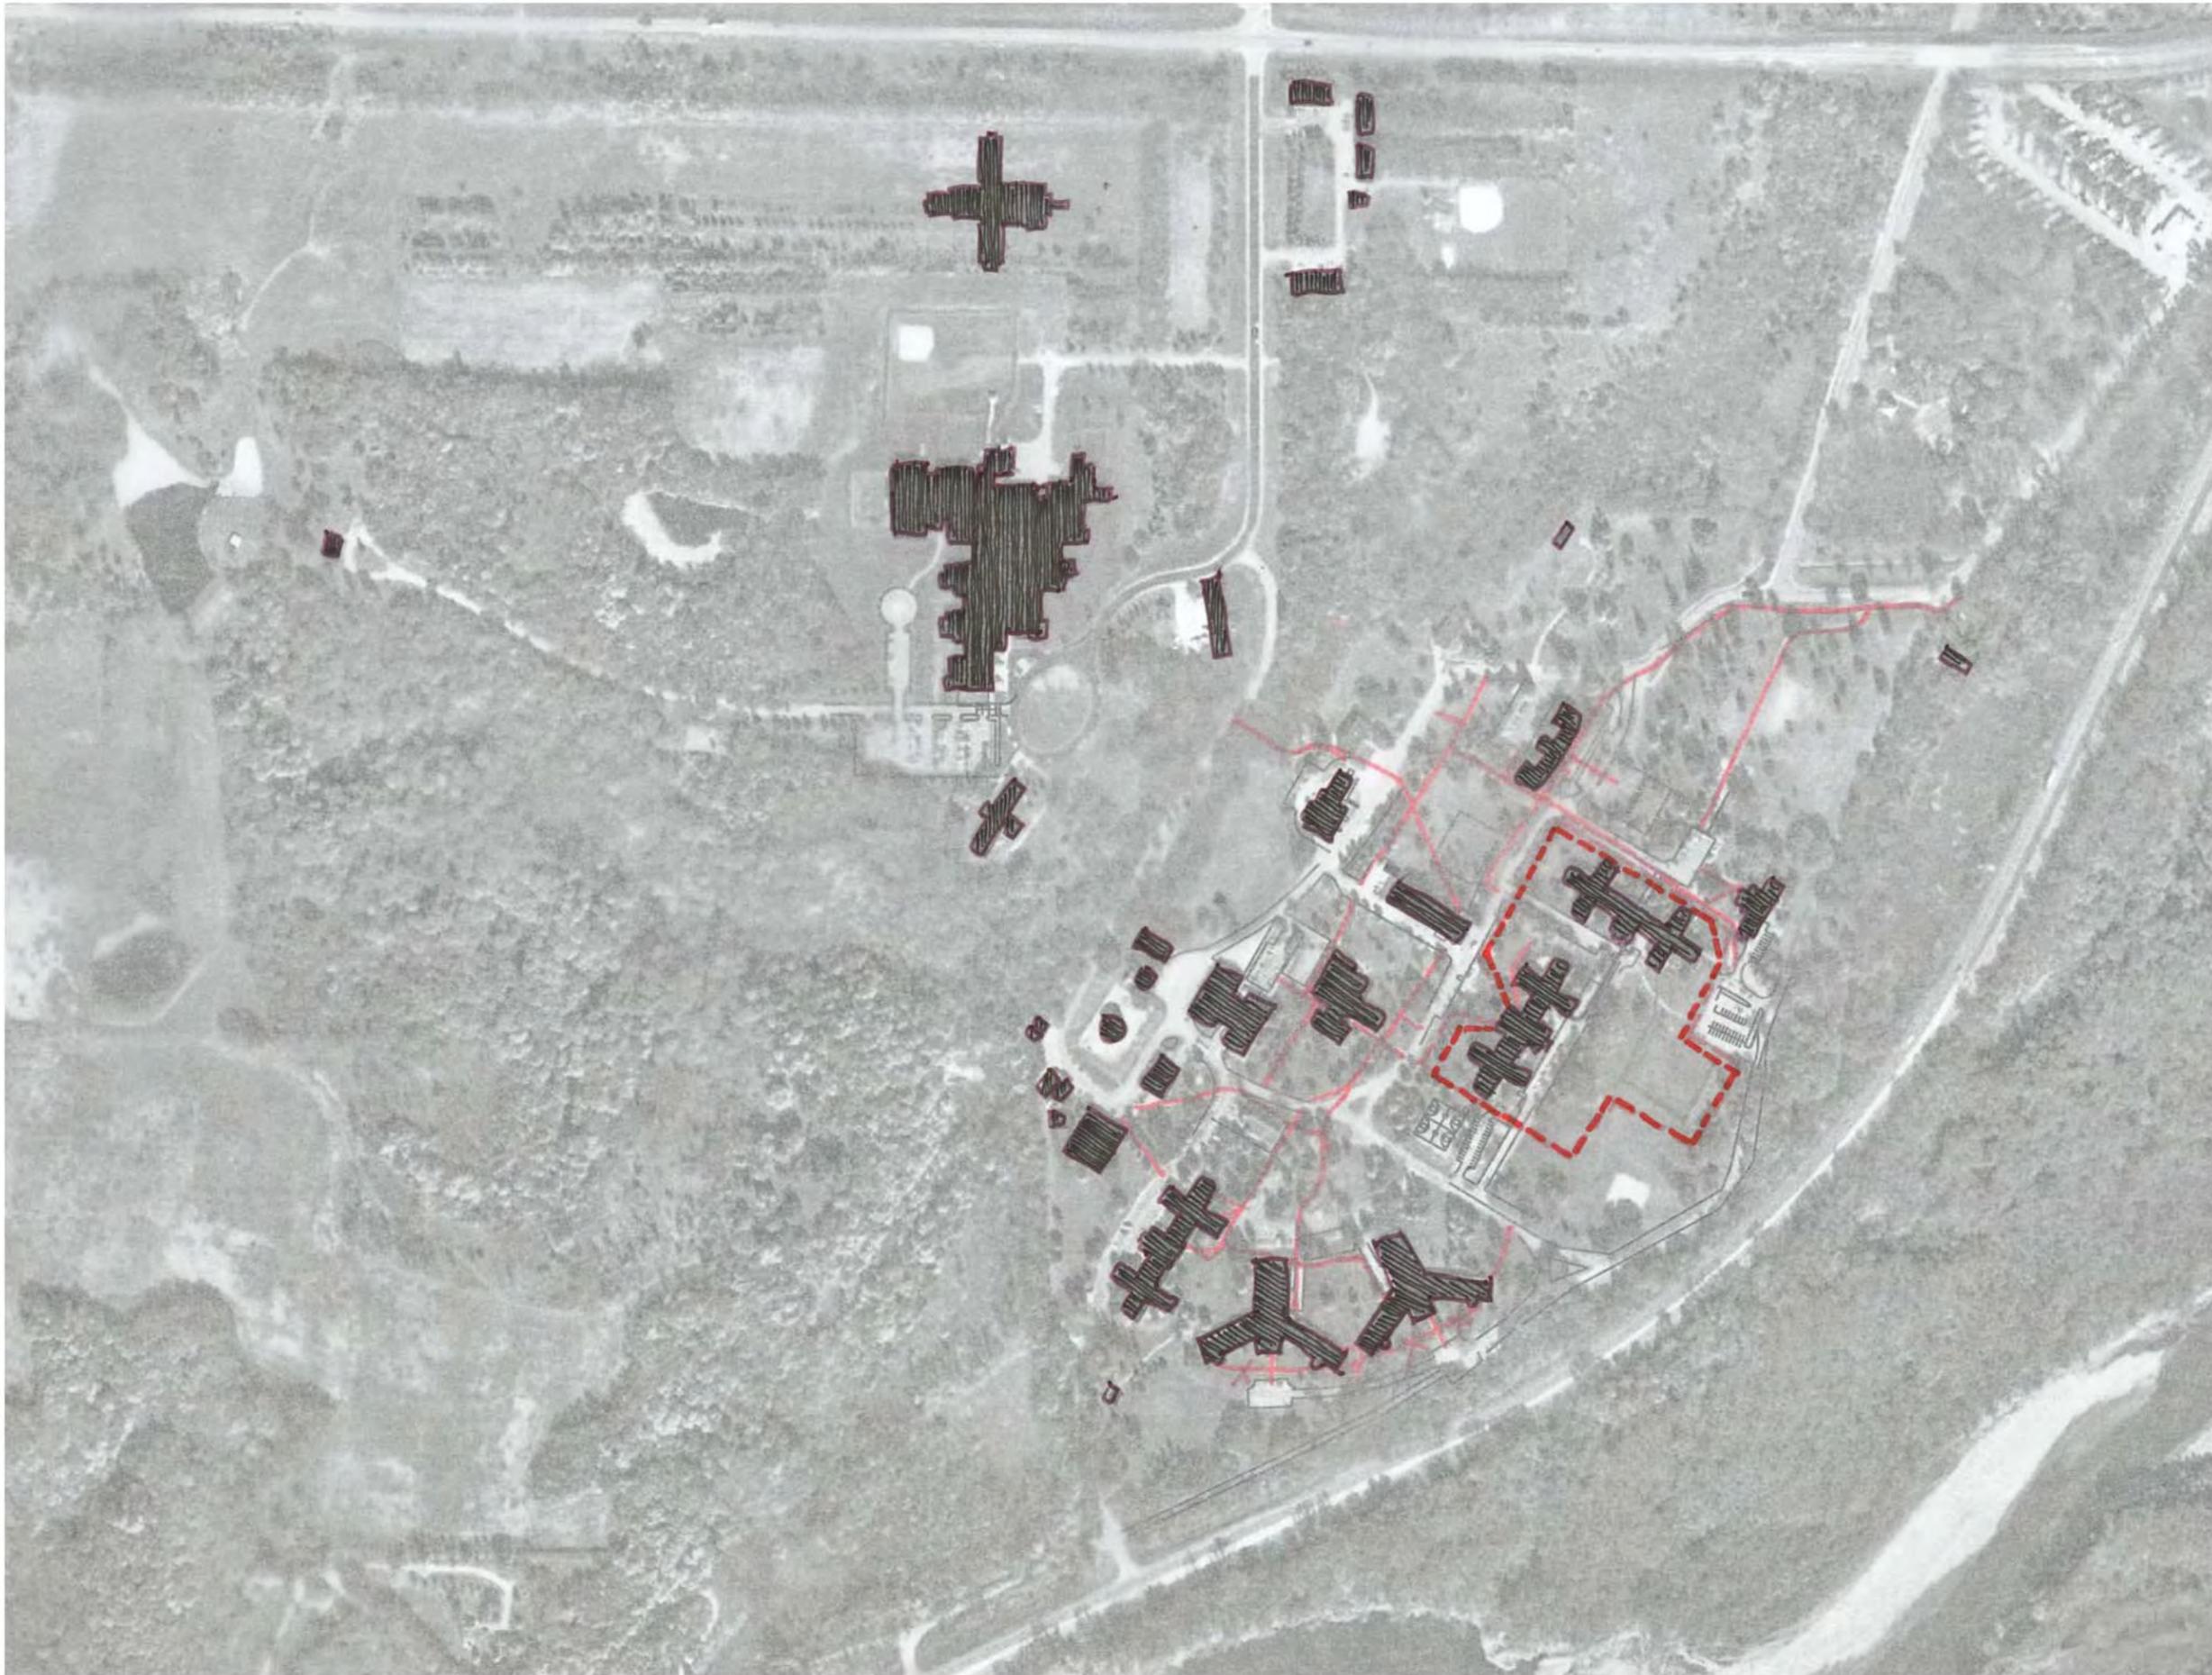
**I. EXISTING
BUILDINGS**

- Administrative activities, and Public Services such as the museum remain concentrated in the Administration building and in Old Center and are situated at the front of campus.
