Section V. ENVIRONMENTAL SITE ASSESSMENT

**PHASE I ENVIRONMENTAL SITE ASSESSMENT  
VACANT PROPERTY AND  
4th ADDITION OF THE WILLMAR INDUSTRIAL PARK  
SECTION 17, TOWNSHIP 119N, RANGE 35W  
WILLMAR, MINNESOTA**

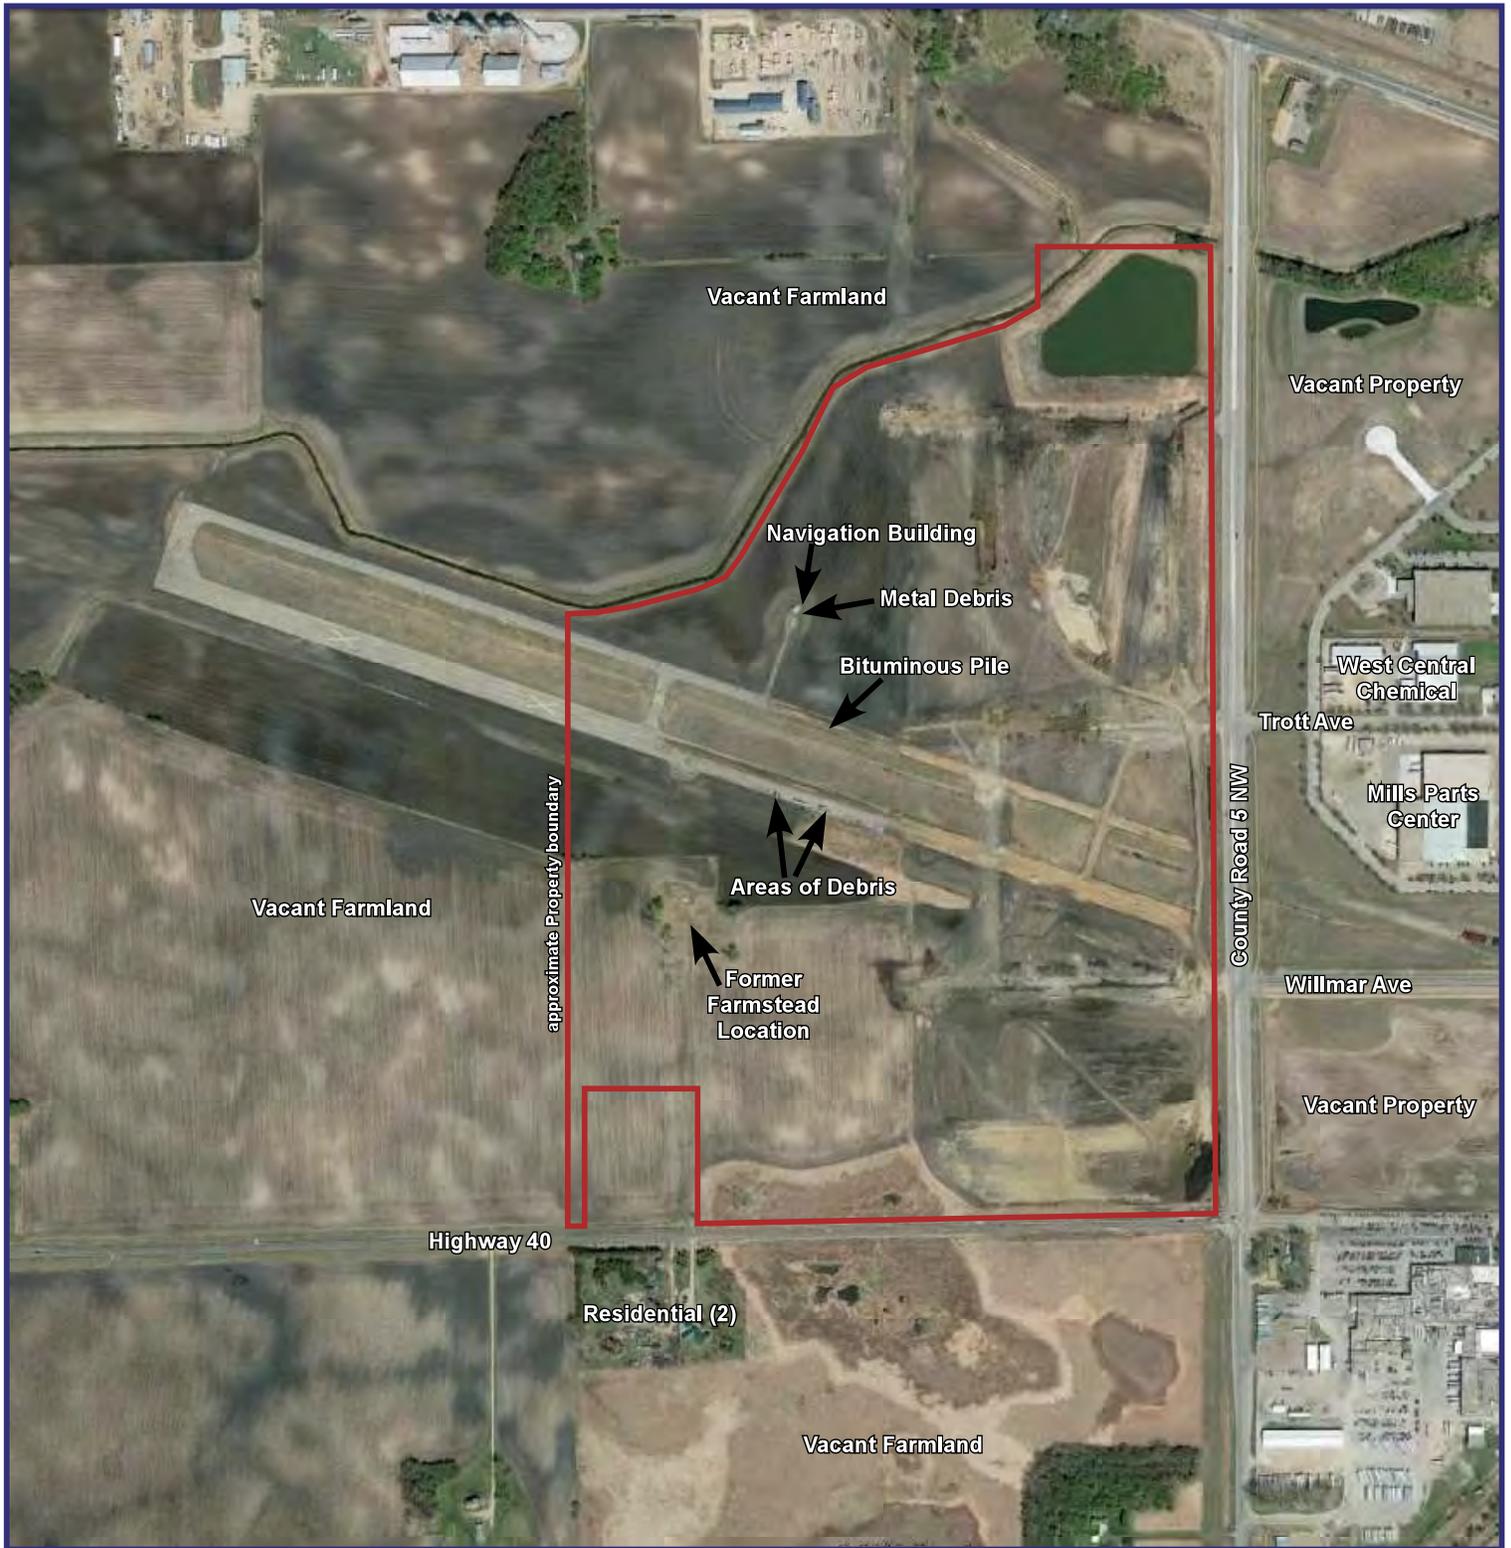
**Figure 2.0**  
**Property Sketch**  
 Vacant Property  
 Section 17, T119N, R35W  
 Kandiyohi County  
 Willmar, Minnesota

On the 2015 aerial photograph, the **Property** and adjacent properties appeared generally as observed during our **Property** reconnaissance and depicted on the attached **Property** Sketch (Figure 2.0) in Appendix B. Of note, portions of the east-west runway had been removed and the eastern half of the **Property** appeared to be in the process of being redeveloped on the 2015 photograph.

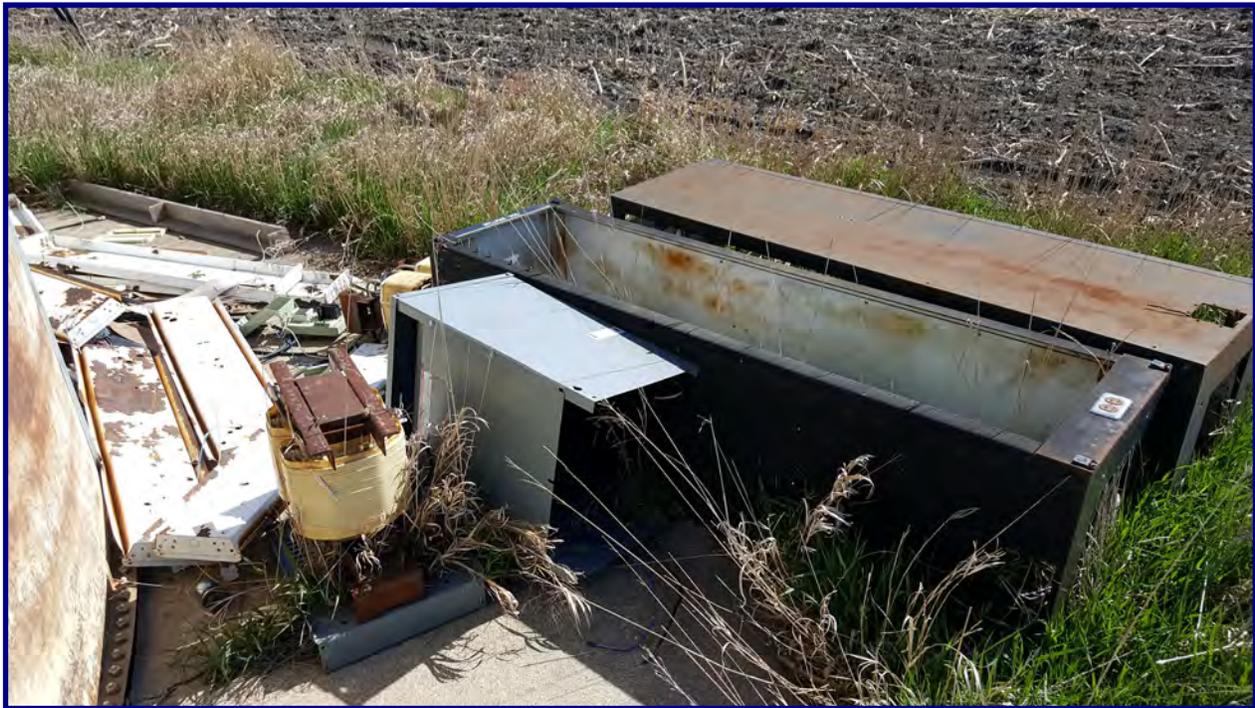
Miscellaneous metal, plastic and wood debris was observed at the **Property** (Photographs #10 through #13). Mr. Peterson was unaware of any petroleum products or hazardous substances associated with the observed debris. In addition, an area of bituminous was observed on the **Property** (Photograph #14 and Figure 2.0).

**Photograph #10**  
Date: April 22, 2016  
Direction: Facing Northeast on the **Property**  
Subject: Metal debris near navigation building

Based on our reconnaissance, areas of miscellaneous metal, plastic and wood debris were located on the **Property**. Although it is recommended that the observed items be disposed of according to local government ordinances, there were no indications of any solid waste disposal or landfilling of any hazardous substances or petroleum products in the areas of observed debris. In addition, **Property** representatives indicated that they were unaware of any solid waste disposal or landfilling at the **Property**. As a result, it does not appear that the presence of the observed solid waste, in their current state, would have had a negative impact on the soil and/or ground water beneath the **Property**.

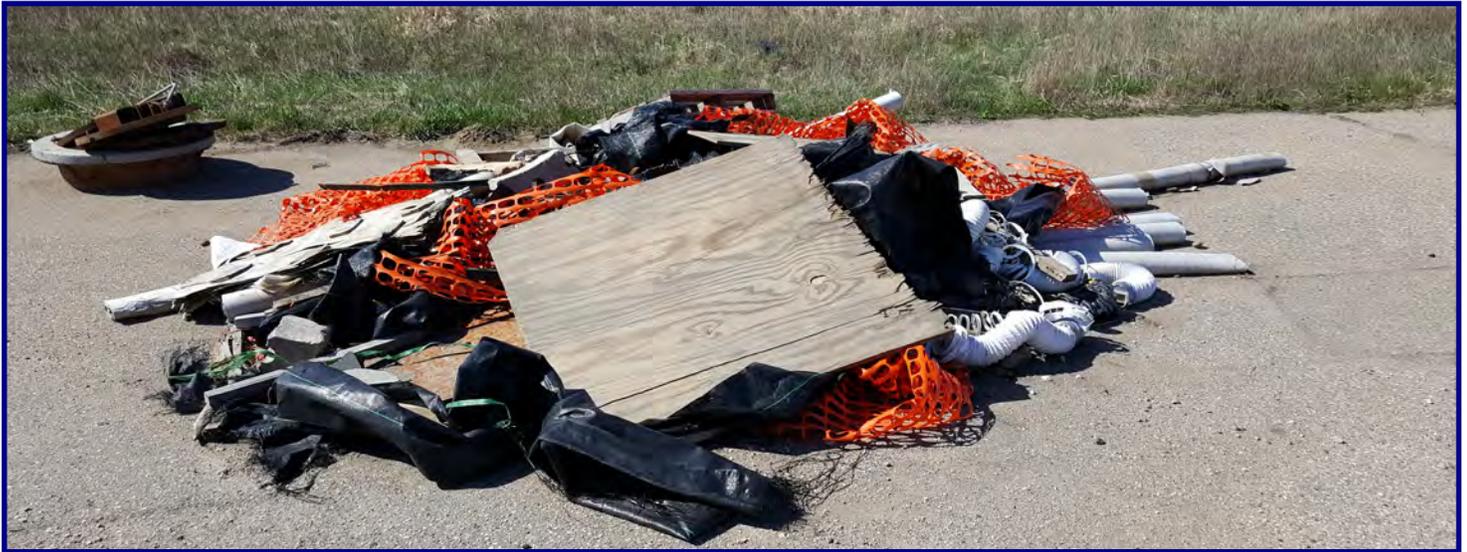
**Photograph #11**

Subject: Miscellaneous metal, plastic and wood debris

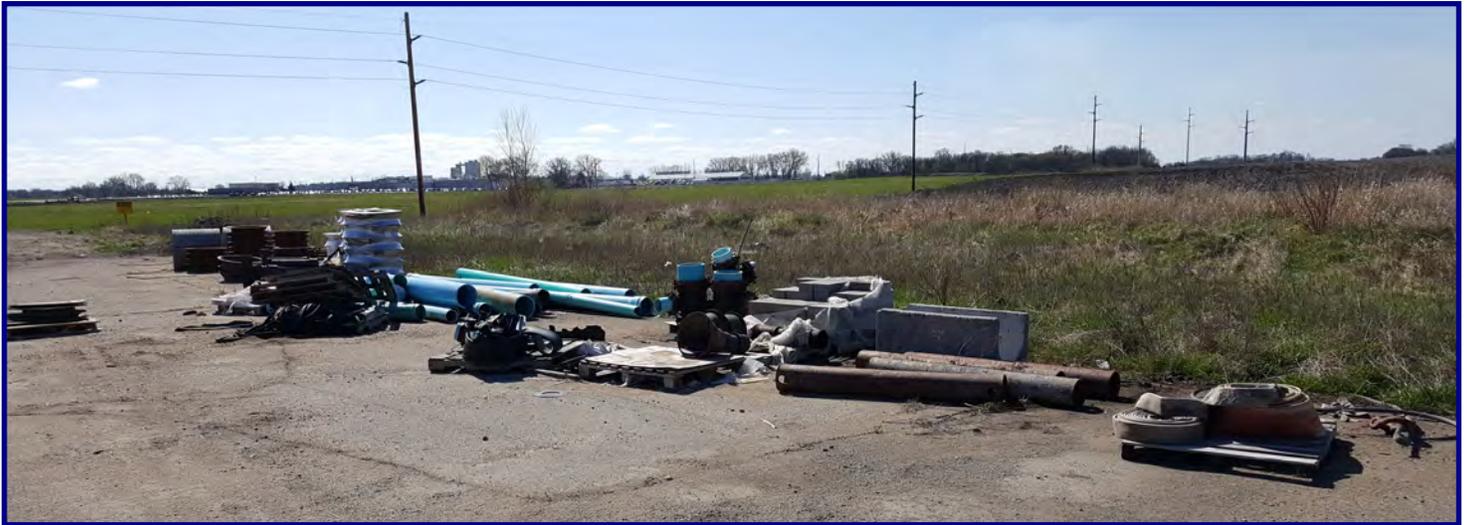
**Photograph #13**  
Date: April 22, 2016  
Direction: Facing Southeast on the **Property**  
Subject: Miscellaneous metal, plastic and wood debris

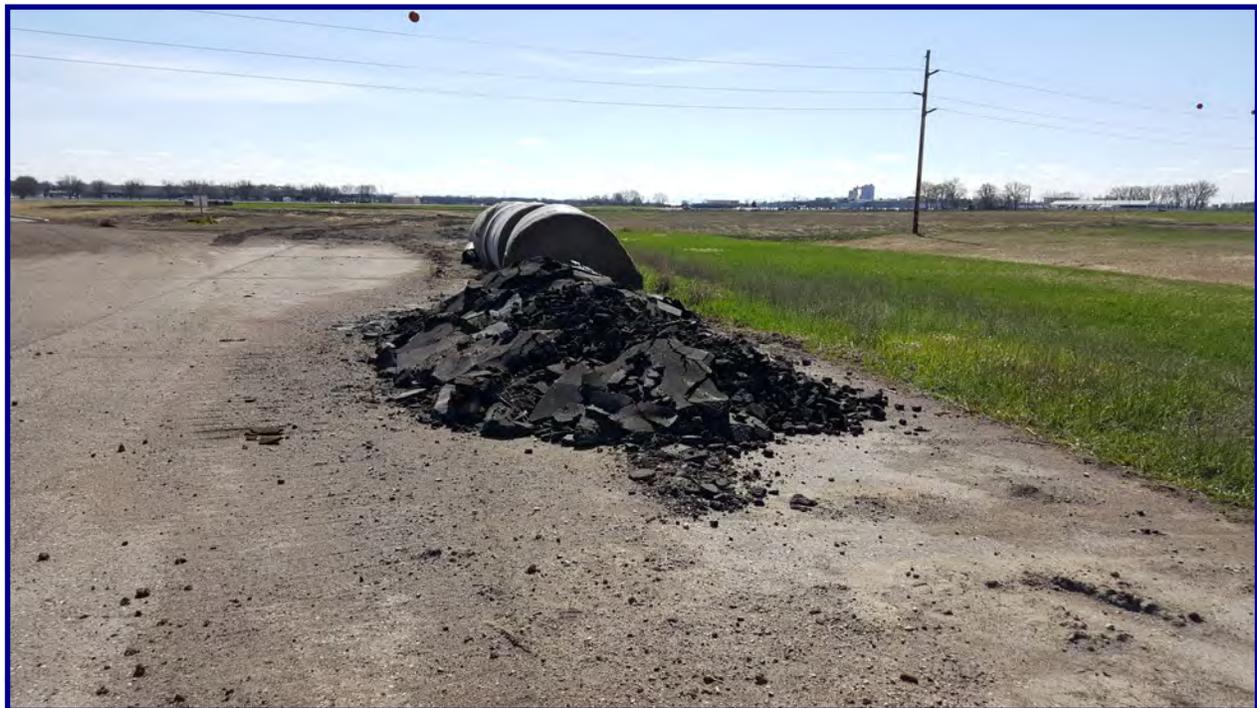
Based on our reconnaissance, an area of bituminous was observed on west-central portion of the **Property**.

Based on our reconnaissance, an area of bituminous was observed on west-central portion of the **Property**. Although the origin of the bituminous could not be specifically determined, only bituminous was observed in the pile. No hazardous substances or petroleum products were observed amongst the debris. It would therefore appear unlikely that the presence of the bituminous has had a negative impact on the soil and/or ground water beneath the **Property**.

**Photograph #14**  
Date: April 22, 2016  
Direction: Facing East on the **Property**  
Subject: Bituminous Pile
