MINNESOTA STATE CAPITOL  
HISTORIC STRUCTURES REPORT  
VOLUME 2.1

SITE DEVELOPMENT AND CONDITIONS

MINNESOTA STATE CAPITOL  
HISTORIC STRUCTURES REPORT  
VOLUME 2.2.2

GROUND FLOOR SPACE INVENTORY AND CONDITIONS

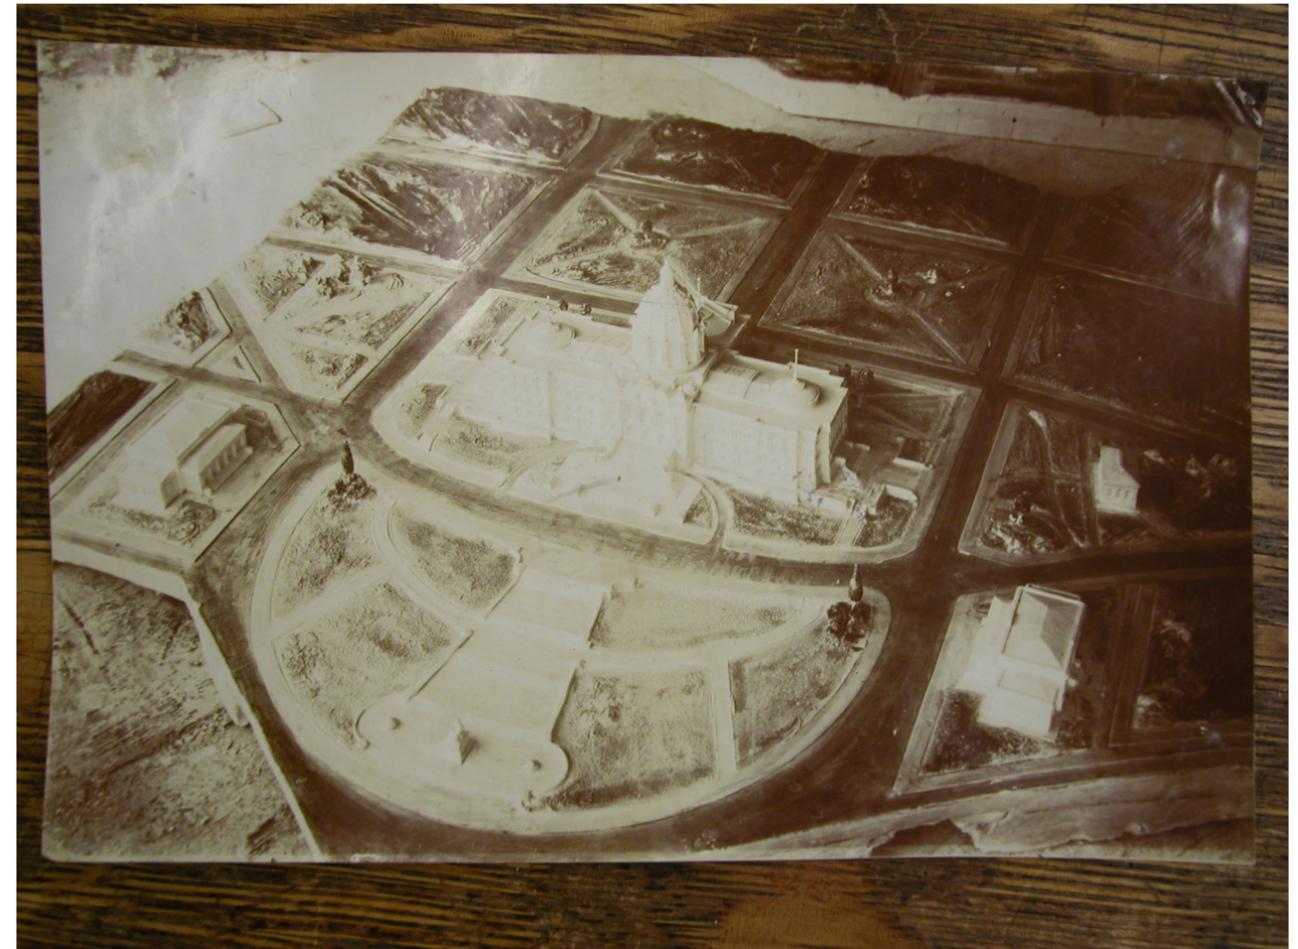
Early Plaster Site plan, New York Historical Society

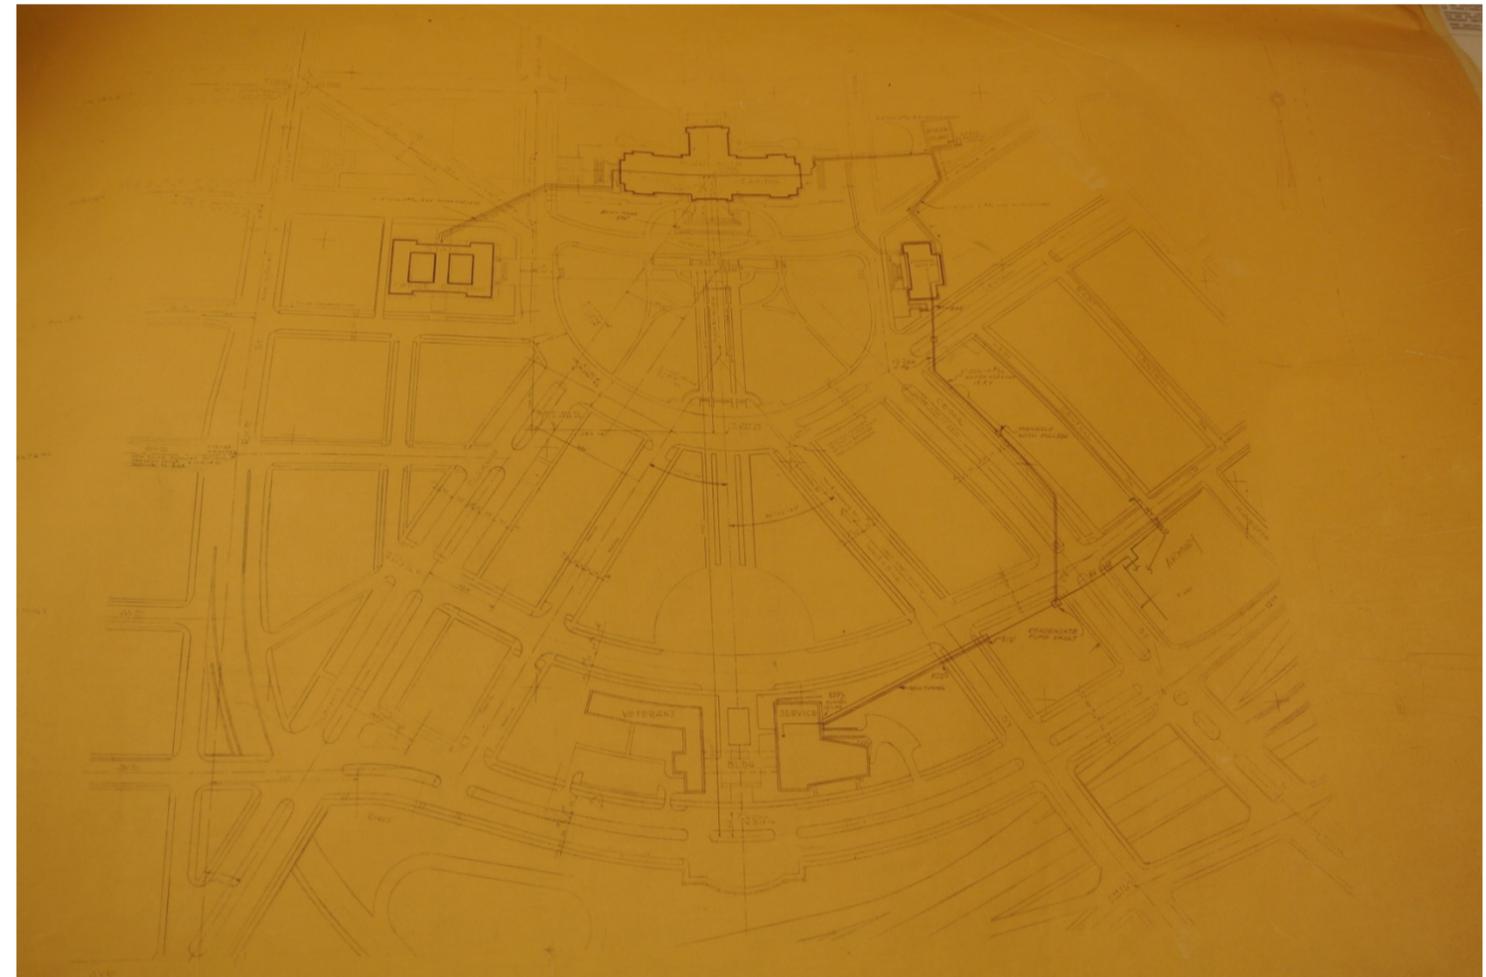
Site plan for hot water routing, dated 1954. S.E. Blunt, Engineer. Note how Wabasha Street still continues to Central Avenue, and a mirror image street was created for symmetry. Highway 94 is shown, along with ‘Summit Parkway’ which would later become John Ireland Boulevard. Twelfth Street and Rice Avenue are now the boundaries of the Capitol mall, but the rationalization of the minor blocks where the Transportation Building would soon be built has yet to occur.

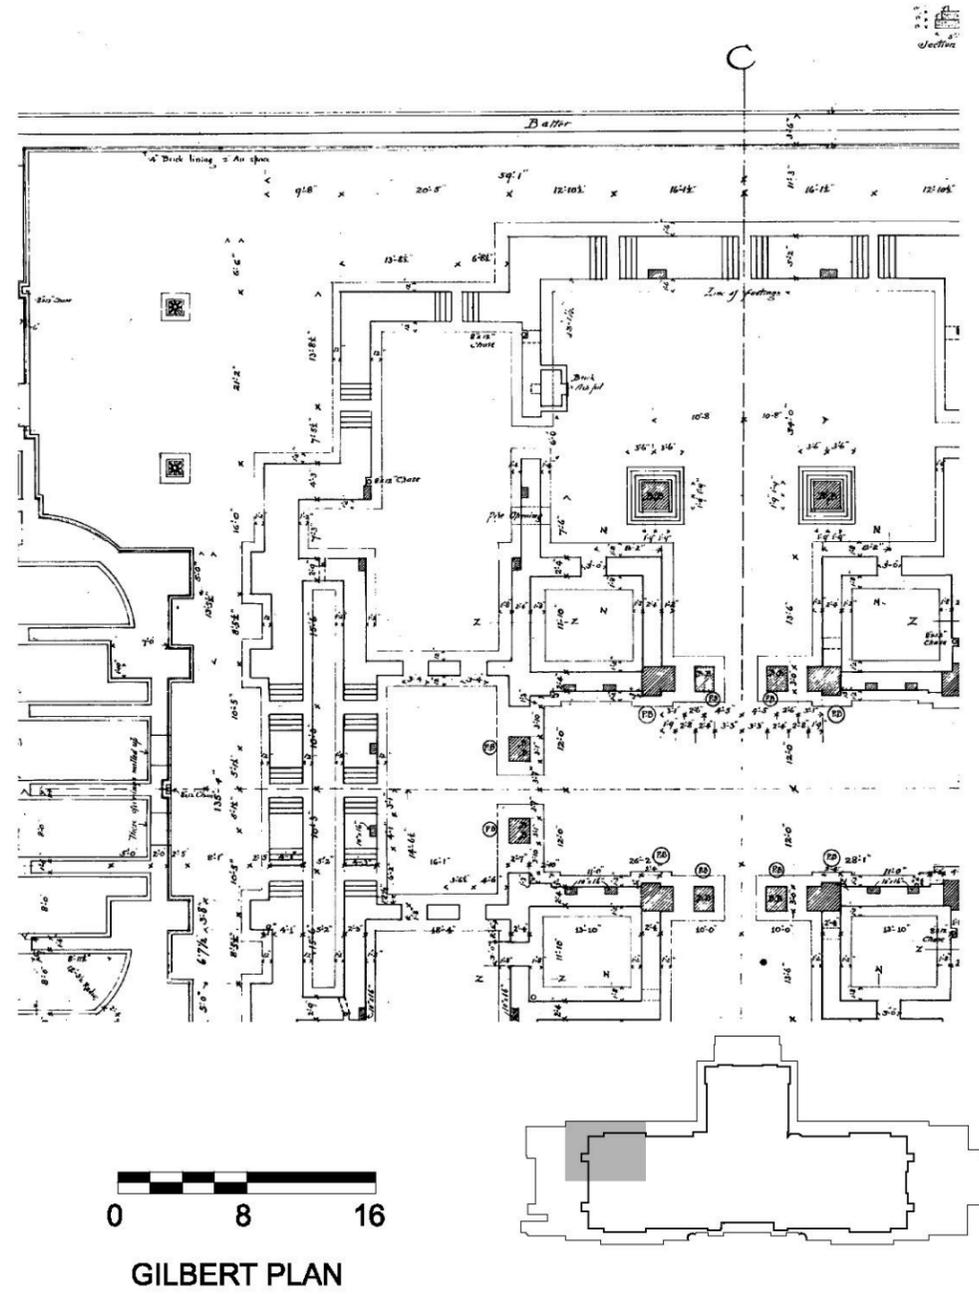
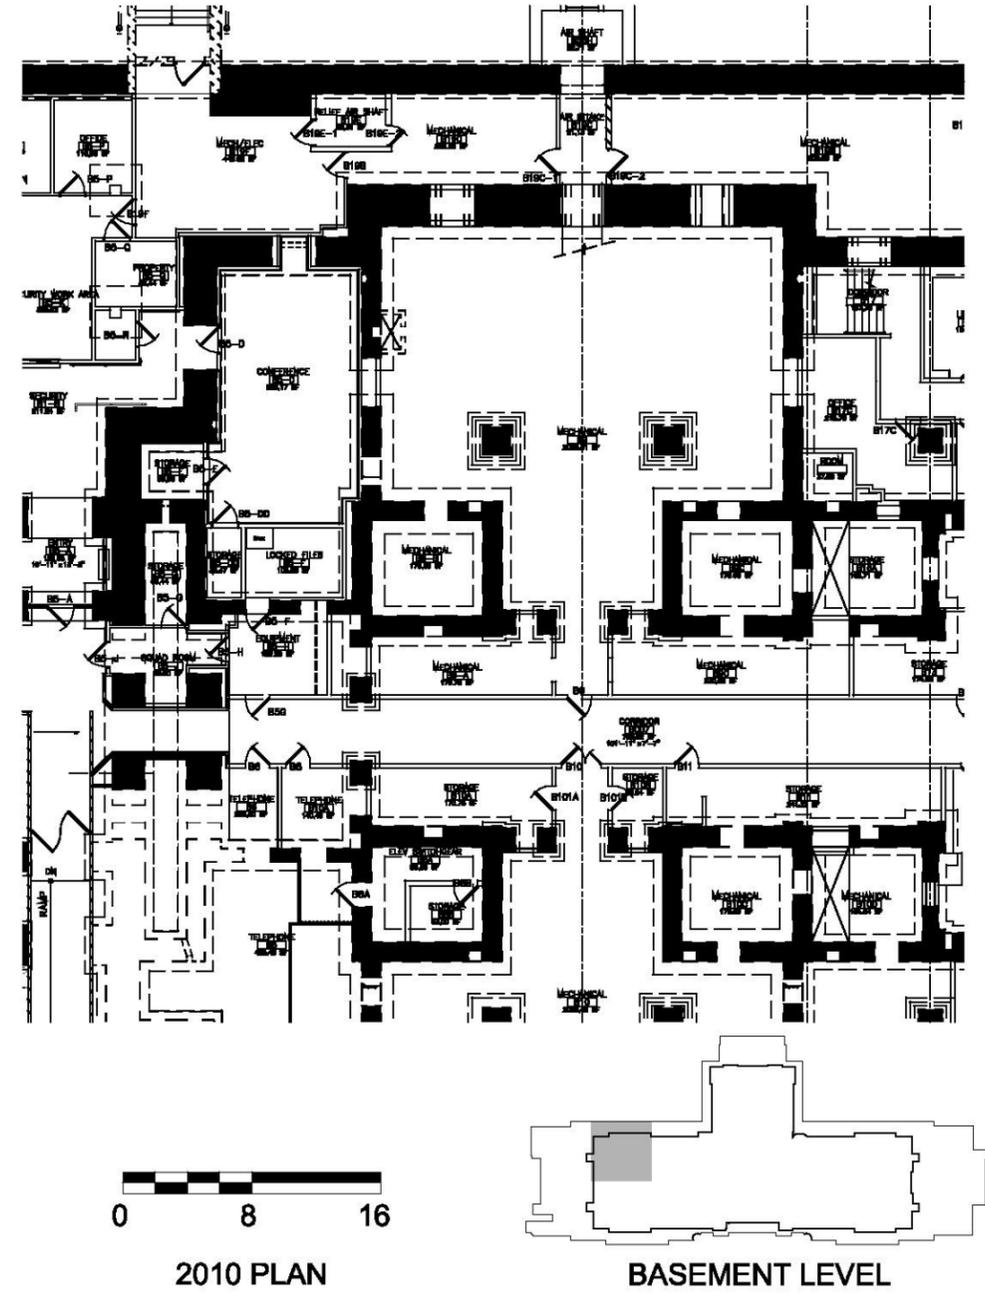
**North West Terrace**

Treatment Level: 4

This area is the Capitol Security Offices. Areas under the terraces are have higher ceilings and are better suited to office functions.

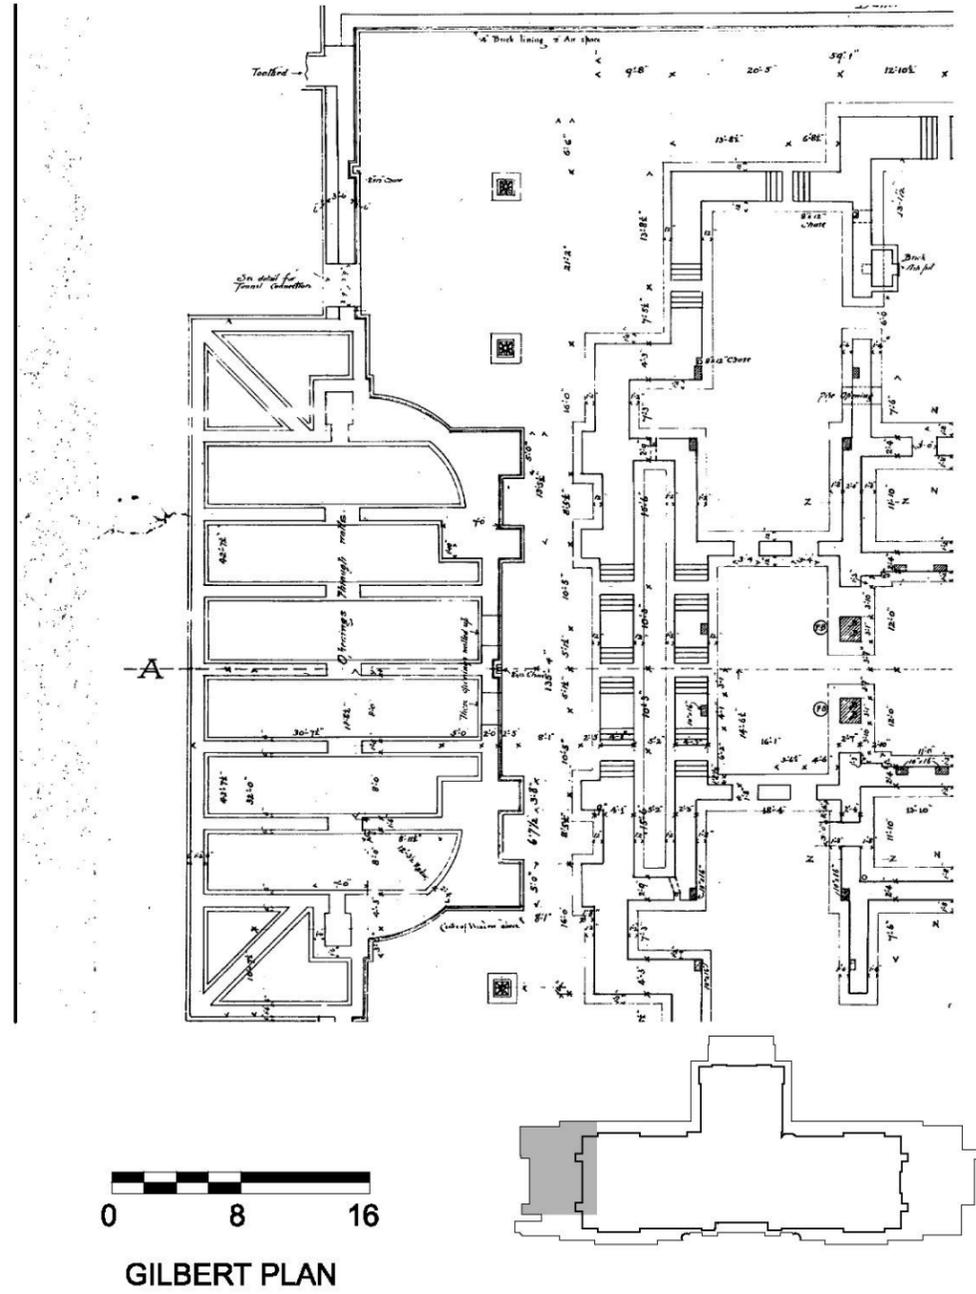
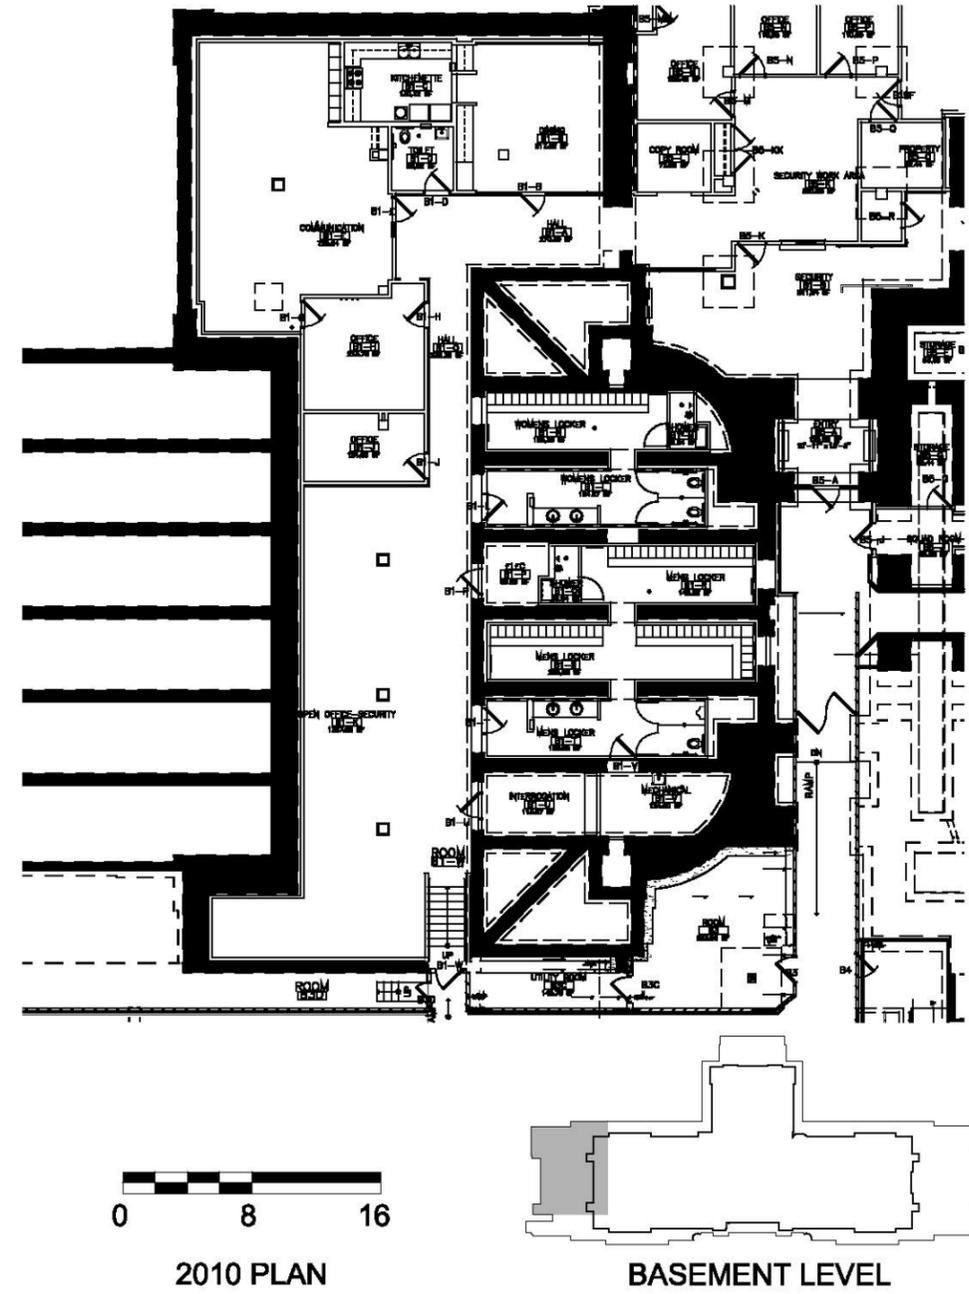
**South West Terrace, Senate  
Duplicating Center.**  
Treatment Level: 4

This area has the tunnel connection to the State Office building (1955) and the Senate Duplicating Center.  
(2004)

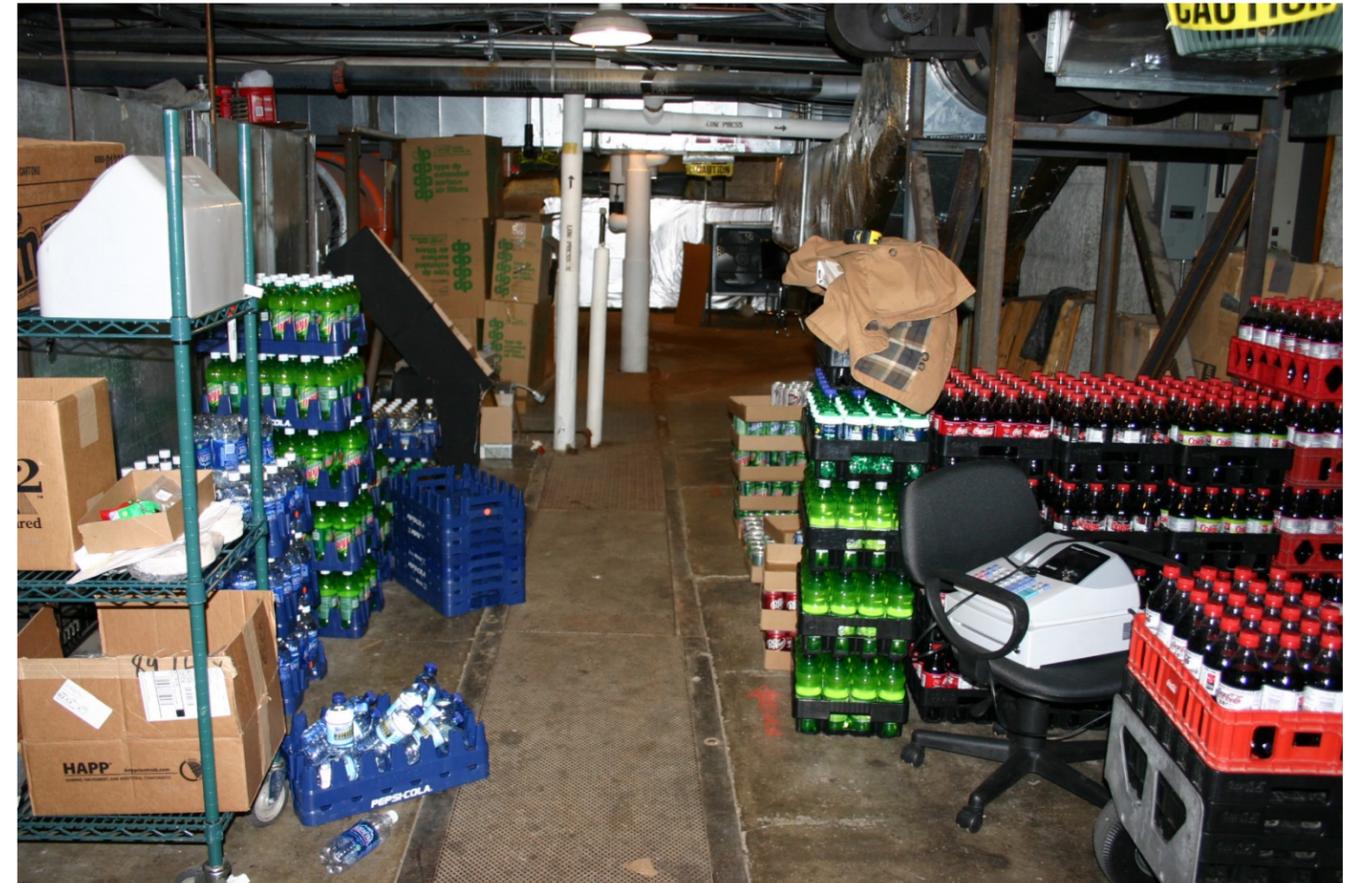
**South West Corner Area**  
Treatment Level: 4

This area consists of mechanical, storage and telecommunications rooms.

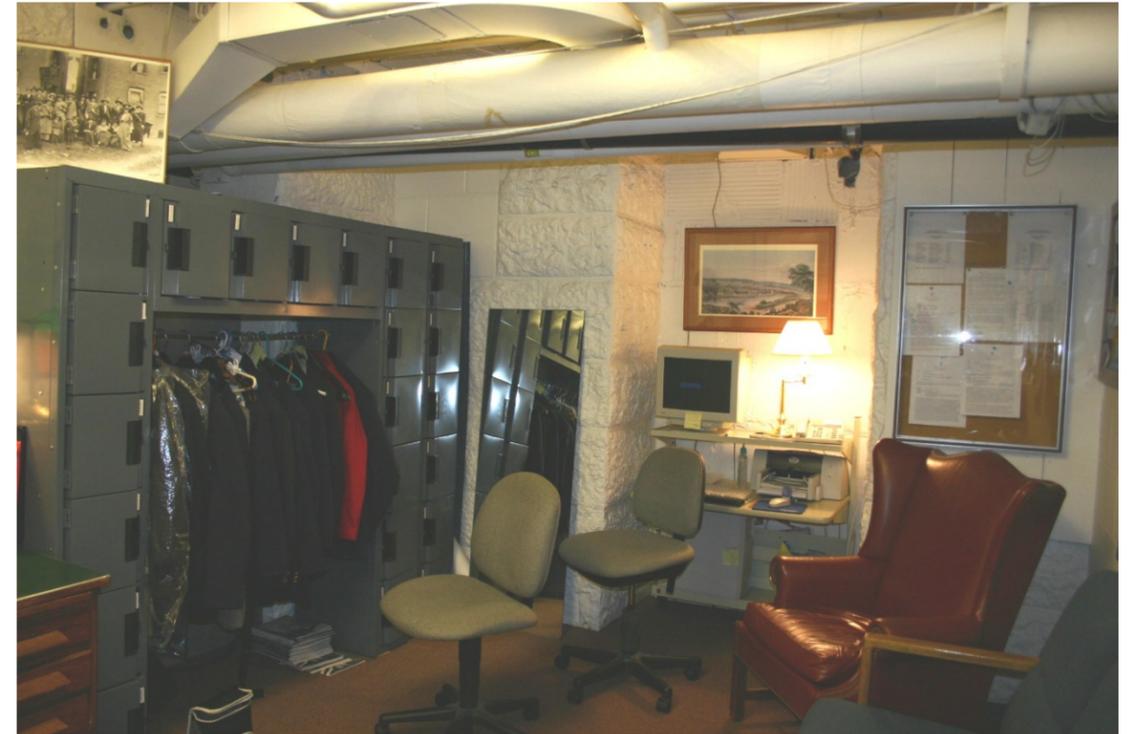
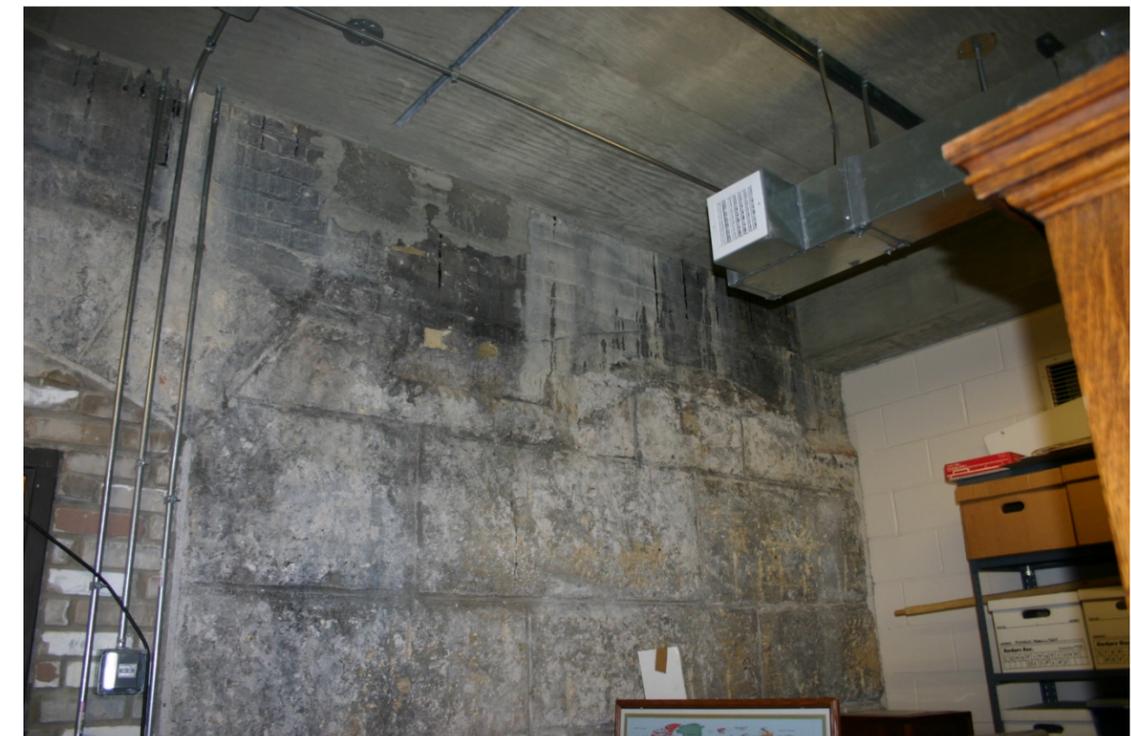
Treatment Level: 4

The large room, like the other similar rooms, is a mechanical room. The Minnesota Historical Society offices are to the east of it.

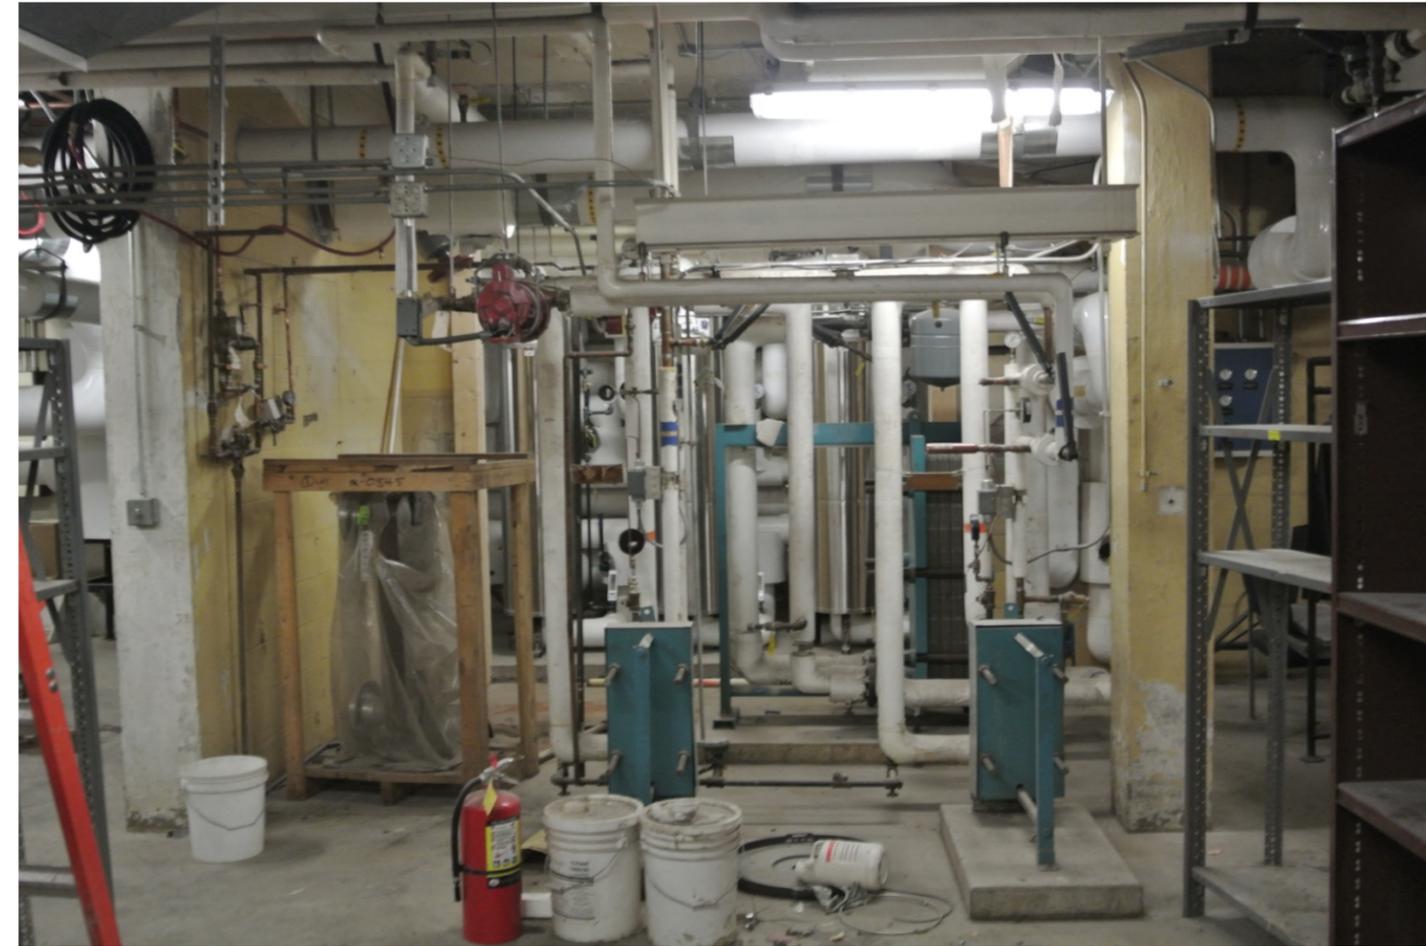
Treatment Level: 4

This area is made up of mechanical and storage spaces. It is very much like the South East terrace space.

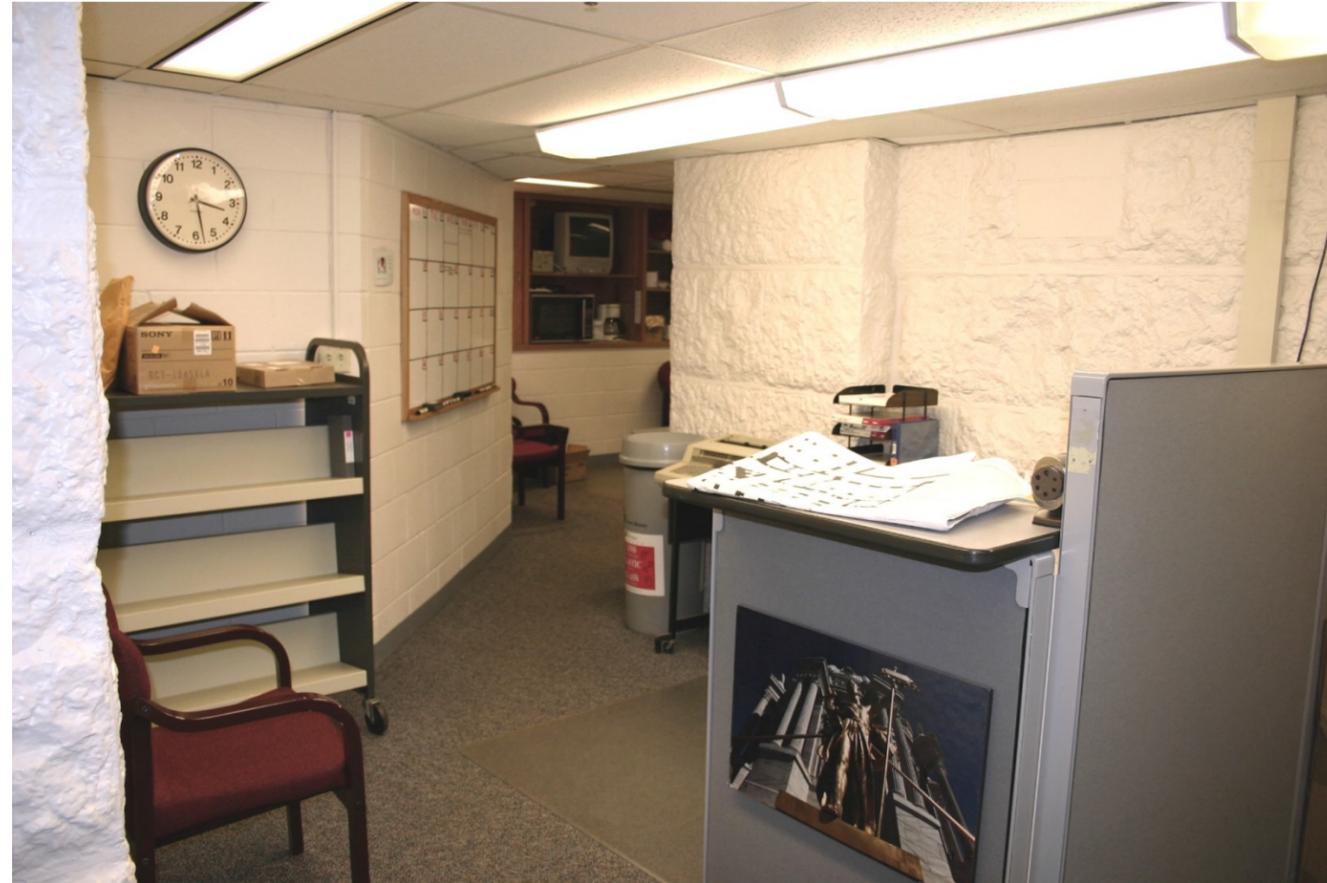
Treatment Level: 4

This area is used as offices and storage for the House.

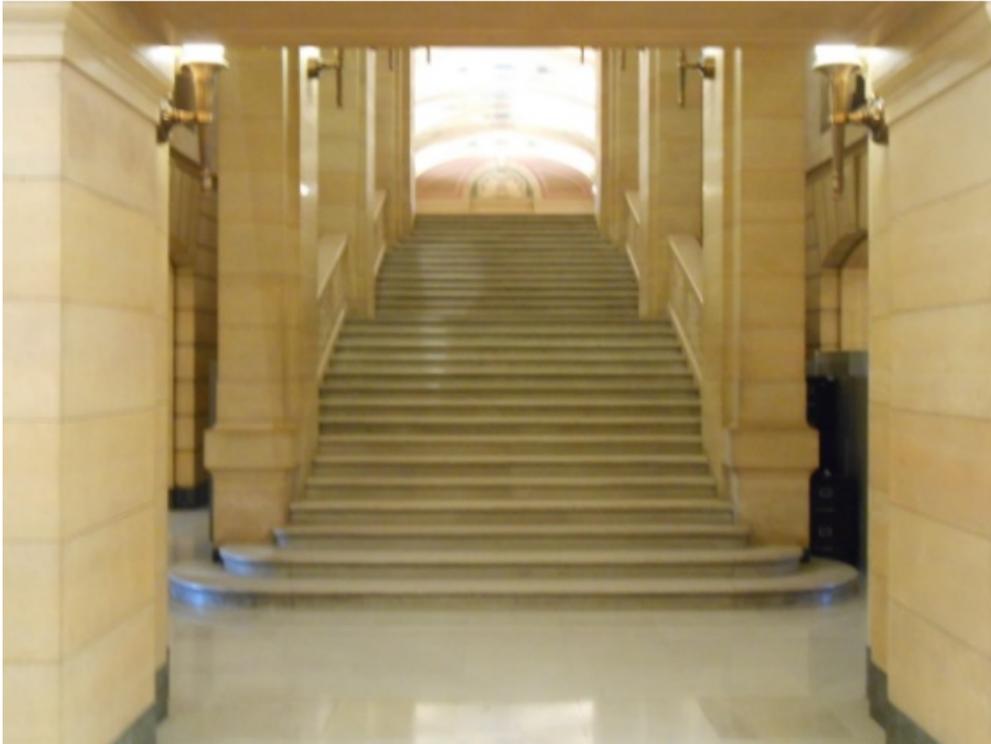
Foot of Stair

Building Element:	Description:	Condition of Material:
Floor	Joliet Limestone, Marble treads.	Intact, Original
Walls	Kasota Stone/Plaster	Intact, Original
Ceiling/Cornice	Plaster, skylight	Intact, Original
Doors/Frame:	Wood, see door section	Some removed, covered with plaster.
Hardware	Brass Lever	Original knobs replaced in ADA upgrade. With replicas.
Light Fixtures	Historic Torcheres, uplights	Torcheres original, though not in original locations/uplights not
Artwork	Decorative Plaster painting/Portraits	Restored/Not original
Mechanical	Bronze decorative Grilles	Intact, Original
Trim	Plaster/Stone	Intact, Original

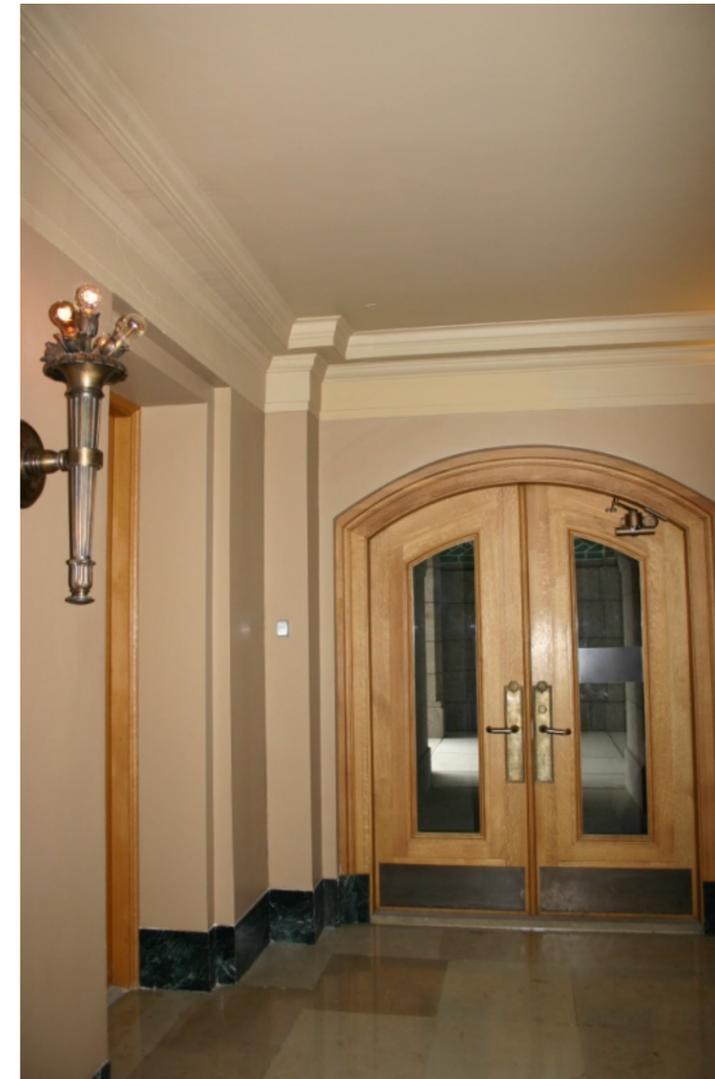
Building Element:	Description:	Condition of Material:
Floor	Joliet Limestone	Intact, original
Walls	Plaster	Possibly damaged by temporary partitions
Ceiling/Cornice	Plaster	Intact
Doors/Frame:	Wood, see door section	Intact
Hardware	Brass Lever	Original knobs replaced in ADA upgrade.
Light Fixtures	Historic Torcheres, uplights	Original, intact
Artwork	None	None
Mechanical	Bronze decorative Grilles	Intact, original
Trim	Plaster/Wood	Intact

Typical Ground Floor vestibule.

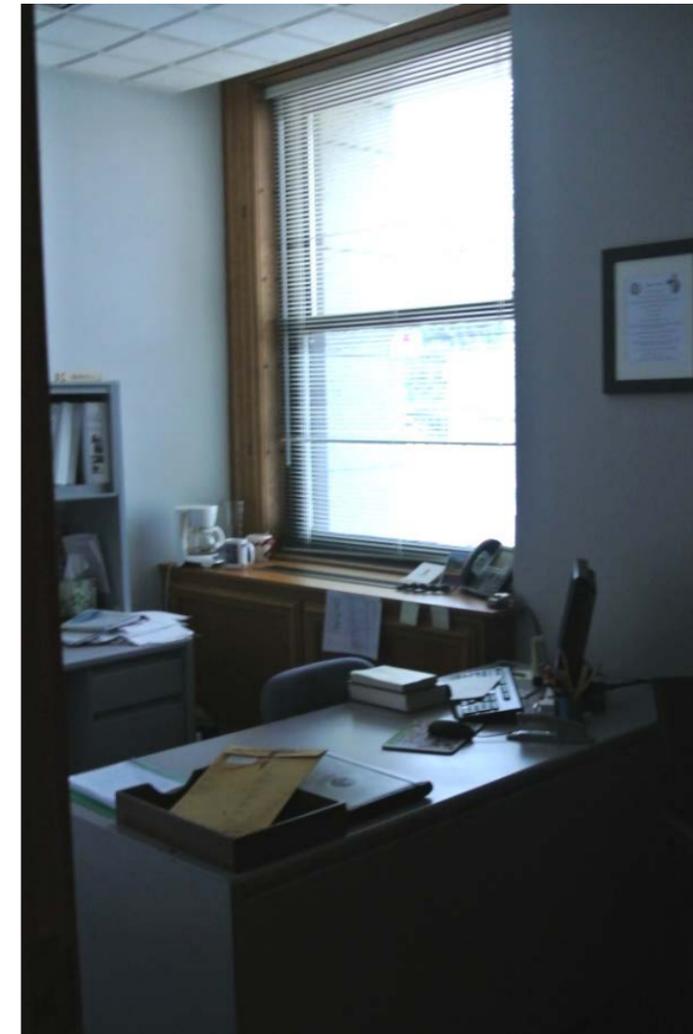
Building Element:	Description:	Condition of Material:
Floor	Concrete/carpet	Destroyed
Walls	Plaster/VWC	Modified, new walls added, walls covered with new treatment
Ceiling/Cornice	Plaster/ACT	Condition of original ceiling above ACT unknown
Doors/Frame:	Wood, see door section	Intact, original (some new)
Hardware	Brass Lever	Original knobs replaced in ADA upgrade. Knobs remain in some closet doors
Light Fixtures	Lay in fixtures	Not Original
Artwork	None	None
Mechanical	Ceiling distribution	Not original
Trim	Wood	Intact, window trim original, casing around heaters not.

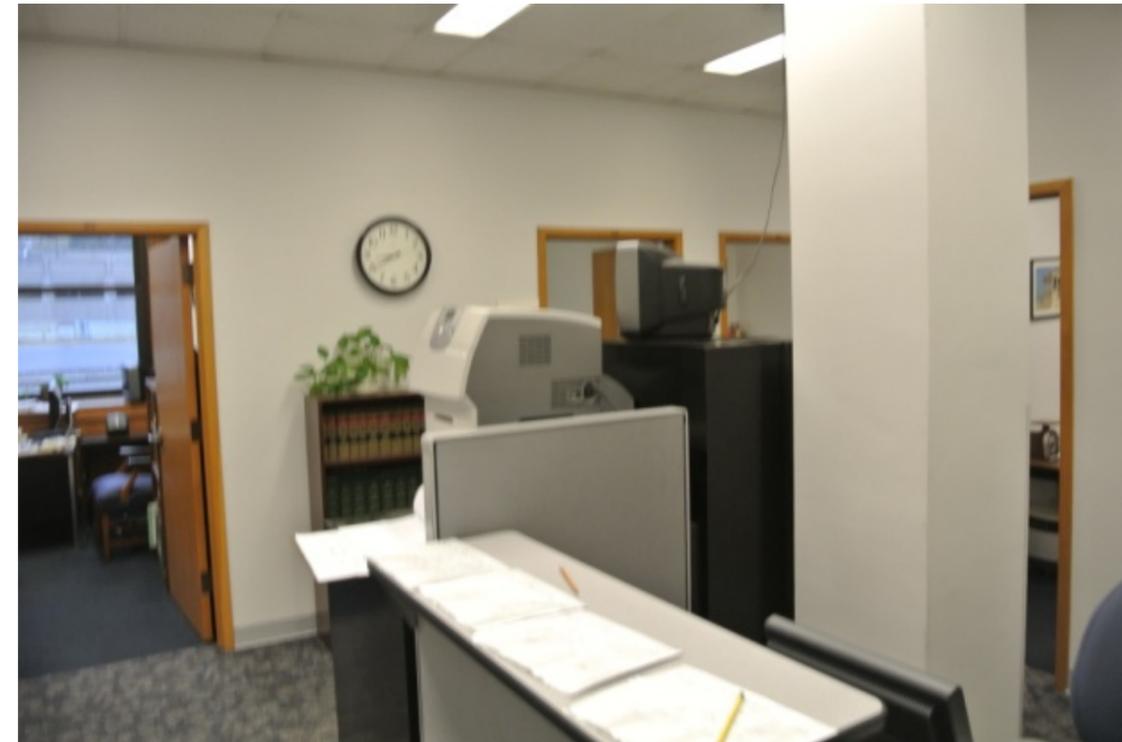
Building Element:	Description:	Condition of Material:
Floor	Concrete/carpet	Original wood destroyed
Walls	Plaster/VWC	Modified, new walls added, walls covered with new treatment
Ceiling/Cornice	Plaster/ACT	Condition of original ceiling above ACT unknown
Doors/Frame:	Corridor doors removed, frames modified	Destroyed/Modified
Hardware	Brass Lever	Not original or replica
Light Fixtures	Lay in fixtures	Not Original
Artwork	None	None
Mechanical	Ceiling distribution	Not original
Trim	Wood	Not original

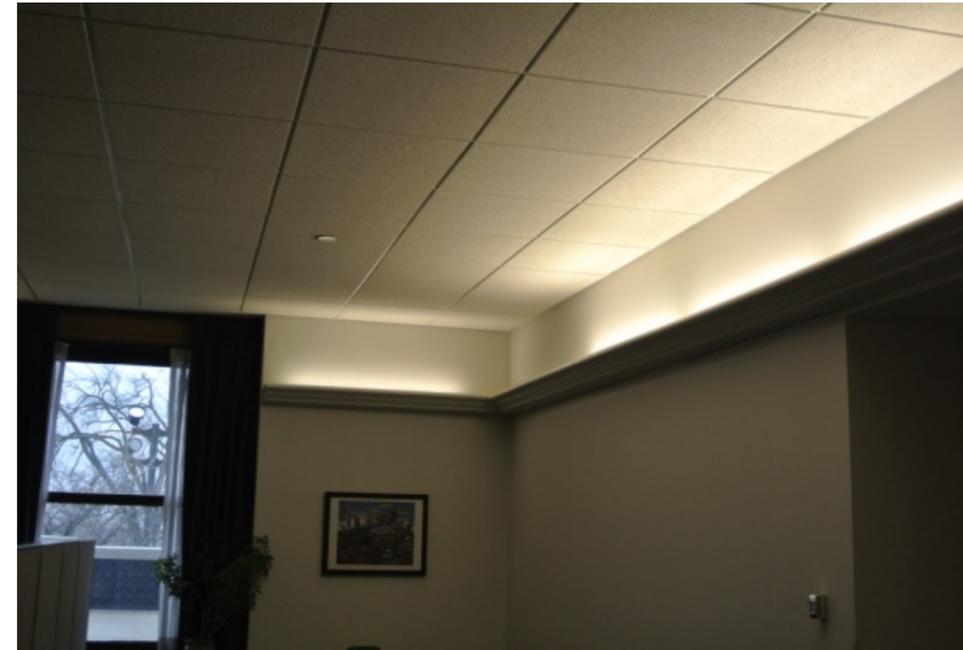
Coved wall lights are typical in these rooms

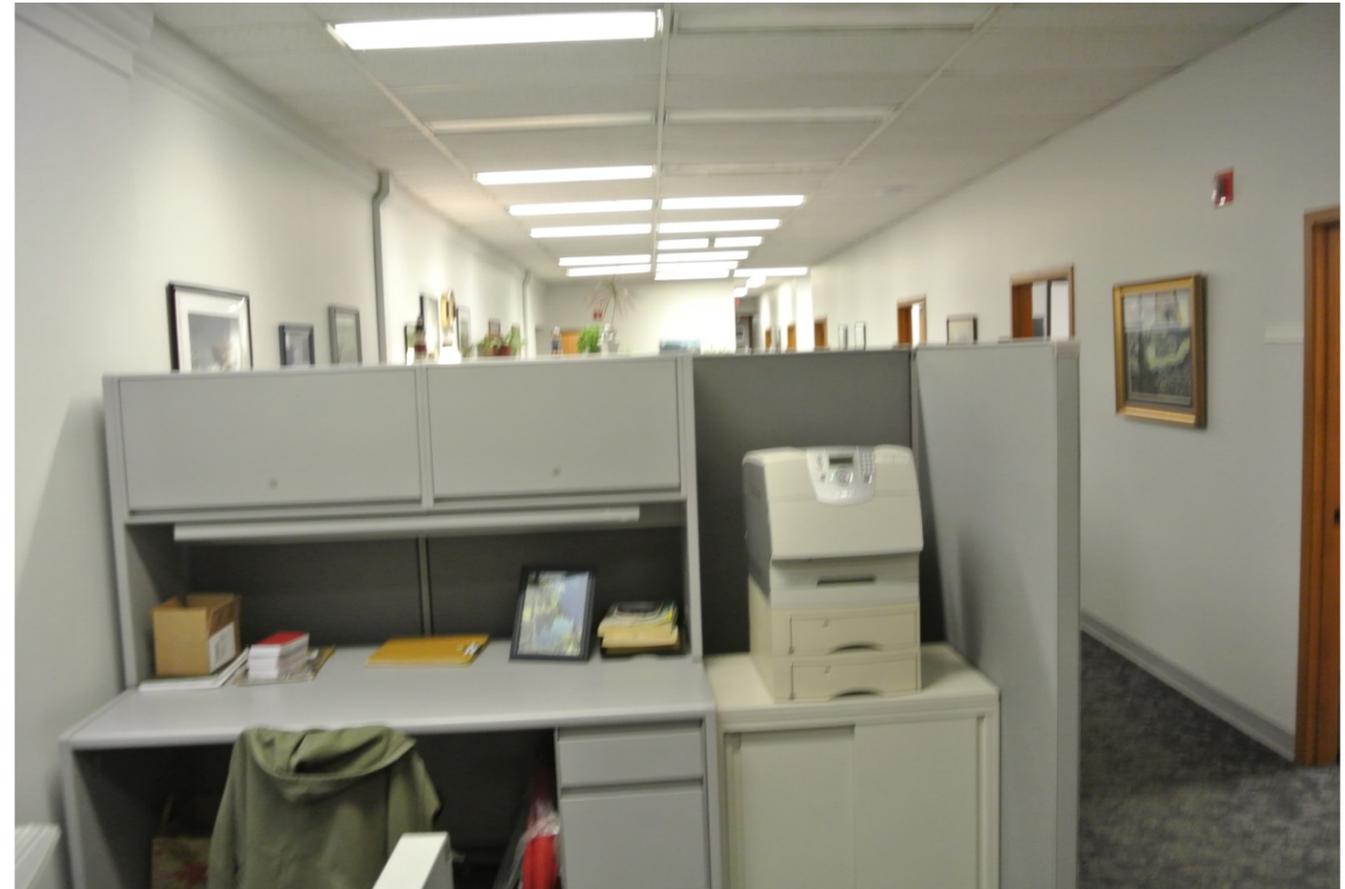
Building Element:	Description:	Condition of Material:
Floor	Concrete/carpet	Destroyed
Walls	Plaster/VWC	Modified
Ceiling/Cornice	Plaster/ACT	Unknown
Doors/Frame:	Original wood at corridor, remainder newer	Modified
Hardware	Replica ADA levers at original doors only.	Not original
Light Fixtures	Lay in fixtures	Not Original
Artwork	None	None
Mechanical	Not original	Not original
Trim	Wood	Not original

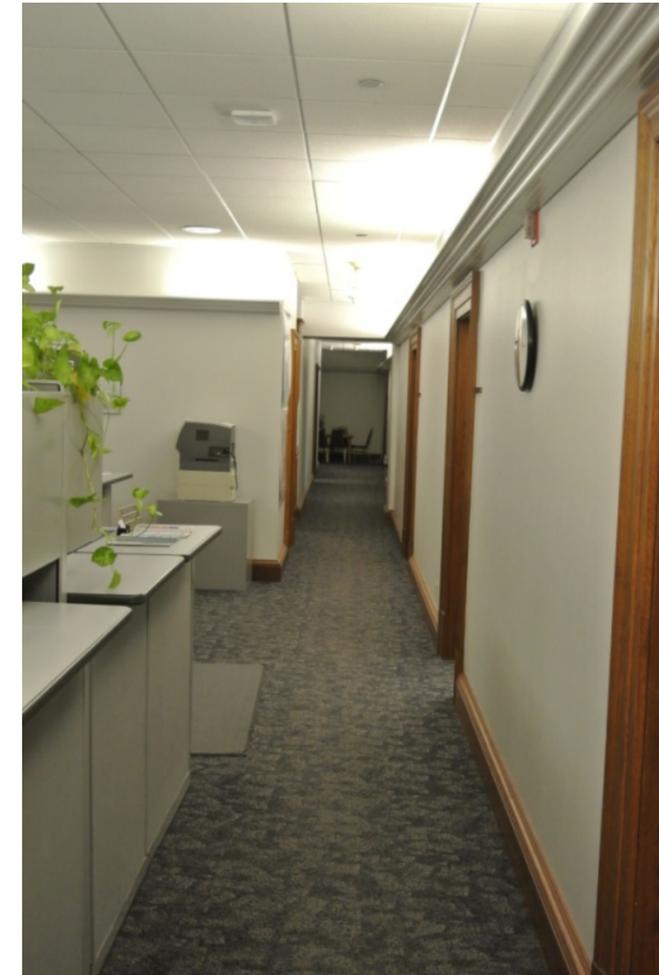
Building Element:	Description:	Condition of Material:
Floor	Concrete/carpet	Original wood destroyed
Walls	Plaster/paint	Modified, new walls added, walls covered with new treatment
Ceiling/Cornice	Plaster/ACT	Condition of original ceiling above ACT unknown
Doors/Frame:	Original wood at corridor, remainder newer	Intact/not original
Hardware	Replica ADA levers at original doors only.	Not original
Light Fixtures	Lay in fixtures	Not Original
Artwork	None	None
Mechanical	Ceiling distribution	Not original
Trim	Wood	Not original

Typical Senate Office treatment

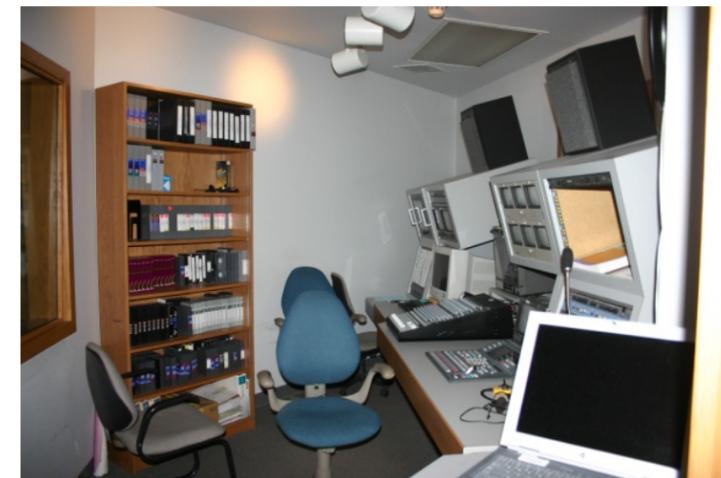
Building Element:	Description:	Condition of Material:
Floor	Concrete/carpet	Original wood destroyed
Walls	Plaster/paint	Modified
Ceiling/Cornice	Plaster/ACT	Condition of original ceiling above ACT unknown
Doors/Frame:	Original wood at corridor, remainder newer	Modified
Hardware	Replica ADA levers at original doors only.	Not original
Light Fixtures	Wall mounted uplights	Not Original
Artwork	None	None
Mechanical	Ceiling distribution	Not original
Trim	Wood	Not original

Typical Senate Office treatment

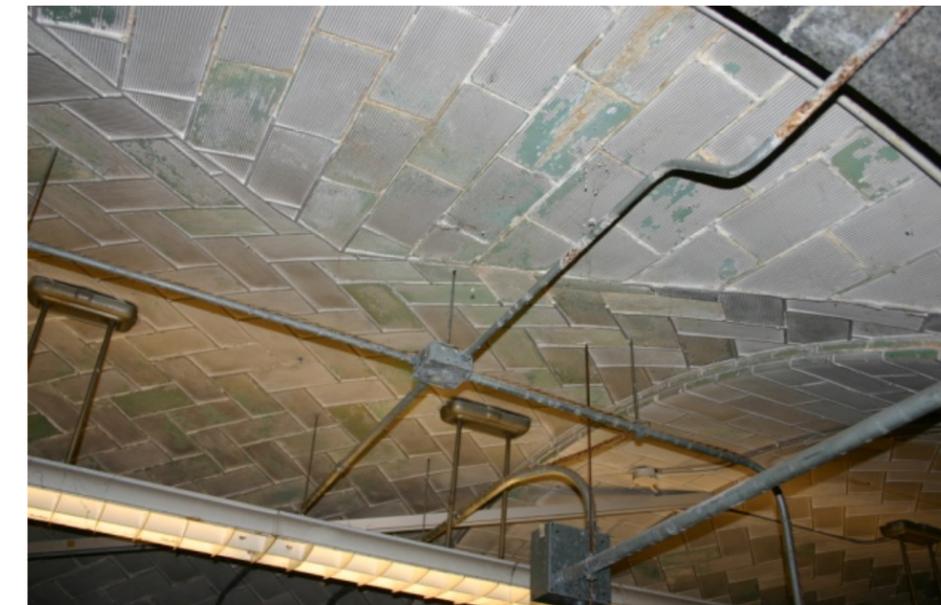
Tile vaults in Porte Cochere as converted into a mechanical room

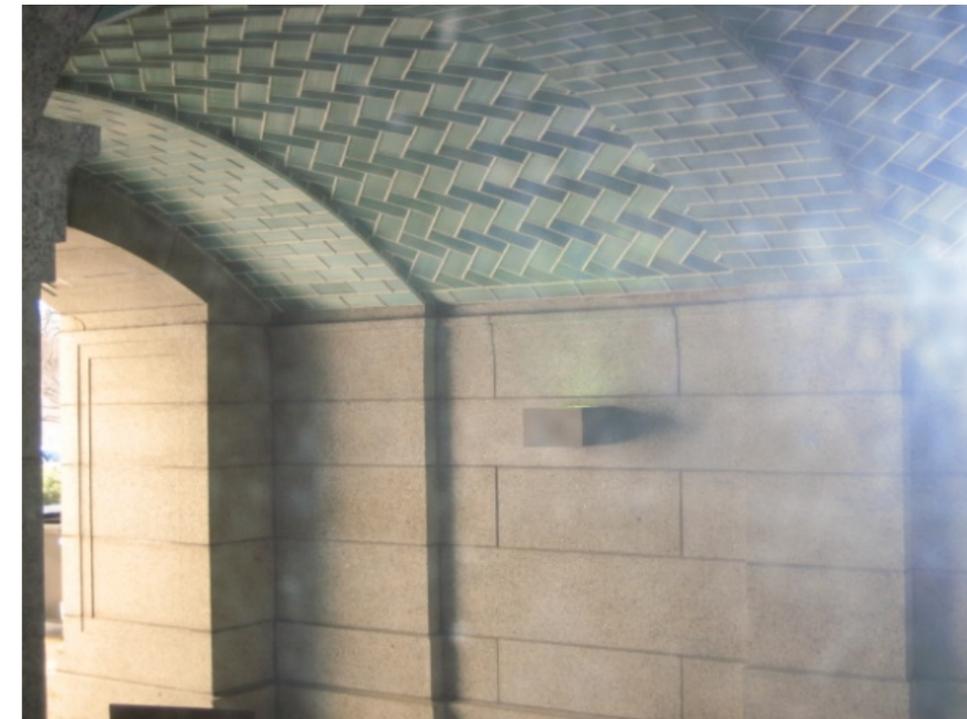
Porte Cochere

Building Element:	Description:	Condition of Material:
Floor	Joliet Limestone	Intact
Walls	Plaster/paint, Granite	Intact
Ceiling/Cornice	Decorative plaster, Green Guastavino vault	Unknown
Doors/Frame:	Original wood	Modified
Hardware	Replica ADA levers at original doors only.	Not original
Light Fixtures	Wall mounted uplights	Not Original
Artwork	None	None
Mechanical	Not original	Not original
Trim	Wood, stone	Not original
