Minnesota State Capitol Exterior Stone Repair Project

Presentation to CAAPB, SHPO, MHS and
DOA Representatives
December 19, 2012

2012 (Phase 1): Stone Repair Trials and Mock-up Evaluation

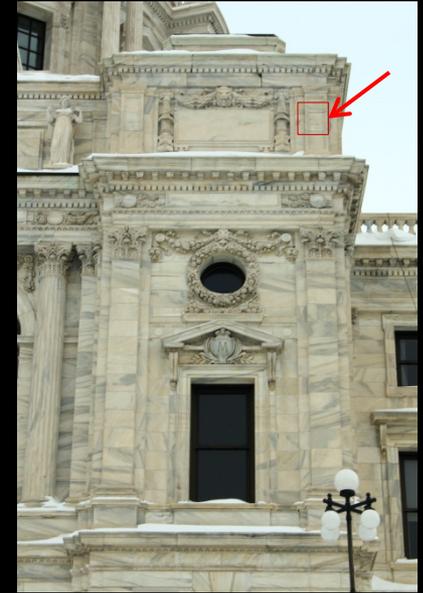
East elevator pilaster (side view) – identified in 2010 as life safety item

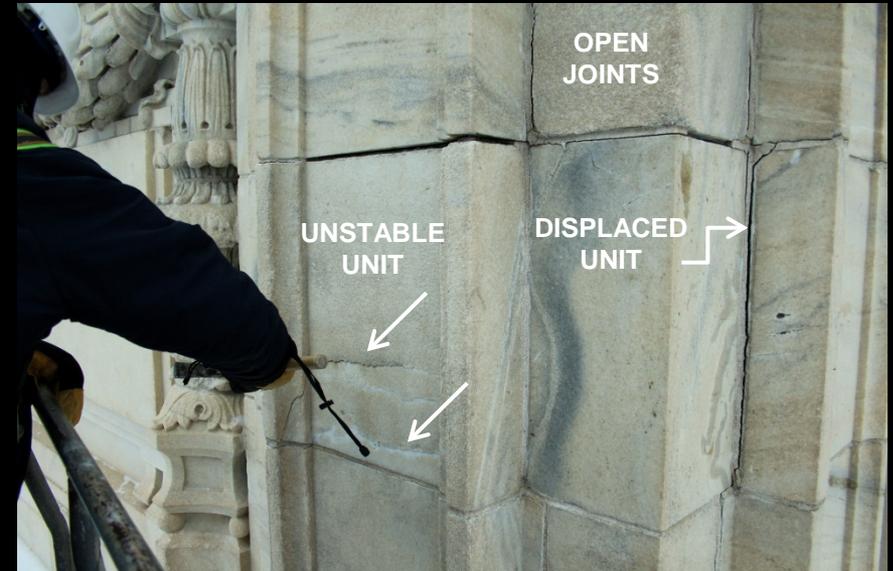
- The east elevator has been subjected to long term water infiltration from above.
- Back-up masonry is saturated and never completely dries.
- Brick and stone show evidence of freeze/thaw damage.
- Stone anchors are corroded and embedded.
- Freeze/thaw expansion is causing several units to shift outward.

East elevator cornice (front view)

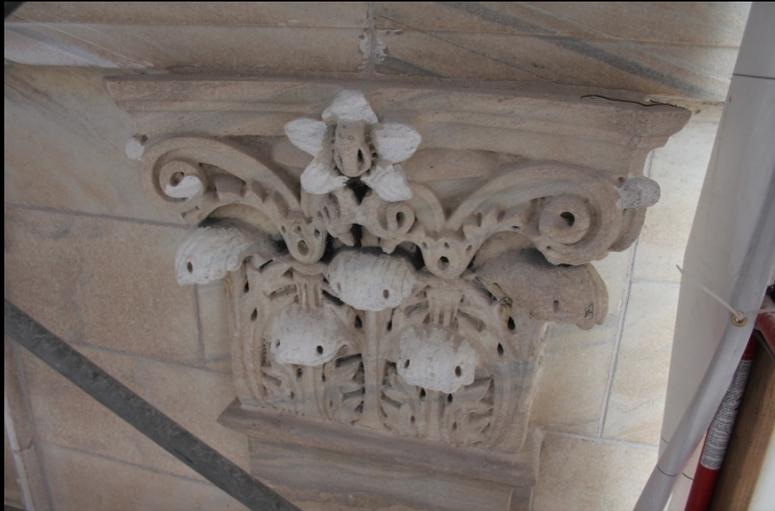
Option C (initial assumption)

Note: Deep deterioration required more extensive removal of original material than was originally assumed.

- + Historic material is retained as much as possible
- + Improved water management and surface protection
- Weathered material is interspersed with fresh stone

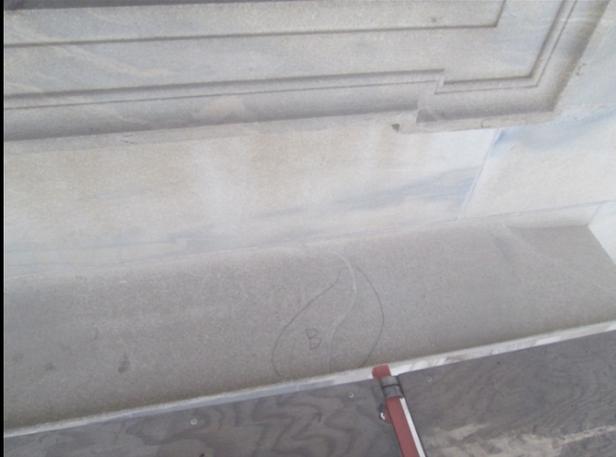
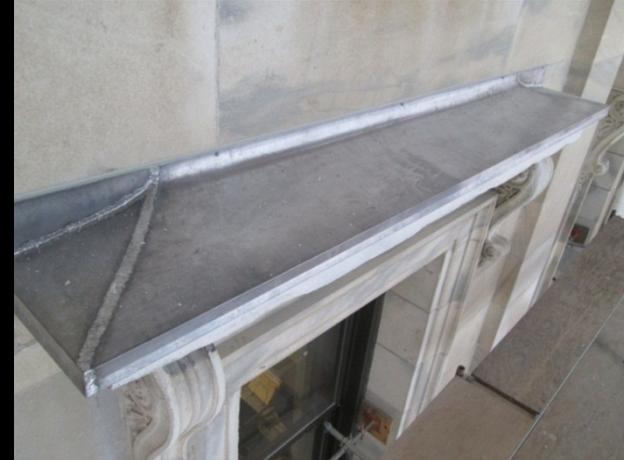
Option A

Note: Feature exceeds maximum length that can be cut from typical quarried block. Replacement units would have to be installed in two pieces or opportunities for custom cut blocks would have to be explored

- + Original material is retained
- Repairs may not address full extent of damage material.
- Routine inspection and ongoing repair are required

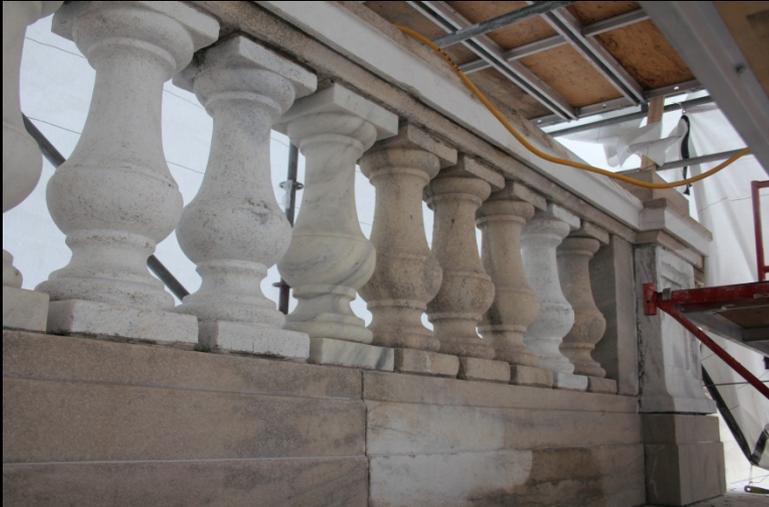
Option A

Note: White Georgia marble was not available when previous unit replacement was undertaken. Balusters were replaced with Cherokee white and Cherokee grey marble which are not visually compatible. *

- + Original material is retained and repaired as required
- + Redressing restores honed surface finish, blends well with new work

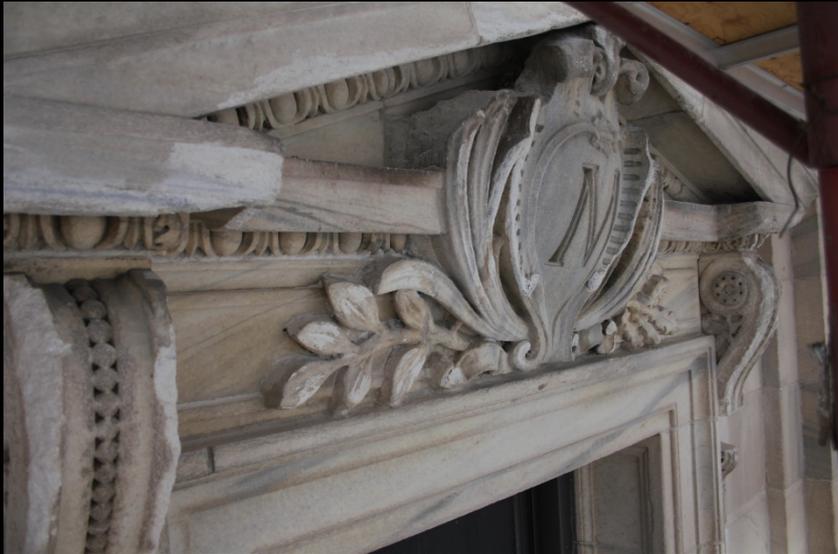
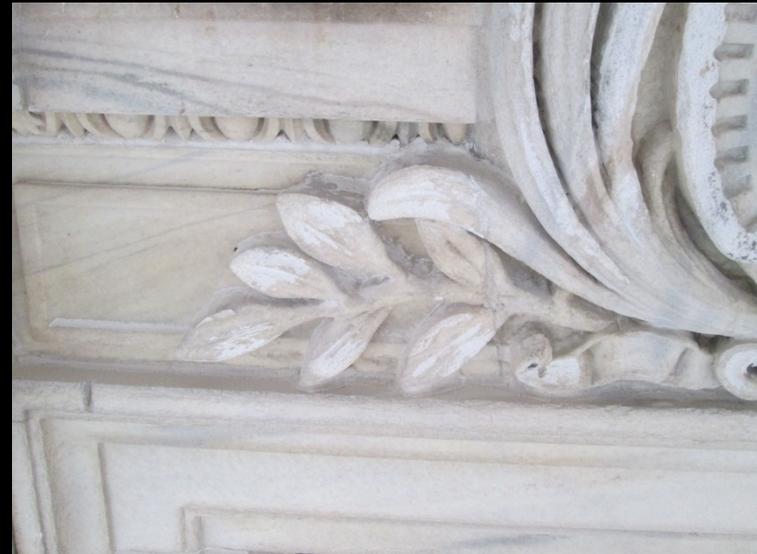
Various Strategies : High and Low Relief Carved Detail (east elevator medallion)

- + Original material is retained
- + Re-carving restores honed surface finish
- Light repair may not remove full extent of damage material.

- Option A – Protect. Mild grinding and smoothing of weathered surfaces. Features are re-carved to removed surface deterioration.

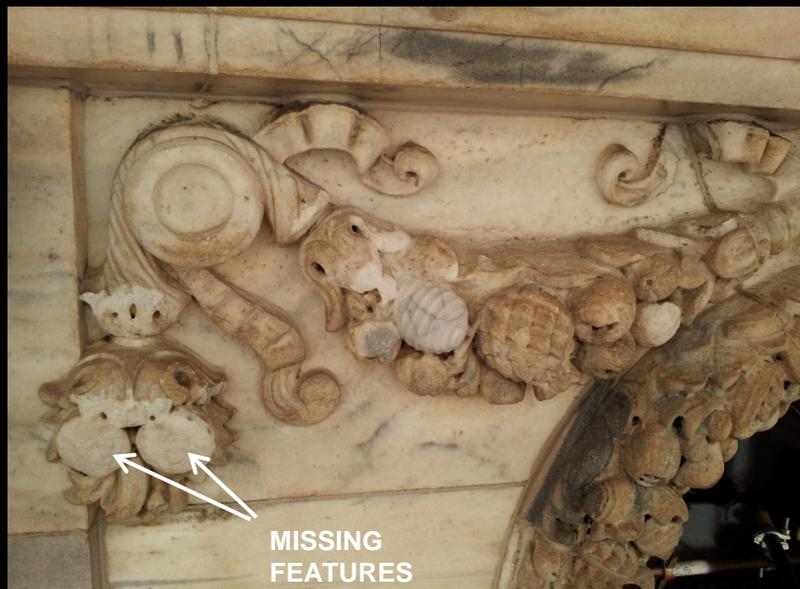
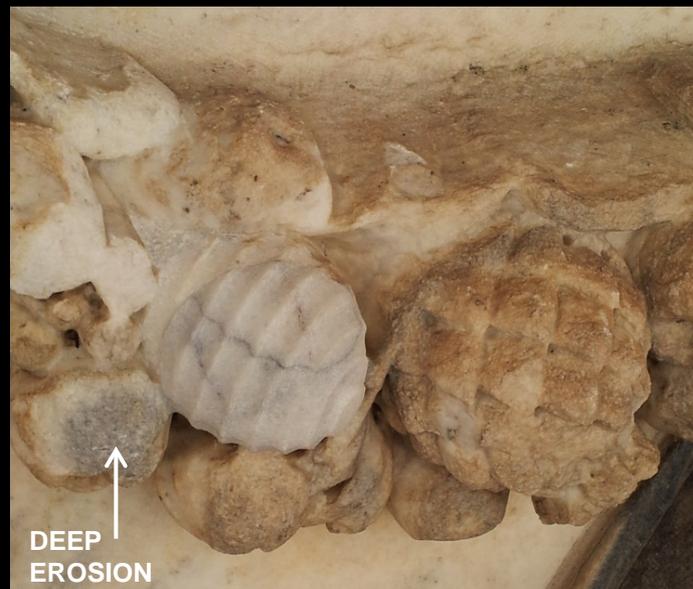
Note: Adjacent features in this location have deep erosion, removal of loose material will result in significant loss of detail.

+ Character is restored

- Option B – Restore. Missing detail is replaced with newly carved detail.

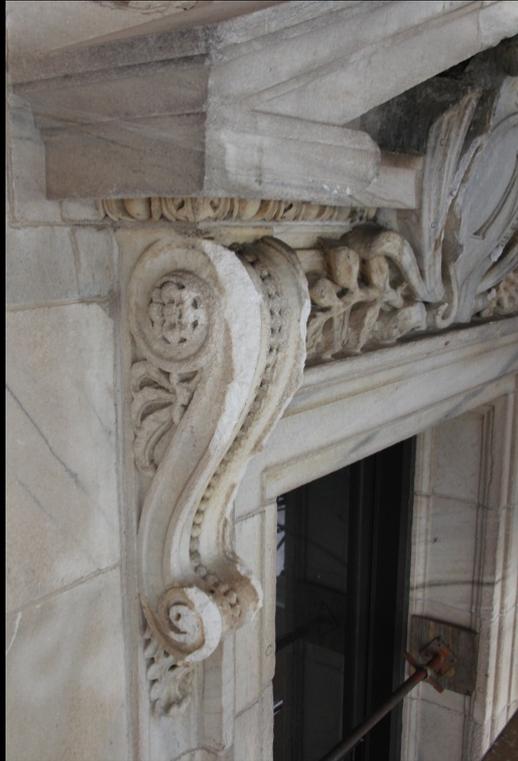
- + Original material is retained
- Detail is lost

- Option A – Protect. Mild grinding and smoothing of weathered surfaces.
- Option B – Replacement. Partial or full replacement where detail is missing.

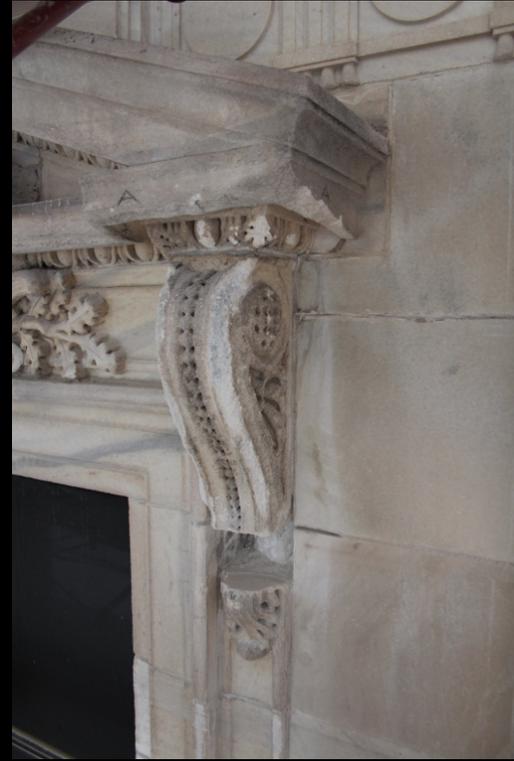
Option B

- + Character is preserved
- Original material is lost
- * Dependent on extent of weathered material left in place

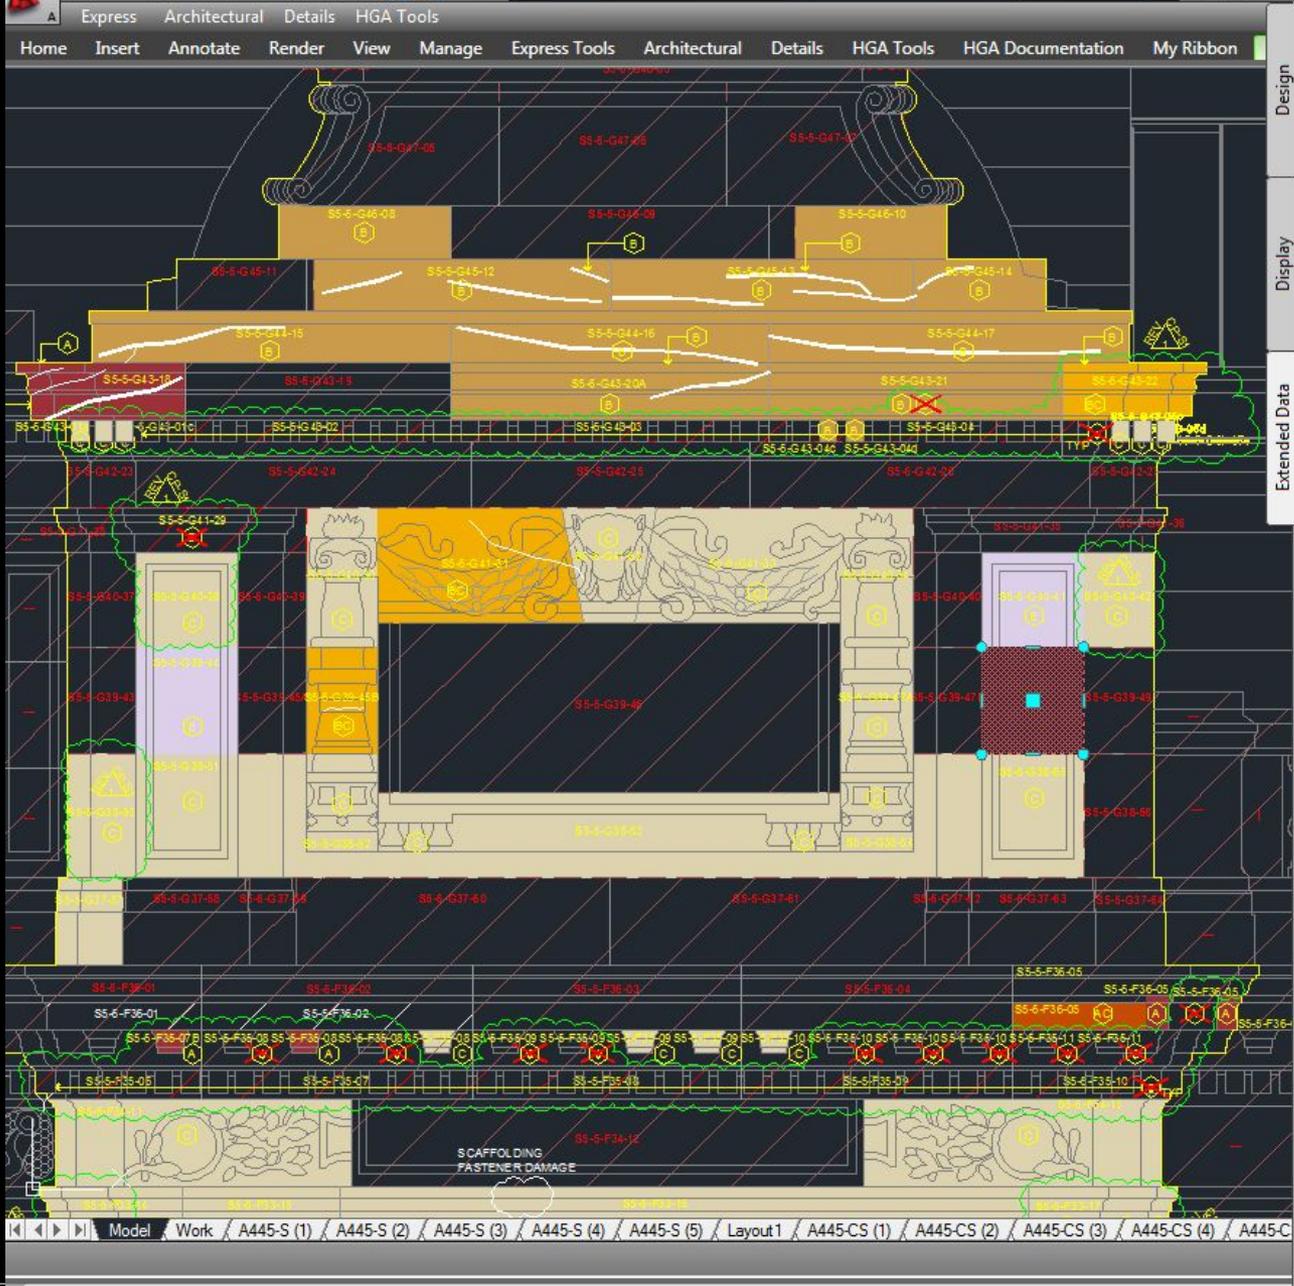
EAST ELEVATOR TOWER ELEVATIONS (DUTCHMAN REPAIRS)
CP-S1
A445

SheetNumber	A445
ElevationBlockID	S5-5-G39-48
PlanLocator	S5
Bay	5
ElevationZone	G
Course	39
Block	48
Element	Pilaster
PayItem	
TCTM	B
RepairType	New Stone
RepairTier	T1
Severity	8
Condition_Unsound	True
Condition_DisplacedUnit	True
Condition_CrackedUnit	True
Condition_SpalledMaterial	False
Condition_SurfaceLoss	False
Condition_Anchors	False
Condition_PreviousRepair	True
Condition_SurfaceStaining	False
Condition_Other	False
Condition_Remarks	Emergency pin repair 2011
RepairPackage	CP-S1
Notes	Total replacement - emerg...
CornerBlockReference	
A_Strategy_DutchmanRepair	False
B_Strategy_CrackRepair	False

Hyperlink	..\..\6. Construction A...
Notes	Total replacement - em...
Reference documents	(0)
