# **Requirement Detail Report**

**By Asset Name and Priority**

**State Capital Building (01)**

**Asset Name:** State Capitol Building  
**Asset Number:** 1

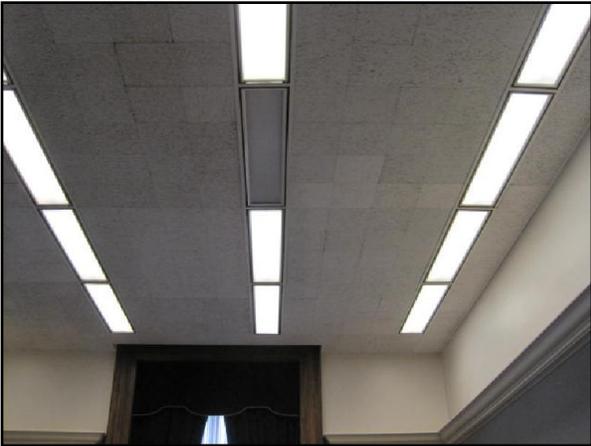
ACT System - Concealed Spline - 1965 Renewal  
 ACT System - Concealed Spline - 1965 Renewal

Auto generated renewal requirement for ACT System - Concealed Spline - 1965. System Description: Concealed spline 12 x 12 x 3/4-in. ACT ceiling system with "Z" grid at isolated offices including: ground floor (NW corner), 1st floor (SE corner), 2nd floor (SE corner), 3rd floor (SE corner).

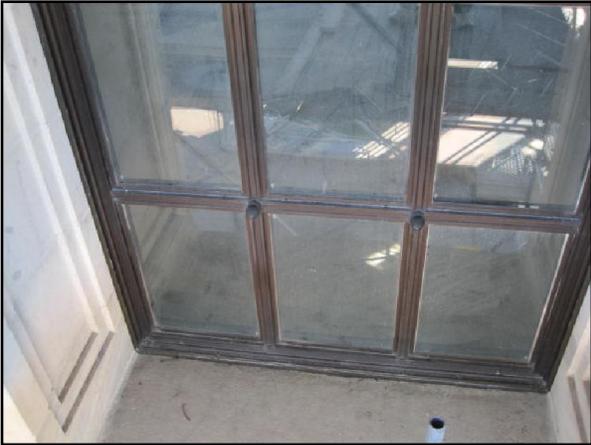
Aluminum Windows - Dome Barrel - 1985 Renewal  
Aluminum Windows - Dome Barrel - 1985 Renewal

Years remaining adjusted per Owner review comments received 02/14/2011.

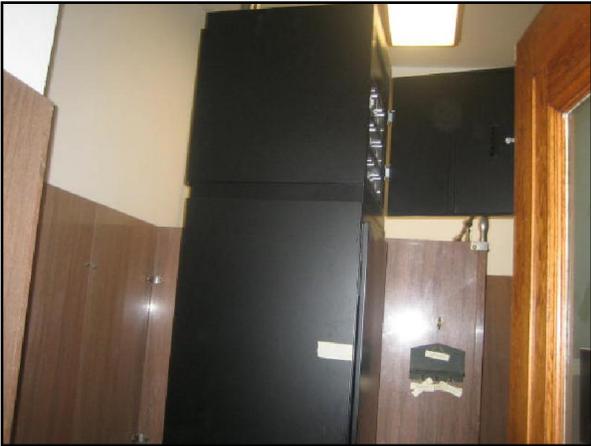
Audio Systems - Amplifier Beyond Rated Life - Room 119  
 Audio Systems - Amplifier Beyond Rated Life - Room 119

There is an aged amplifier located in a restroom, Room 119 on the first floor.

Replace the aged amplifier located in Room 119. Relocate the amplifier to a proper location. Reroute all conduit and wiring as applicable. Unit counts for budget purposes only. Actual counts may vary.

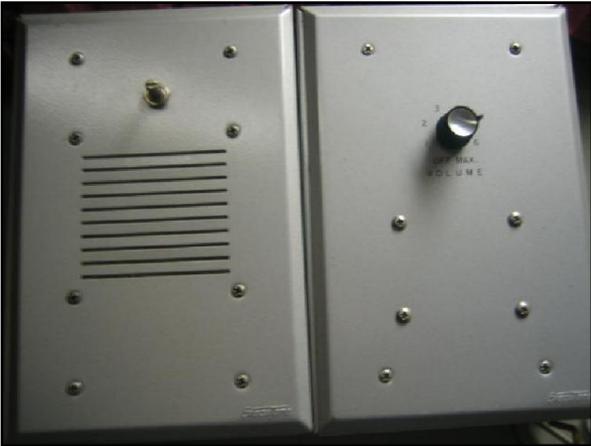
Audio Systems - Volume Control Beyond Rated Life - Room 316B  
 Audio Systems - Volume Control Beyond Rated Life - Room 316B

There is a small aged sound control box located in Room 316B serving the Supreme Court.

Replace the aged sound control station located in Room 316B. Unit counts for budget purposes only. Actual counts may vary.

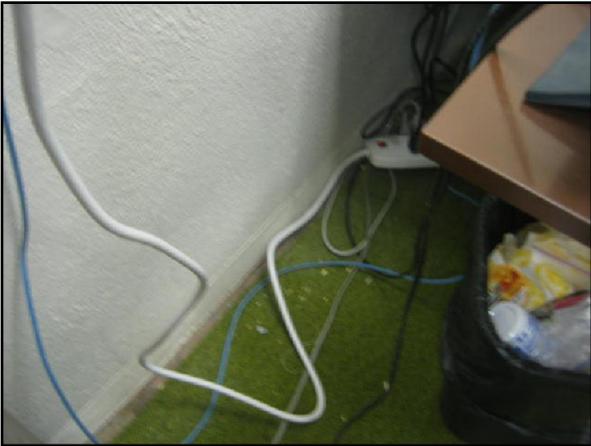
Branch Wiring - Insufficient Outlets - Basement  
Branch Wiring - Insufficient Outlets - Basement

There are an insufficient number of receptacle outlets in many areas of the Basement resulting in widespread use of extension cords and power strips. Specific locations include Room B59B.

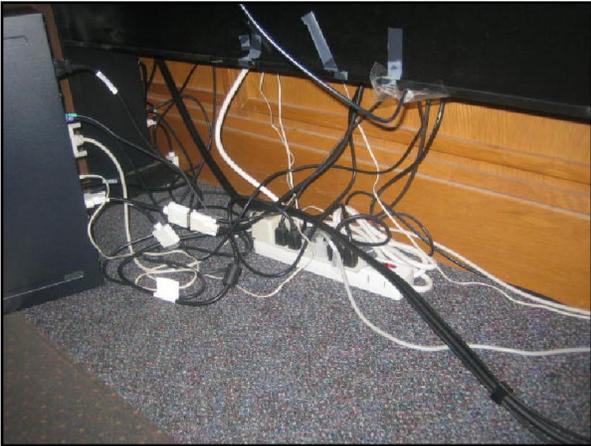
Branch Wiring - Insufficient Outlets - First Floor  
Branch Wiring - Insufficient Outlets - First Floor

There are an insufficient number of receptacle outlets in many areas of the First Floor resulting in widespread use of extension cords and power strips. Specific locations include Room 120, 103E.

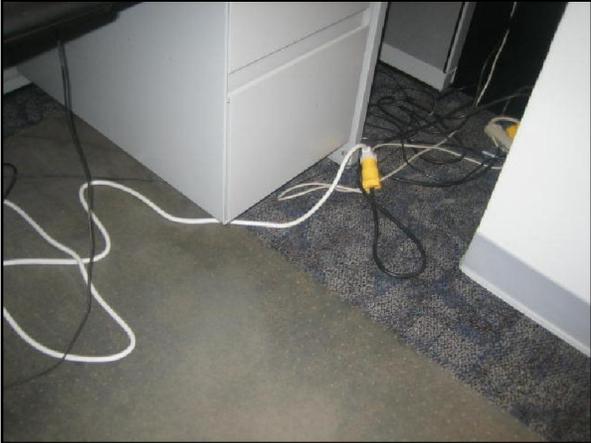
Branch Wiring - Insufficient Outlets - Ground Floor  
 Branch Wiring - Insufficient Outlets - Ground Floor

There are an insufficient number of receptacle outlets in many areas of the Ground Floor resulting in widespread use of extension cords and power strips. Specific locations include Room G18.

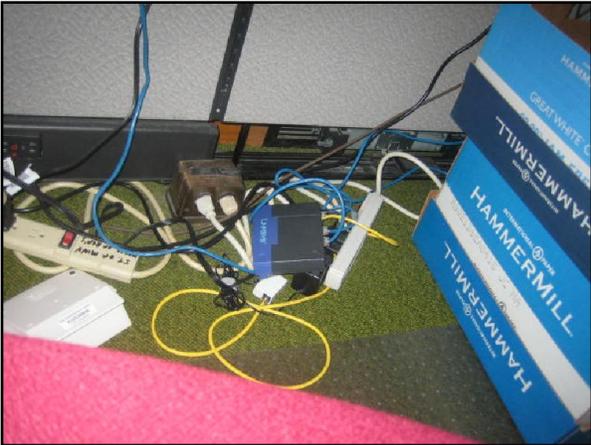
Branch Wiring - Insufficient Outlets - Second Floor  
Branch Wiring - Insufficient Outlets - Second Floor

There are an insufficient number of receptacle outlets in many areas of the Second Floor resulting in widespread use of extension cords and power strips. Specific locations include Room 214.

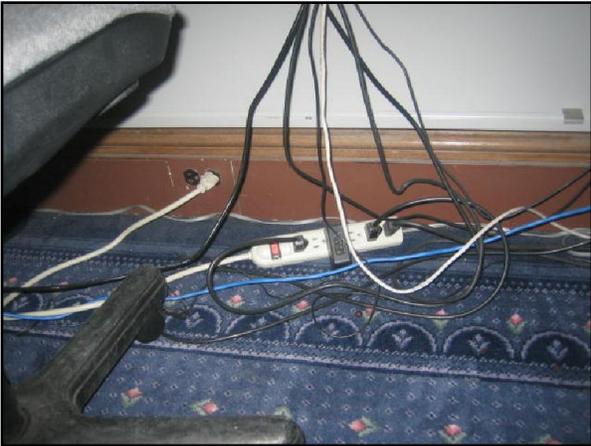
Branch Wiring - Insufficient Outlets - Third Floor  
Branch Wiring - Insufficient Outlets - Third Floor

There are an insufficient number of receptacle outlets in many areas of the Third Floor resulting in widespread use of extension cords and power strips. Specific locations include Rooms 317A/B/C, 321, 323-330, 302-309.

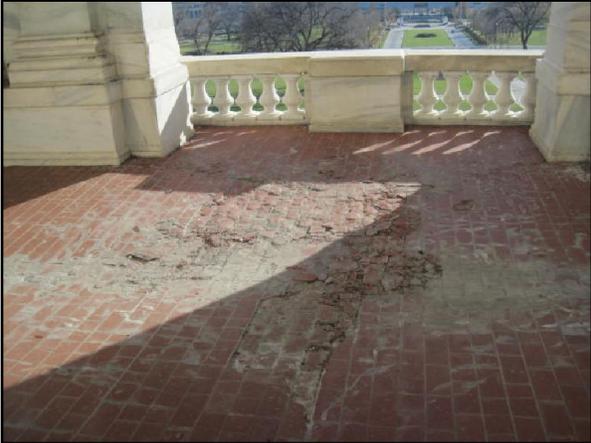
Built-up Membrane with Thickset Pavers on Roof - 2nd Floor Balconies - 1985 Renewal

Auto generated renewal requirement for Built-up Membrane with Thickset Pavers on Roof - 2nd Floor Balconies - 1985. System Description: The roof covering includes thickset brick paver ballast above asphalt membrane on concrete or masonry roof deck at 2nd floor balconies.

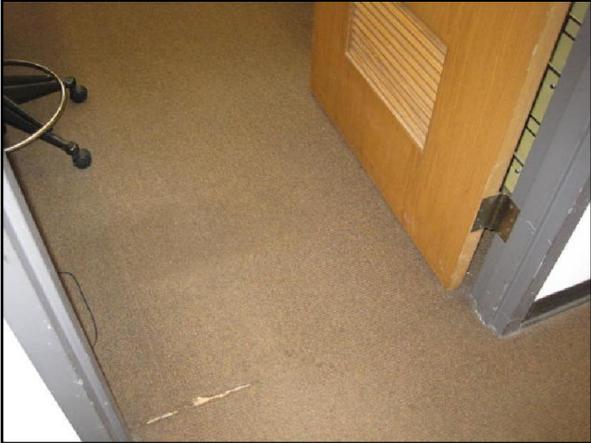
Carpeting - Broadloom - High Quality - 3rd Floor - 1980 Renewal  
 Carpeting - Broadloom - High Quality - 3rd Floor - 1980 Renewal

Auto generated renewal requirement for Carpeting - Broadloom - High Quality - 3rd Floor - 1980. System Description: Floor finishes include deluxe carpeting with carpet pad in 3rd floor NE corner TV room (317), corridors, support spaces, etc.

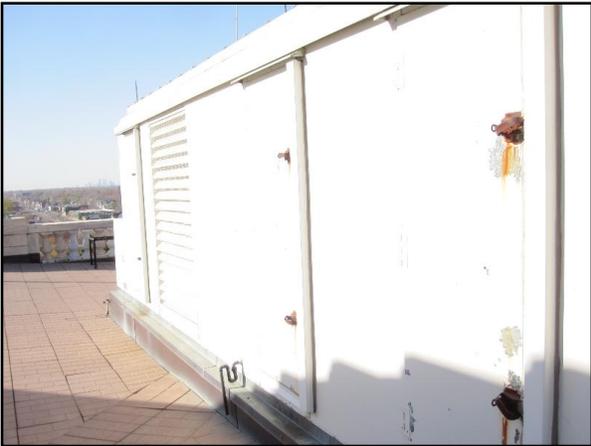
Central AHU - Const Volume w/Distribution Renewal  
 Central AHU - Const Volume w/Distribution Renewal

Auto generated renewal requirement for Central AHU - Const Volume w/Distribution. System Description: The HVAC system includes constant volume air handling units, distribution ductwork, diffusers and plenum return. There are a total of 28 air handling units throughout the building, most with constant velocity terminal units.

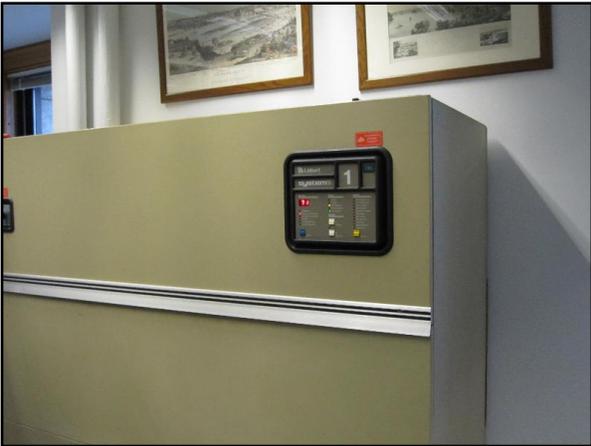
Computer Room Cooling - DX w/Air Cooled Remote Condenser Renewal  
 Computer Room Cooling - DX w/Air Cooled Remote Condenser Renewal

Auto generated renewal requirement for Computer Room Cooling - DX w/Air Cooled Remote Condenser. System Description: The HVAC system includes a computer room cooling unit with an air cooled remote condenser. The Liebert under floor AC unit is located on the ground floor computer room 3B.

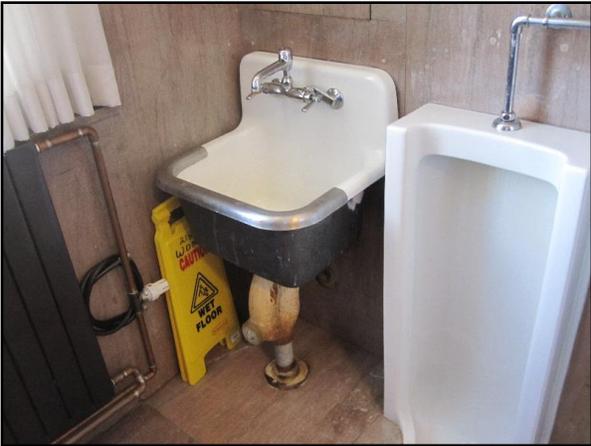
Custodial/Utility Sinks Renewal  
 Custodial/Utility Sinks Renewal

Auto generated renewal requirement for Custodial/Utility Sinks. System Description: The plumbing fixtures include wall hung CI and floor mounted custodial/utility sinks. Includes rough-in and faucet.

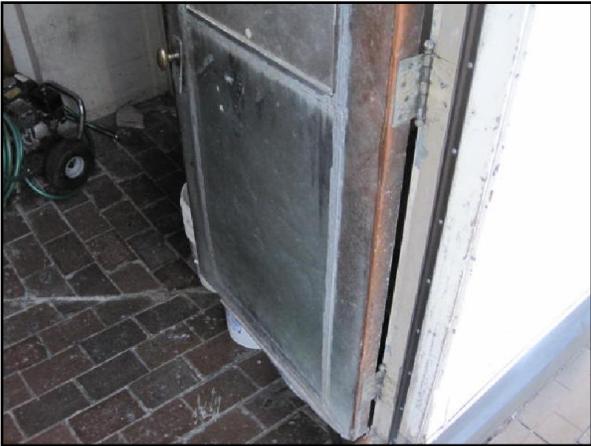
Door Assembly - 3 x 7 HM - 1965 Renewal  
 Door Assembly - 3 x 7 HM - 1965 Renewal

Auto generated renewal requirement for Door Assembly - 3 x 7 HM - 1965. System Description: Exterior doors include 3 x 7 steel door and steel frame with hinges and lockset. Includes painted door and painted frame at storage areas below south steps, NE equipment access and dome barrel.

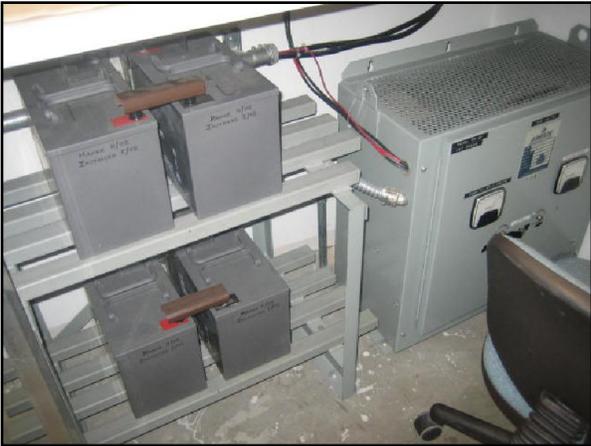
Emergency Lighting Renewal  
 Emergency Lighting Renewal

Auto generated renewal requirement for Emergency Lighting. System Description: Emergency lighting consists of an aged antiquated 32V system with a minimal number of wall mount light fixtures over several doorways and in corridors.

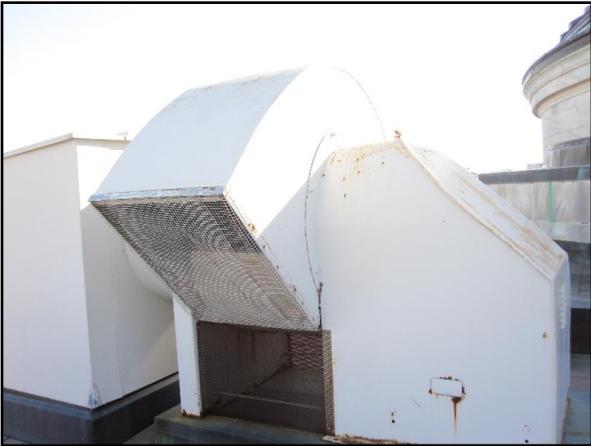
Exhaust System - General Building Renewal  
 Exhaust System - General Building Renewal

Auto generated renewal requirement for Exhaust System - General Building. System Description: The HVAC ventilation system includes roof-mounted and in-line exhaust fans with ducting.

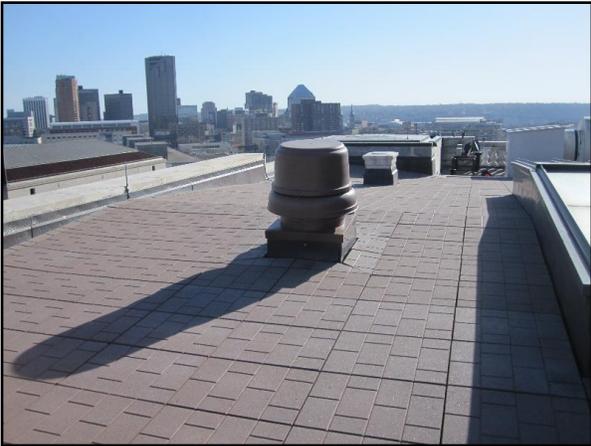
Exhaust System - Restroom Renewal  
 Exhaust System - Restroom Renewal

Auto generated renewal requirement for Exhaust System - Restroom. System Description: HVAC ventilation system includes roof-mounted restroom exhaust fans with ducting.

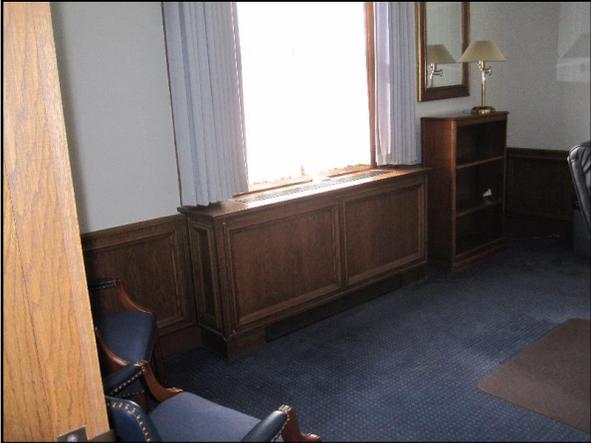
Fan Coil System - Cabinet - Heating/Cooling - 4 Pipe Renewal  
 Fan Coil System - Cabinet - Heating/Cooling - 4 Pipe Renewal

Auto generated renewal requirement for Fan Coil System - Cabinet - Heating/Cooling - 4 Pipe. System Description: HVAC system includes perimeter wall hung cabinet type fan coil 4-pipe chilled water and heating water system.

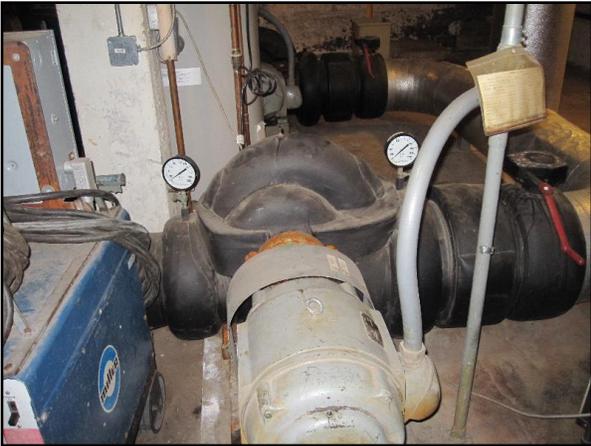
Four Pipe Distribution System w/Pump Renewal  
Four Pipe Distribution System w/Pump Renewal

Auto generated renewal requirement for Four Pipe Distribution System w/Pump. System Description: HVAC distribution is provided by a four-pipe distribution system. This system provides heating hot water and chilled water to air handlers and terminal devices such as fan coil units and reheat coils.

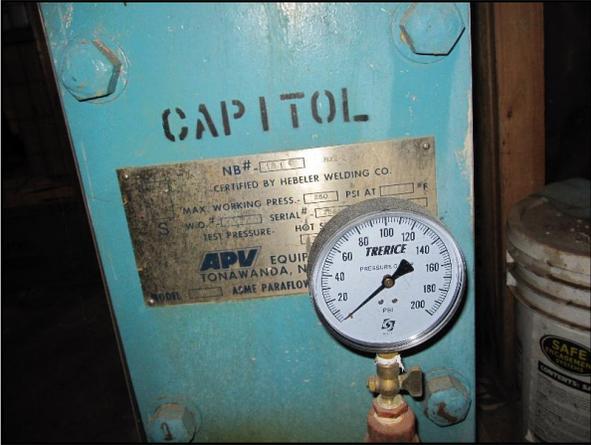
Heat Exchanger - Liquid/Liquid - Plate and Frame Renewal  
Heat Exchanger - Liquid/Liquid - Plate and Frame Renewal

Auto generated renewal requirement for Heat Exchanger - Liquid/Liquid - Plate and Frame. System Description: Heating hot water is provided by a primary heat exchanger which takes heated water from "District Energy" and uses it to produce heating hot water for the building. This water is then used to provide heating hot water for air handling units and reheat units as well as domestic hot water (via separate heat exchangers from the ones in this system).

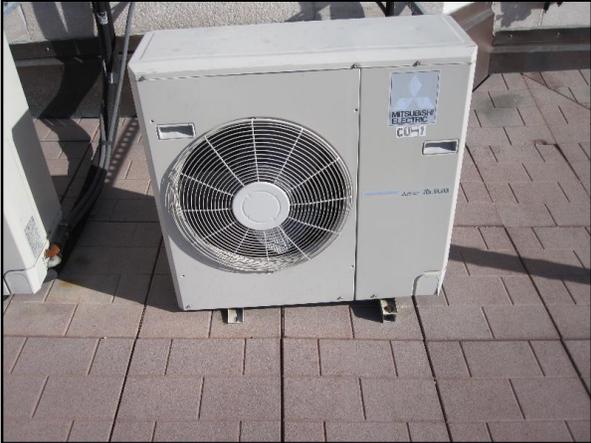
Heat Pump - Split DX - 1995 Renewal  
Heat Pump - Split DX - 1995 Renewal

Auto generated renewal requirement for Heat Pump - Split DX - 1995. System Description: The HVAC system includes a number of split DX heat pumps, typically used to provide supplemental cooling to specific areas like tel/data rooms. This system is specifically for the 4 units that were installed in the mid-1990's.

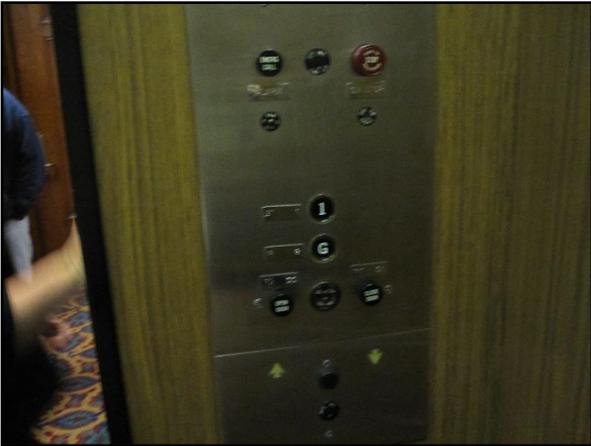
Hydraulic Passenger Elevator Renewal  
Hydraulic Passenger Elevator Renewal

Auto generated renewal requirement for Hydraulic Passenger Elevator. System Description: The conveying equipment includes a passenger hydraulic elevator. This elevator serves two floors of the the governor's office, and has a capacity of 1,200 lb.

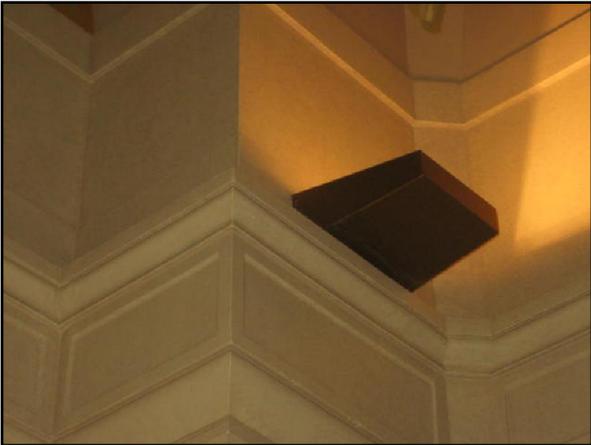
Interior Lighting - Quartz Wall Sconces Renewal

Auto generated renewal requirement for Interior Lighting - Quartz Wall Sconces. System Description: Brass wall sconces are installed throughout most corridors, around the Rotunda on all levels and in the Supreme Court. Luminaires utilize 300W quartz lamps and provide accent uplighting throughout. The sconces are wired and connected with mineral insulated (MI) cable.

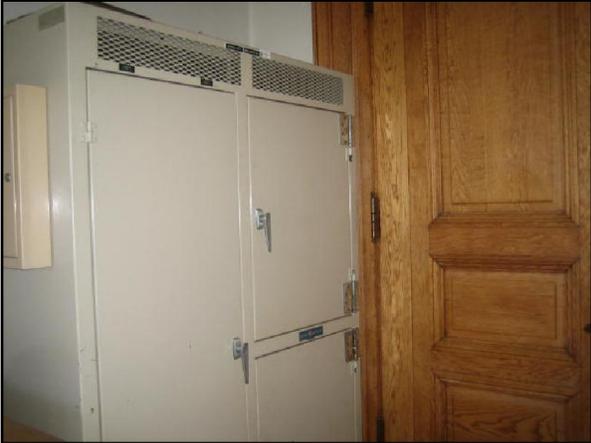
Lighting Dimming Systems - Supreme Court - Located in Stairwell  
 Lighting Dimming Systems - Supreme Court - Located in Stairwell

The lighting dimming control board serving the Supreme Court is aged and beyond its rated life. The board is old technology and replacement parts are becoming obsolete. The control panel is also located in the stairwell on the NE corner of the third floor in violation of NFPA 101 (2006) Section 7.1.3.2.3.

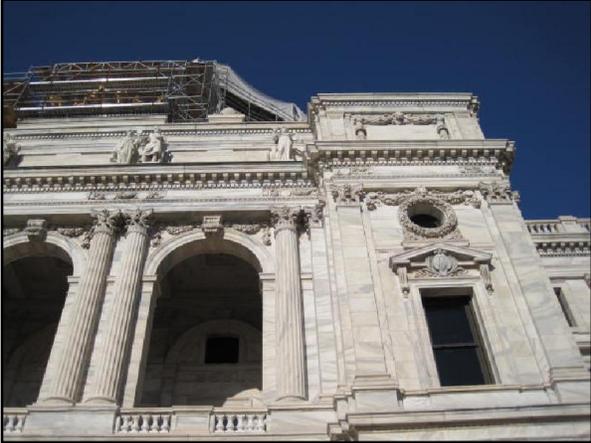
Marble Veneer Walls and Ornate Trim - Main Building Renewal  
 Marble Veneer Walls and Ornate Trim - Main Building Renewal

Note: Some immediate renewal work is required to eliminate possibility of pieces of stone breaking away and falling to the ground and injuring a passing citizen. Coordinate system renewal with other Owner initiated studies that identify and prioritize potential immediate hazards.

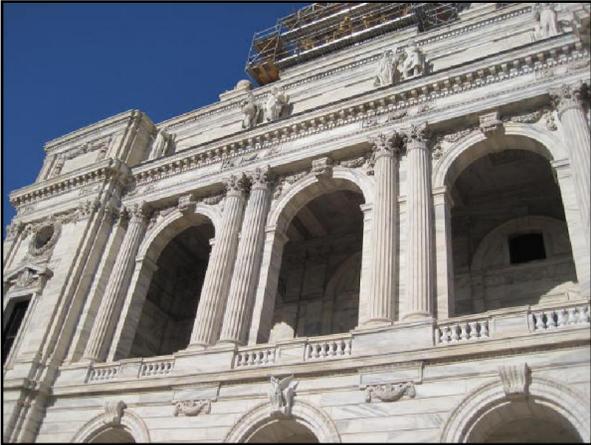
Marble Veneer Walls and Ornate Trim - Record Study  
 Marble Veneer Walls and Ornate Trim - Record Study

Many, if not most of these elements (statuary, quoins, belts, window trim, columns and capitals, etc.) are 2-3 floors or more above finish grade and thus difficult to accurately inventory. Plans should be undertaken to develop a 3D laser imagery database of all exterior marble details and trim so accurate reproductions can be made and the visual integrity of the entire building maintained.

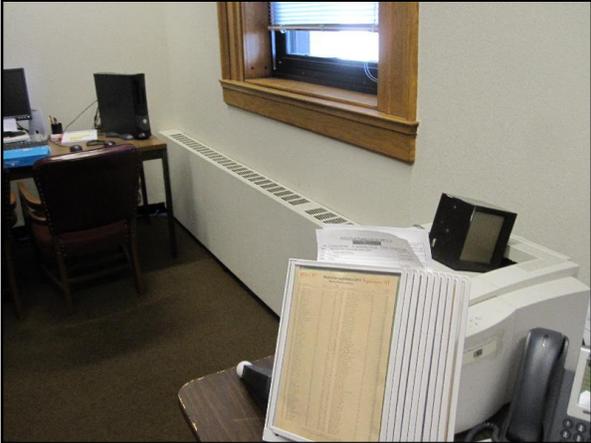
Perimeter Heat System - Hydronic Fin Tube Renewal  
 Perimeter Heat System - Hydronic Fin Tube Renewal

Auto generated renewal requirement for Perimeter Heat System - Hydronic Fin Tube. System Description: HVAC distribution includes a two-pipe system of heating hot water, with perimeter units. These units are found primarily on the second floor perimeter offices beneath the doors and windows.

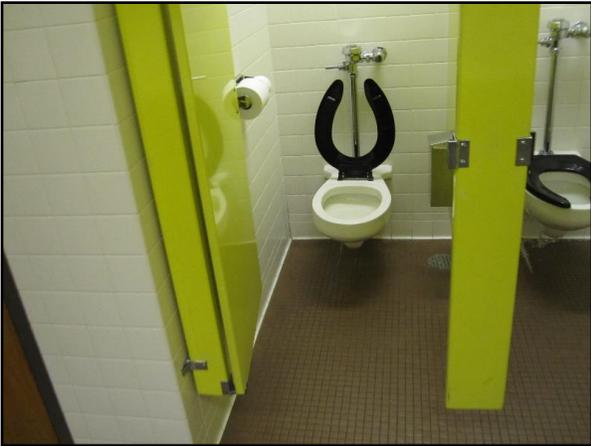
Restroom Fixtures Renewal  
 Restroom Fixtures Renewal

Auto generated renewal requirement for Restroom Fixtures. System Description: The restroom fixtures include vitreous china urinals, water closets, and lavatories. There are also two tile shower units in the basement.

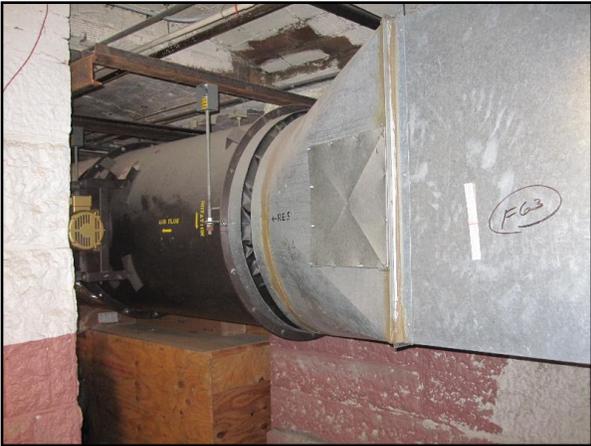
Return Air Ductwork and Fan Renewal  
Return Air Ductwork and Fan Renewal

Auto generated renewal requirement for Return Air Ductwork and Fan. System Description: The HVAC system has return air ductwork and centrifugal and axial in-line return air fans. These fans return air back to the air handling units.

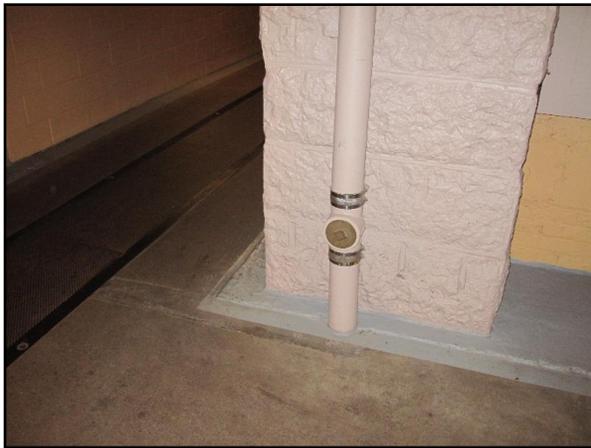
Roof Drainage - Gravity Renewal

Auto generated renewal requirement for Roof Drainage - Gravity. System Description: Rain water drainage includes interior piping, roof drains and 4-inch discharge piping by gravity flow to a municipal main.

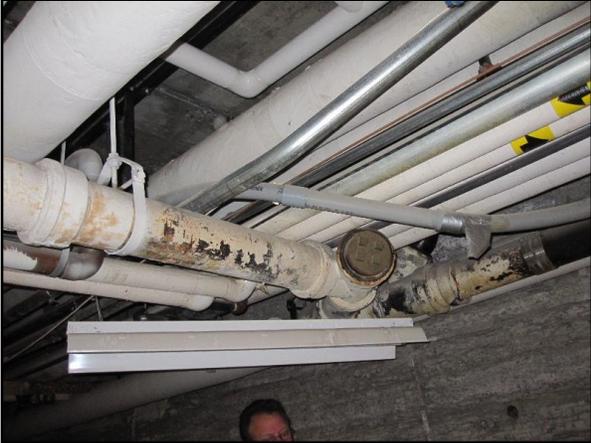
Sanitary Waste - Gravity Disch Renewal  
Sanitary Waste - Gravity Disch Renewal

Auto generated renewal requirement for Sanitary Waste - Gravity Disch. System Description: The building includes a sanitary waste system, of cast iron piping, with gravity discharge to the municipal system.

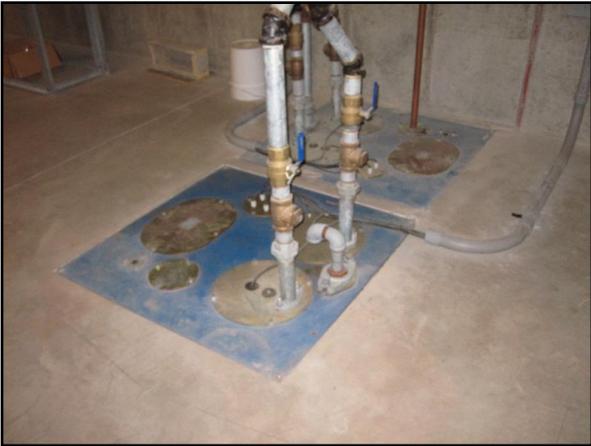
Sump Pump - Submersible Renewal  
Sump Pump - Submersible Renewal

Auto generated renewal requirement for Sump Pump - Submersible. System Description: The water drainage system includes a sump 1/2 HP submersible pump. Note: available Means cost line items for alarm system selected for budgetary purposes only.

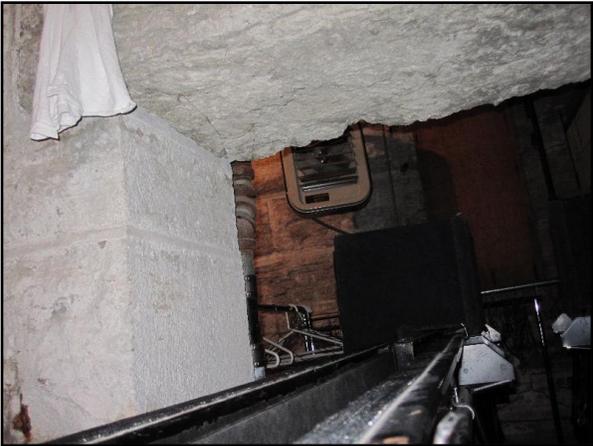
Unit Heaters - Electric Renewal  
Unit Heaters - Electric Renewal

Auto generated renewal requirement for Unit Heaters - Electric. System Description: Heating is provided by suspended, electric unit heaters. These are located in electrical rooms and service areas that do not have access to heating hot water.

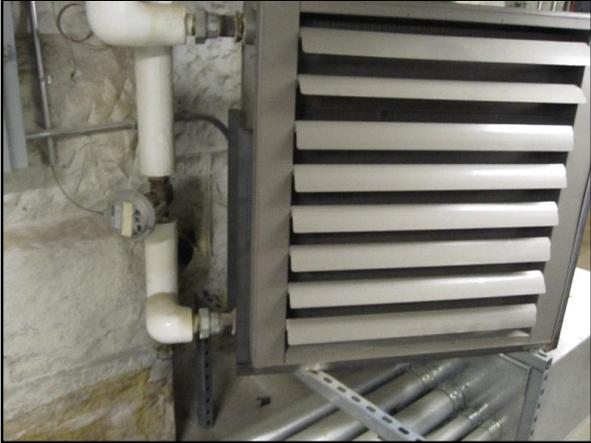
Unit Heaters - Hot Water Renewal  
Unit Heaters - Hot Water Renewal

Auto generated renewal requirement for Unit Heaters - Hot Water. System Description: Heating is provided by suspended, forced hot water unit heaters. These are found typically in service areas and mechanical rooms.

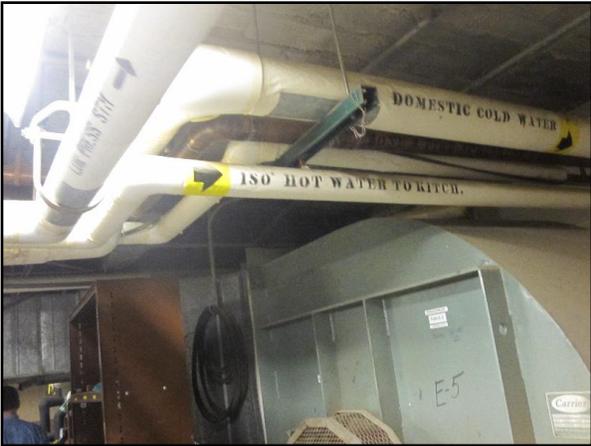
Water Dist Complete Renewal  
Water Dist Complete Renewal

Auto generated renewal requirement for Water Dist Complete. System Description: The building domestic water distribution system includes two 3 inch main lines, water meters, double check backflow preventers, with rough ins included. This system does not include a water heater.

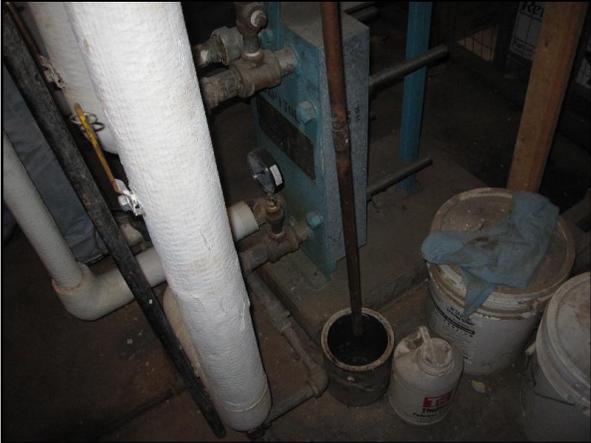
Water Heater - Domestic Hot Water Heat Exchangers Renewal  
 Water Heater - Domestic Hot Water Heat Exchangers Renewal

Auto generated renewal requirement for Water Heater - Domestic Hot Water Heat Exchangers. System Description: Domestic hot water is produced from heating hot water that is circulated through two plate and frame heat exchangers to produce domestic hot water.

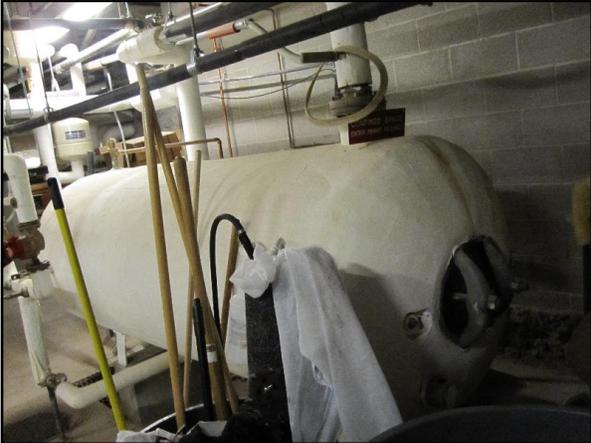
Water Heater - Hot Water Heat Exchanger and Storage Tank Renewal  
 Water Heater - Hot Water Heat Exchanger and Storage Tank Renewal

Note: An exact match for this item was not available in RS Means. Similar components have been selected for budgetary purposes.

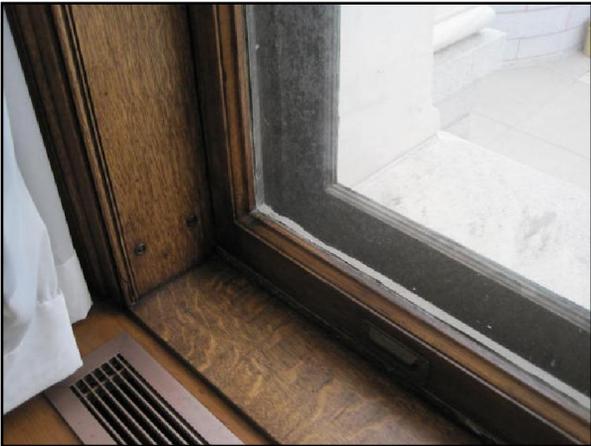
Wood Windows - Main Building Renewal  
Wood Windows - Main Building Renewal

Note: Replacement windows shall respect historic nature of building.

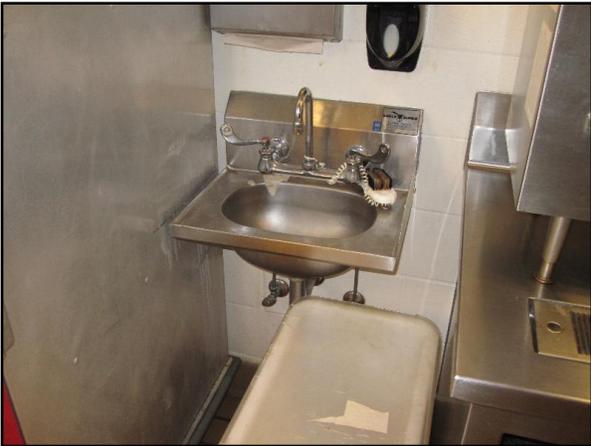
Work and Exam Stations - Wall Sink Renewal  
 Work and Exam Stations - Wall Sink Renewal

Auto generated renewal requirement for Work and Exam Stations - Wall Sink. System Description: The plumbing fixtures include wall mounted stainless steel lavatories. These are located in the kitchen area for hand washing.

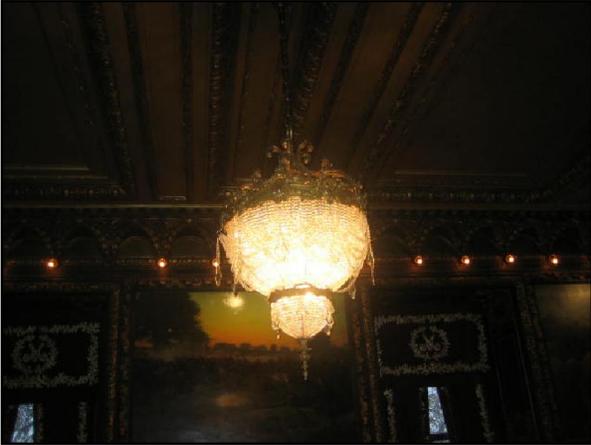
Antique Lighting - Crystal Chandeliers - Type W Renewal  
 Antique Lighting - Crystal Chandeliers - Type W Renewal

"The chandeliers are 106 years old and it is expected to last another 100 years under same environment but will require new or retrofitted lamp sockets in the near future. Observed years remaining has been increased slightly but sockets and wiring needs to be replaced or completely reconditioned in the near future."

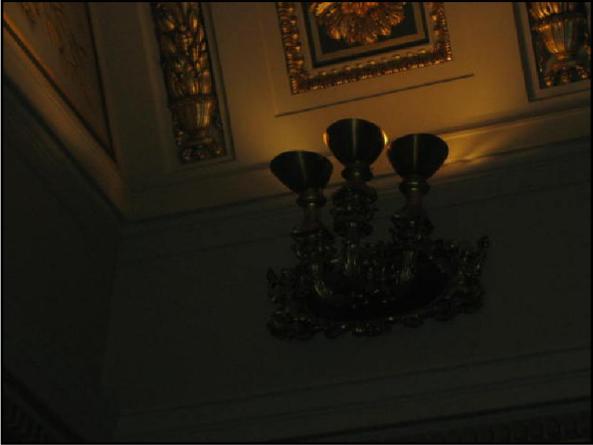
Antique Lighting - Faux Brass Composite Accent Lights - Type AA Renewal  
 Antique Lighting - Faux Brass Composite Accent Lights - Type AA Renewal

"Fixture bodies are 106 years old and it is expected they will last another 100 years under same environment but will require new or retrofitted lamp sockets in the near future. The fixtures are in good working order for their age due to diligent maintenance. Observed years remaining have been increased slightly but fixtures need to be replaced or completely reconditioned in the near future."

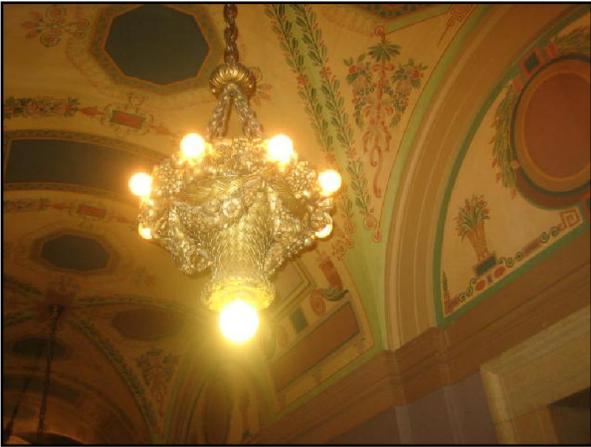
Antique Lighting - Faux Brass Composite Chandeliers - Type V4 Renewal  
 Antique Lighting - Faux Brass Composite Chandeliers - Type V4 Renewal

"Fixture bodies are 106 years old and it is expected they will last another 100 years under same environment but will require new or retrofitted lamp sockets in the near future. The fixtures are in good working order for their age due to diligent maintenance. Observed years remaining have been increased slightly but fixtures need to be replaced or completely reconditioned in the near future."

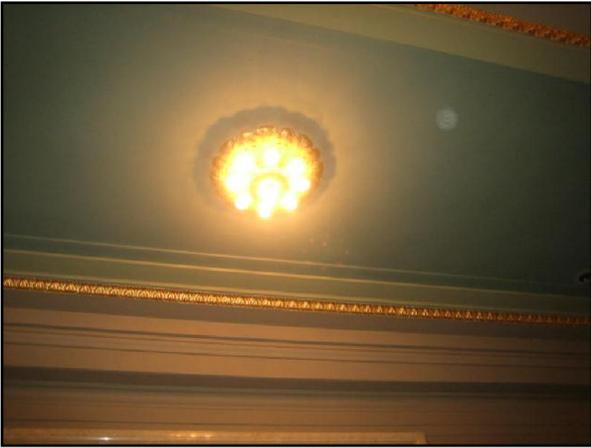
Antique Lighting - Faux Brass Composite Rosettes - Type N Renewal  
 Antique Lighting - Faux Brass Composite Rosettes - Type N Renewal

"Fixture bodies are 106 years old and it is expected they will last another 100 years under same environment but will require new or retrofitted lamp sockets in the near future. The fixtures are in good working order for their age due to diligent maintenance. Observed years remaining have been increased slightly but fixtures need to be replaced or completely reconditioned in the near future."

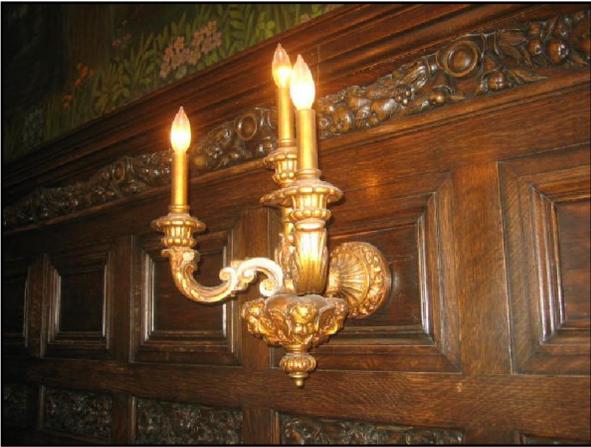
Antique Lighting - Faux Brass Composite Wall Fixture - Type EE Renewal  
 Antique Lighting - Faux Brass Composite Wall Fixture - Type EE Renewal

"Fixture bodies are 106 years old and it is expected they will last another 100 years under same environment but will require new or retrofitted lamp sockets in the near future. The fixtures are in good working order for their age due to diligent maintenance. Observed years remaining have been increased slightly but fixtures need to be replaced or completely reconditioned in the near future."

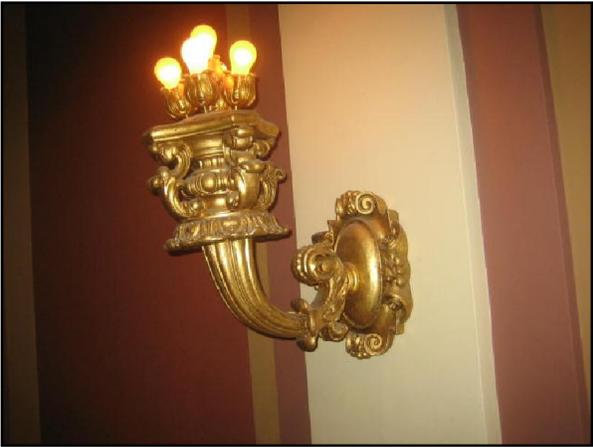
Antique Lighting - Faux Brass Composite Wall Fixture - Type GG Renewal  
 Antique Lighting - Faux Brass Composite Wall Fixture - Type GG Renewal

"Fixture bodies are 106 years old and it is expected they will last another 100 years under same environment but will require new or retrofitted lamp sockets in the near future. The fixtures are in good working order for their age due to diligent maintenance. Observed years remaining have been increased slightly but fixtures need to be replaced or completely reconditioned in the near future."

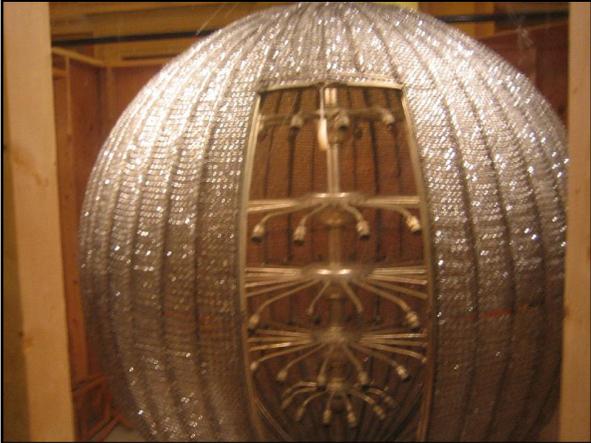
Antique Lighting - Main Crystal Chandelier Renewal

"The main chandelier is 106 years old and it is expected to last another 100 years under same environment but will require new or retrofitted lamp sockets in the near future. During the 2010 assessment, the chandelier was in the process of being cleaned and relamped. Observed years remaining has been increased slightly but sockets and wiring needs to be replaced or completely reconditioned in the near future."

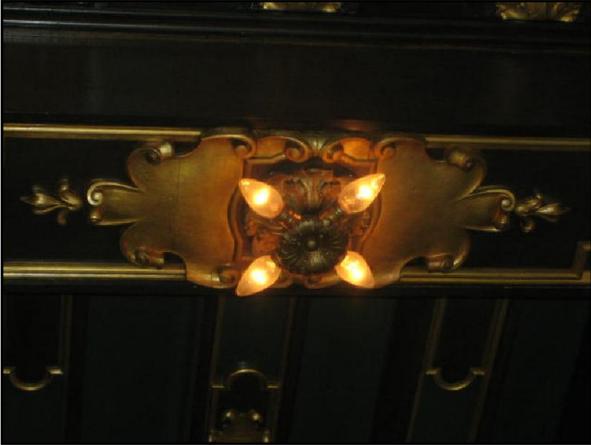
Antique Lighting - Solid Bronze Rosettes - Type DD Renewal  
 Antique Lighting - Solid Bronze Rosettes - Type DD Renewal

"Fixture bodies are 106 years old and it is expected they will last another 100 years under same environment but will require new or retrofitted lamp sockets in the near future. The fixtures are in good working order for their age due to diligent maintenance. Observed years remaining have been increased slightly but fixtures need to be replaced or completely reconditioned in the near future."

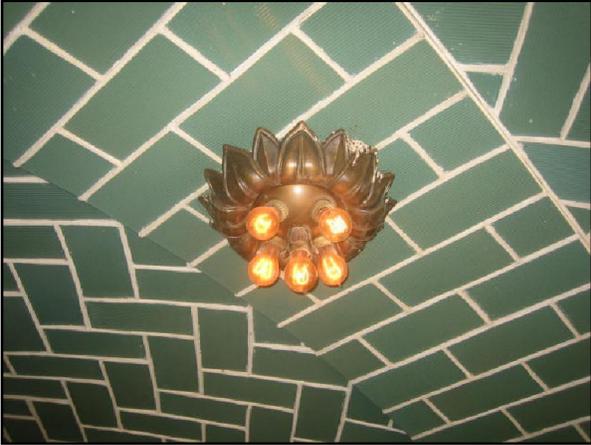
Antique Lighting - Solid Bronze Rosettes - Type V6 Renewal  
 Antique Lighting - Solid Bronze Rosettes - Type V6 Renewal

"Fixture bodies are 106 years old and it is expected they will last another 100 years under same environment but will require new or retrofitted lamp sockets in the near future. The fixtures are in good working order for their age due to diligent maintenance. Observed years remaining have been increased slightly but fixtures need to be replaced or completely reconditioned in the near future."

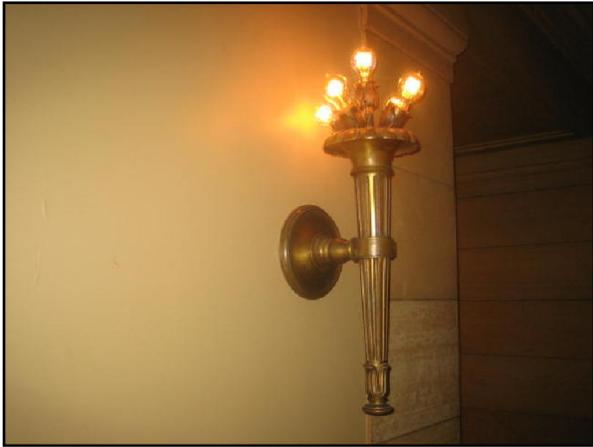
Antique Lighting - Solid Bronze Wall Fixture - Type VI Renewal  
 Antique Lighting - Solid Bronze Wall Fixture - Type VI Renewal

"Fixture bodies are 106 years old and it is expected they will last another 100 years under same environment but will require new or retrofitted lamp sockets in the near future. The fixtures are in good working order for their age due to diligent maintenance. Observed years remaining have been increased slightly but fixtures need to be replaced or completely reconditioned in the near future."

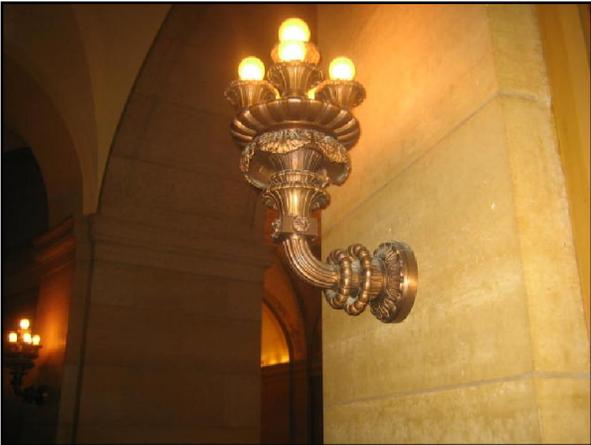
Antique Lighting - Solid Bronze Wall Fixture - Type VII Renewal  
 Antique Lighting - Solid Bronze Wall Fixture - Type VII Renewal

"Fixture bodies are 106 years old and it is expected they will last another 100 years under same environment but will require new or retrofitted lamp sockets in the near future. The fixtures are in good working order for their age due to diligent maintenance. Observed years remaining have been increased slightly but fixtures need to be replaced or completely reconditioned in the near future."

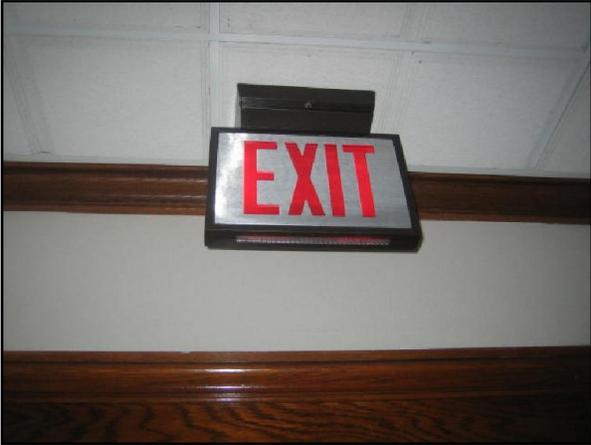
Exit Signs Renewal

“This system is functional but lamps are starting to burn out in accordance with maintenance personnel and should be upgraded or replaced in the near future as replacement parts become obsolete. The observed years remaining have been adjusted to reflect a slight extended life expectancy of this system.”

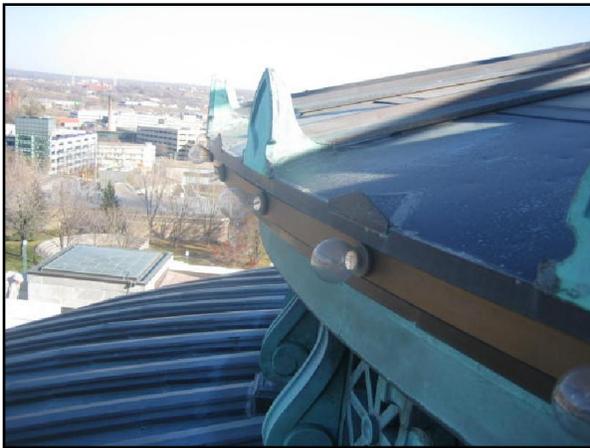
Exterior Lighting - Cupola Accent Lighting Renewal

“This system is functional and adequate for the facility due to good maintenance but all controls should be upgraded or replaced in the near future as replacement parts are obsolete. The observed years remaining have been adjusted to reflect the extended life expectancy of this system.”

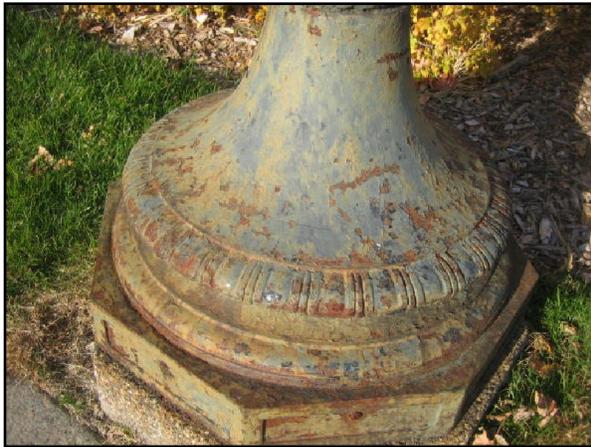
Exterior Lighting - Pole Lights Renewal  
 Exterior Lighting - Pole Lights Renewal

"Although recently retrofitted with new lamps, several poles have broken lenses or lamps, and steel poles are aged and showing signs of rust damage on bases and risers. Condition does not warrant an immediate need and observed years have been increased slightly to compensate for recent retrofit but poles should be replaced or reconditioned in the near future."

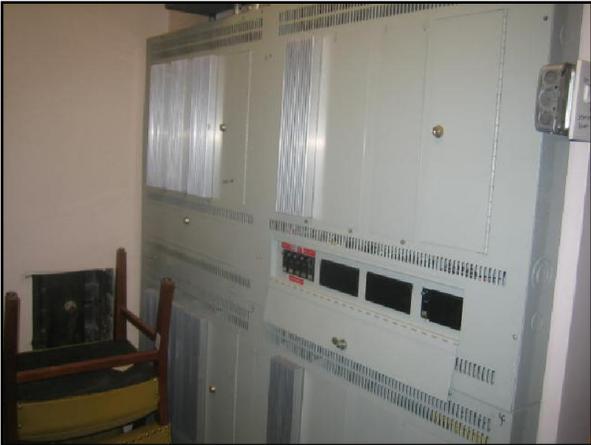
Lighting Dimming Systems - Beyond Rated Life - Conference Room 107

The lighting dimming control board serving the Conference Room 107 is aged and beyond its rated life. The board is old technology and replacement parts are becoming obsolete.

Replace the Conference Room 107 lighting dimming control panel located in Room 107B. Unit counts for budget purposes only. Actual counts may vary.

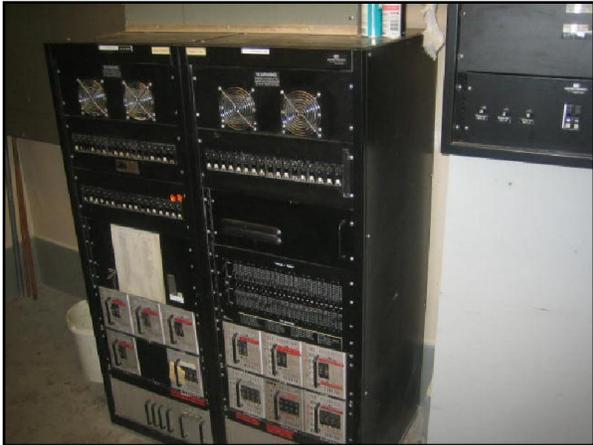
Lighting Dimming Systems - Beyond Rated Life - House Chamber  
 Lighting Dimming Systems - Beyond Rated Life - House Chamber

The lighting dimming control board serving the House Chambers is aged and beyond its rated life. The board is old technology and replacement parts are becoming obsolete.

Replace the House Chamber lighting dimming control panel located in Room 310. Unit counts for budget purposes only. Actual counts may vary.

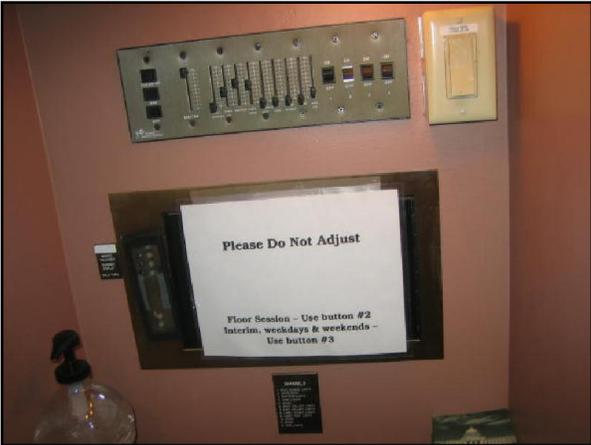
Lighting Dimming Systems - Beyond Rated Life - Senate Chamber

The lighting dimming control board serving the Senate Chambers is aged and beyond its rated life. The board is old technology and replacement parts are becoming obsolete.

Replace the Senate Chamber lighting dimming control panel located in Closet located adjacent to Corridor 239. Unit counts for budget purposes only. Actual counts may vary.

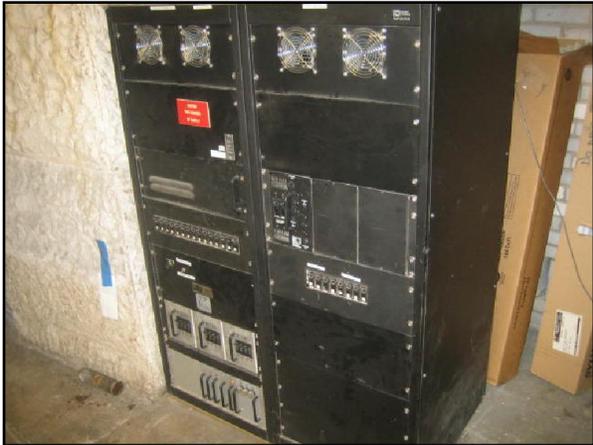
Lighting Dimming Systems - Beyond Rated Life - Senate Hearing Room  
 Lighting Dimming Systems - Beyond Rated Life - Senate Hearing Room

The lighting dimming control board serving the Senate Hearing Room is aged and beyond its rated life. The board is old technology and replacement parts are becoming obsolete.

Replace the Senate Hearing Room lighting dimming control panel located in Room B36. Unit counts for budget purposes only. Actual counts may vary.

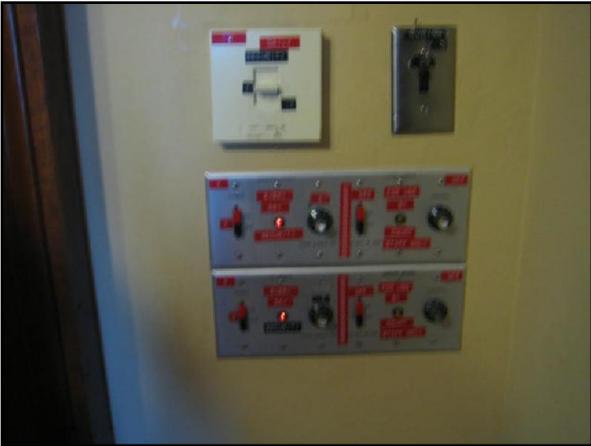
Lighting Dimming Systems - Dimmer Switches Beyond Rated Life - Supreme Court  
 Lighting Dimming Systems - Dimmer Switches Beyond Rated Life - Supreme Court

The dimmer switches serving the Supreme Court are aged and beyond its rated life and replacement parts are becoming obsolete.

Replace the Supreme Court dimmer switches located in the walkway behind the court room on the Second Floor. Unit counts for budget purposes only. Actual counts may vary.

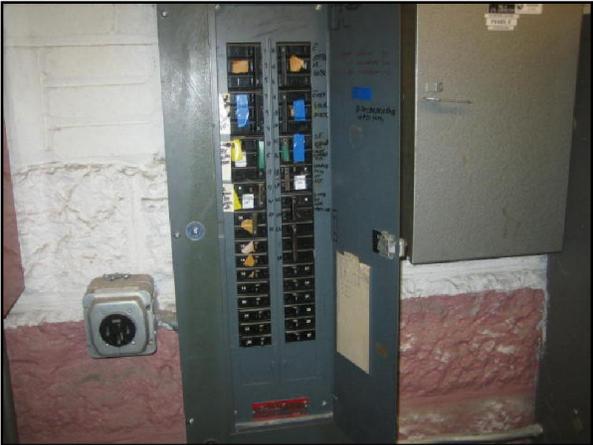
Panelboards - Beyond Rated Life - Basement

Various panelboards located in the basement were not replaced with the recent electrical system upgrade and are approaching or beyond their rated life in accordance with BOMA (2003) recommendations. Equipment is dated and replacement parts are becoming obsolete. Panelboards observed include but may not necessarily be limited to Rooms B36 (1) B71B (1), B56 (1), B46D (1), Corridor B10B (2).

Replace the aged panelboards in the basement including all feeder conduit and wiring back to source as applicable. Panelboards include but may not necessarily be limited to Rooms B13 (1), B36 (1), B71B (1), B56 (1), B46D (1), Corridor B10B (2). Unit counts for budget purposes only. Actual counts may vary.
