# **Requirement Detail Report**

**By Asset Name and Priority**

**State Capital Building (01)**

**Asset Name:** State Capitol Building  
**Asset Number:** 1

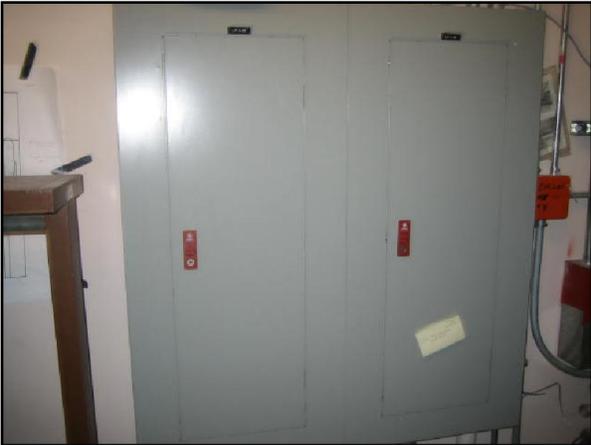
Panelboards - Beyond Rated Life - First Floor

Various panelboards located on the First Floor were not replaced with the recent electrical system upgrade and are approaching or beyond their rated life in accordance with BOMA (2003) recommendations. Equipment is dated and replacement parts are becoming obsolete. Panelboards observed include but may not necessarily be limited to Rooms 112A (1).

Replace the aged panelboards on the First Floor including all feeder conduit and wiring back to source as applicable. Panelboards include but may not necessarily be limited to Rooms 112A (1). Unit counts for budget purposes only. Actual counts may vary.

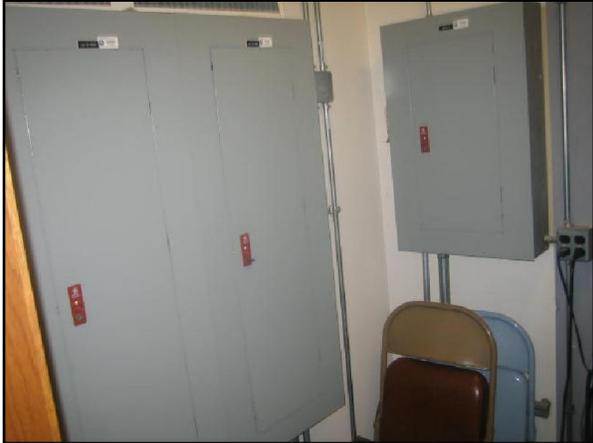
Panelboards - Beyond Rated Life - Ground Floor

Various panelboards located on the Ground Floor were not replaced with the recent electrical system upgrade and are approaching or beyond their rated life in accordance with BOMA (2003) recommendations. Equipment is dated and replacement parts are becoming obsolete. Panelboards observed include but may not necessarily be limited to Rooms G24J (3), G14 (1), Storage Room at South Entrance (1).

Replace the aged panelboards on the Ground Floor including all feeder conduit and wiring back to source as applicable. Panelboards include but may not necessarily be limited to Rooms G24J (3), G14 (1), Storage Room at South Entrance (1). Unit counts for budget purposes only. Actual counts may vary.

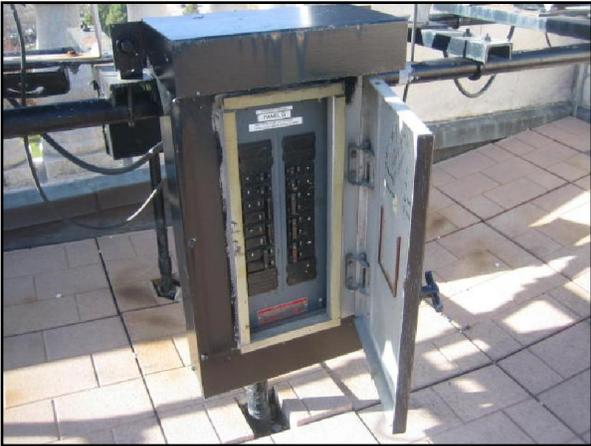
Panelboards located on the roof serving the roof mounted building floodlights are aged and beyond their rated life in accordance with BOMA (2003) recommendations. Finishes are starting to deteriorate from exposure to the weather and replacement parts are becoming obsolete.

Panelboards - Beyond Rated Life - Roof  
 Panelboards - Beyond Rated Life - Roof

Replace the panelboards on the roof serving the building floodlights including all feeder conduit and wiring back to source as applicable. Unit counts for budget purposes only. Actual counts may vary.

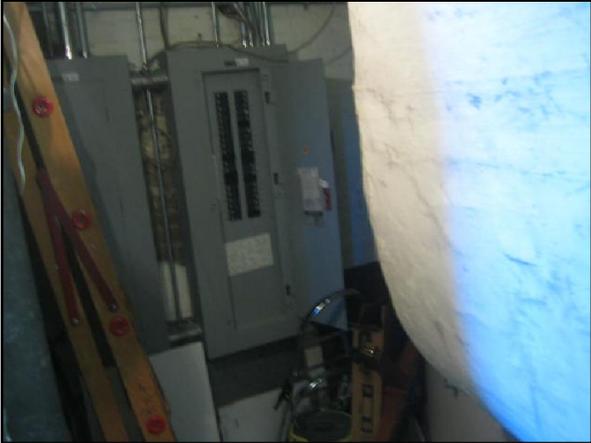
Various panelboards located on the Second Floor were not replaced with the recent electrical system upgrade and are approaching or beyond their rated life in accordance with BOMA (2003) recommendations. Equipment is dated and replacement parts are becoming obsolete. Panelboards observed include but may not necessarily be limited to Rooms 211E(2).

Panelboards - Beyond Rated Life - Second Floor

Replace the aged panelboards on the Second Floor including all feeder conduit and wiring back to source as applicable. Panelboards include but may not necessarily be limited to Rooms 211E(2). Unit counts for budget purposes only. Actual counts may vary.

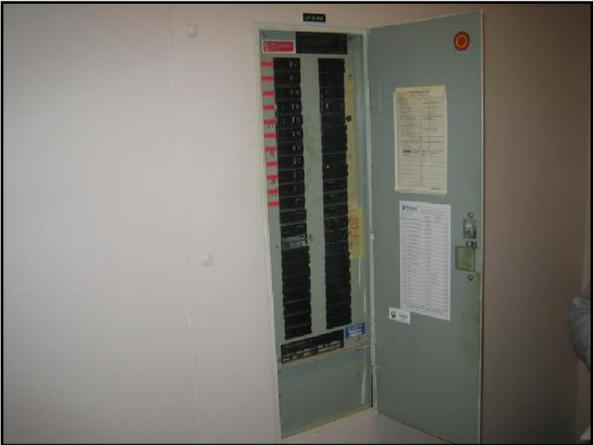
Various panelboards located on the Third Floor were not replaced with the recent electrical system upgrade and are approaching or beyond their rated life in accordance with BOMA (2003) recommendations. Equipment is dated and replacement parts are becoming obsolete. Panelboards observed include but may not necessarily be limited to Corridor at Room 323 (1), Electrical Room Senate Chamber (3), Electrical Room off of Room 313 (2), Room 318C (2).

Panelboards - Beyond Rated Life - Third Floor

Replace the aged panelboards on the Third Floor including all feeder conduit and wiring back to source as applicable. Panelboards include but may not necessarily be limited to Corridor at Room 323 (1), Electrical Room Senate Chamber (3), Electrical Room off of Room 313 (2), Room 318C (2). Unit counts for budget purposes only. Actual counts may vary.

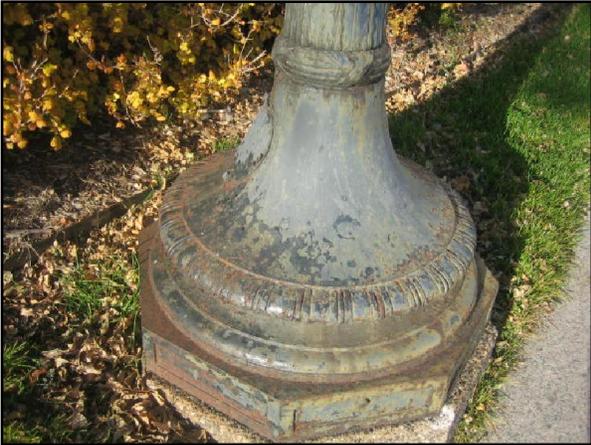
"Although recently retrofitted with new lamps, several poles have broken lenses or lamps, and steel poles are aged and showing signs of rust damage on bases and risers. Condition does not warrant an immediate need and observed years have been increased slightly to compensate for recent retrofit but poles should be replaced or reconditioned in the near future."

Site Lighting Renewal  
 Site Lighting Renewal

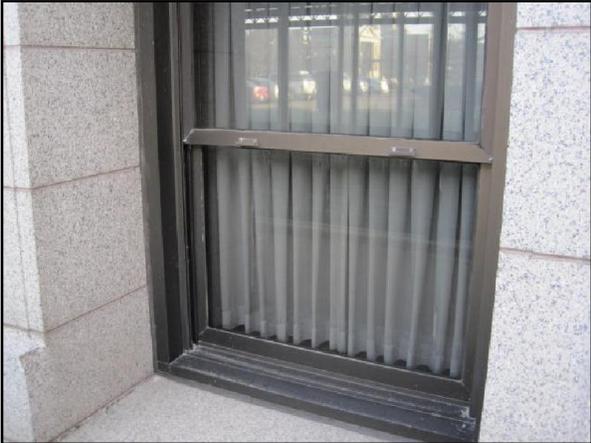
Aluminum Windows - Main Building - 1985 Renewal  
Aluminum Windows - Main Building - 1985 Renewal

Note: Replacement windows shall respect historic nature of building.

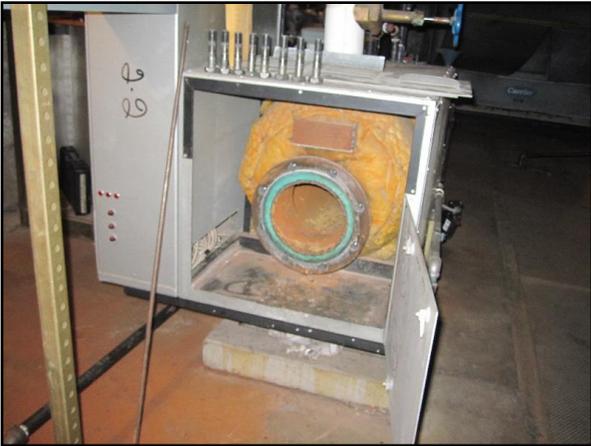
Auto generated renewal requirement for Boiler Steam - Humidification. System Description: The building has two 120kW electric steam boilers used for humidification.

Boiler Steam - Humidification Renewal  
 Boiler Steam - Humidification Renewal

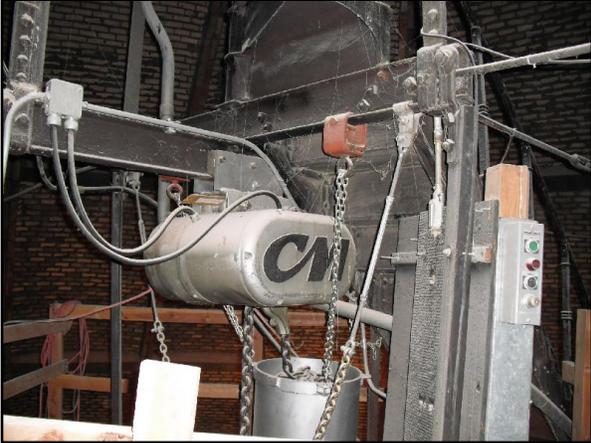
Auto generated renewal requirement for Chandelier Hoist. System Description: There is a 2 ton electric hoist installed above the dome used to raise and lower the main crystal chandelier.

Chandelier Hoist Renewal  
Chandelier Hoist Renewal

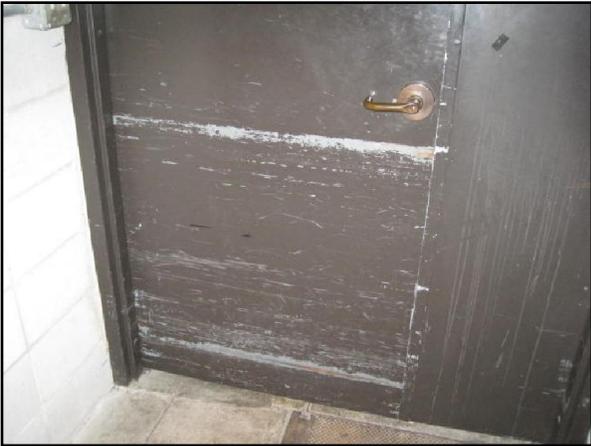
Auto generated renewal requirement for Door Assembly - 3 x 7 HM - 1985. System Description: Exterior doors include 3 x 7 steel door and steel frame with hinges, lockset (lever), exit hardware and closer. Includes painted door and painted frame at basement exits.

Door Assembly - 3 x 7 HM - 1985 Renewal  
 Door Assembly - 3 x 7 HM - 1985 Renewal

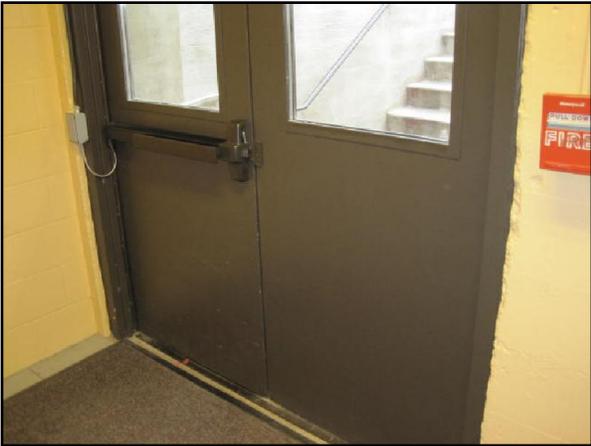
Auto generated renewal requirement for Door Assembly - 6 x 7 HM - 1985. System Description: Exterior doors include pr. 3 x 7 steel doors and steel frame with hinges, locksets (lever), exit hardware and closers at exterior service locations. Includes painted doors and painted frame.

Door Assembly - 6 x 7 HM - 1985 Renewal  
 Door Assembly - 6 x 7 HM - 1985 Renewal

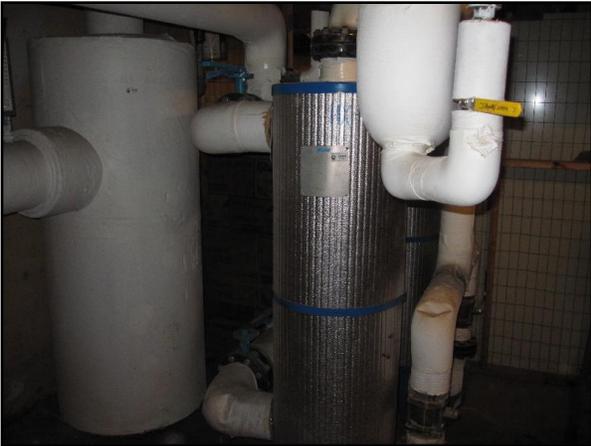
Auto generated renewal requirement for Heat Exchanger - Shell and Tube. System Description: The HVAC system includes two liquid / liquid shell and tube heat exchangers used to produce building heating hot water.

Heat Exchanger - Shell and Tube Renewal  
Heat Exchanger - Shell and Tube Renewal

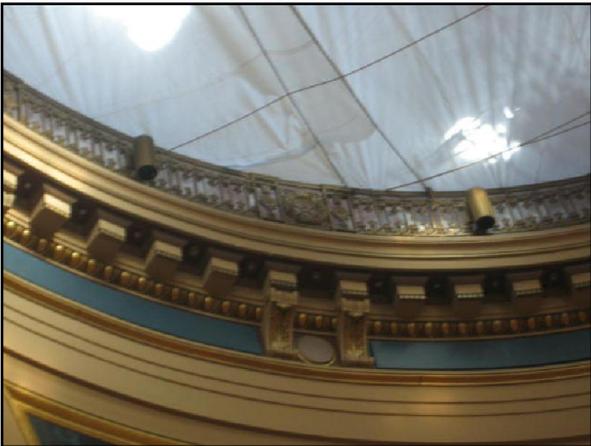
“This system is in good working order due to good maintenance but maintenance indicates the lamps burn out on a regular basis. The observed years remaining have been increased due to good maintenance but the fixtures should be replaced or retrofitted with more energy efficient lamps with longer life spans to reduce maintenance efforts.”

Interior Lighting - Spotlights - Rotunda Renewal  
 Interior Lighting - Spotlights - Rotunda Renewal

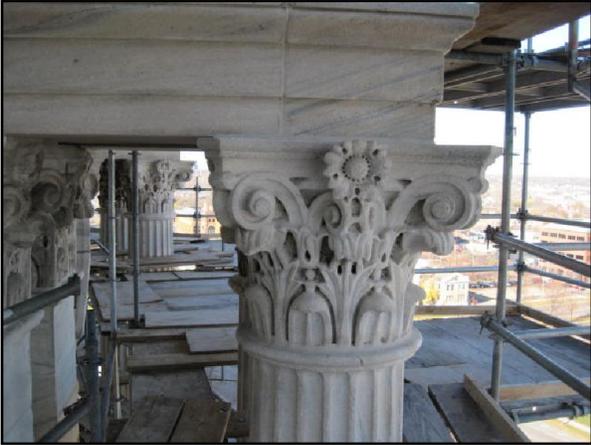
Dome rehabilitation was underway at time of 2010 reassessment. Adjust Years Remaining to account for ultimate scope of work on this system.

Marble Veneer Walls and Ornate Trim - Dome Barrel Renewal  
 Marble Veneer Walls and Ornate Trim - Dome Barrel Renewal

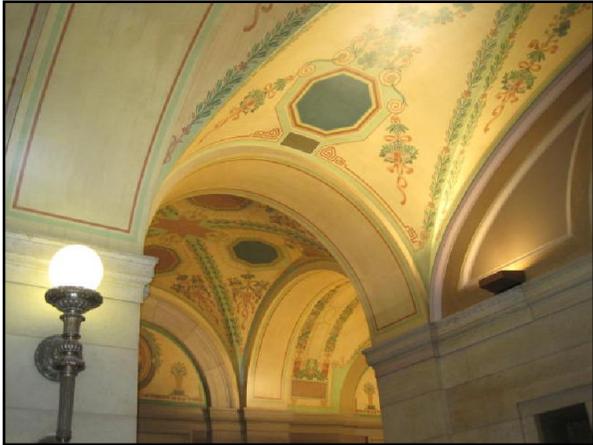
% renewal increased to allow for historical palette research.

Ornately Detailed Vaulted Painted Plaster Ceilings - 1st and 2nd Floors - 1965 Renewal  
 Ornately Detailed Vaulted Painted Plaster Ceilings - 1st and 2nd Floors - 1965 Renewal

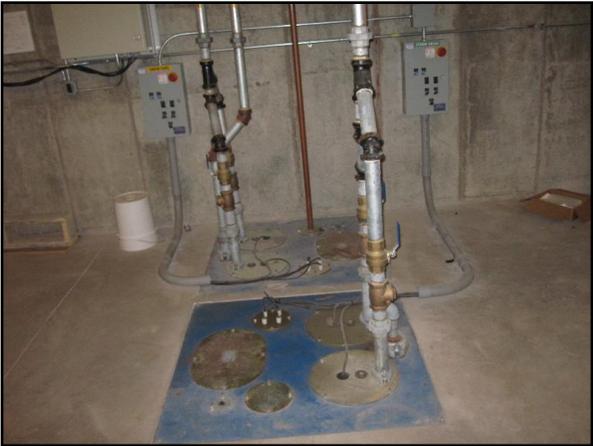
Auto generated renewal requirement for Sewage Ejector Pumps - Duplex. System Description: Duplex sewage ejector pumps. These systems are located in the west electric vault and the B-25 machinery room.

Sewage Ejector Pumps - Duplex Renewal  
Sewage Ejector Pumps - Duplex Renewal

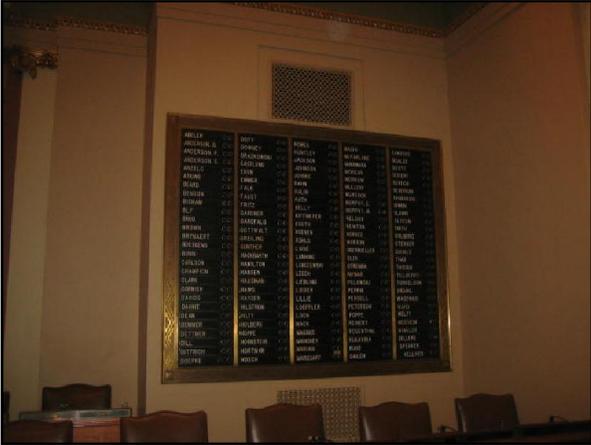
“This system is functional and adequate for the facility due to good maintenance but should be upgraded or replaced in the near future as replacement parts become obsolete. The observed years remaining have been adjusted to reflect the extended life expectancy of this system.”

Voting Boards - House Chamber Renewal

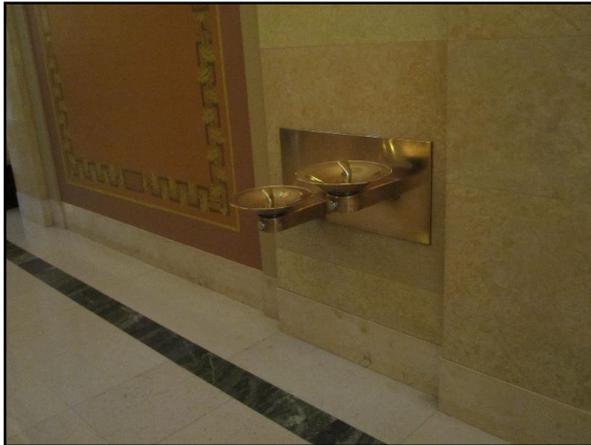
The system includes supply and drain piping. Unit quantity adjusted to account for the high end finish used.

Water Coolers - Wall-Mount Dual-Height Renewal

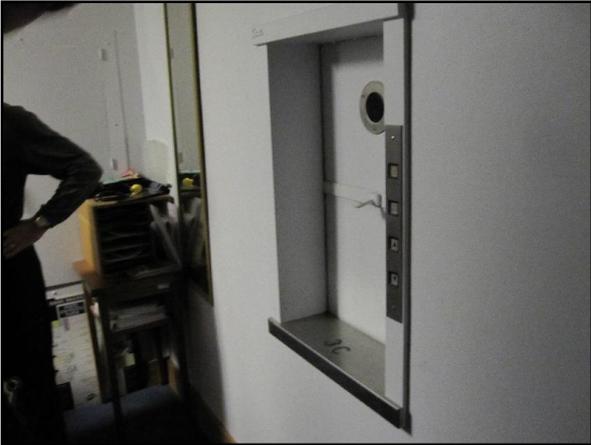
The building includes an abandoned dumb waiter system. This system should be removed to make room for other equipment.

Dumb Waiter - Abandoned In Place  
Dumb Waiter - Abandoned In Place

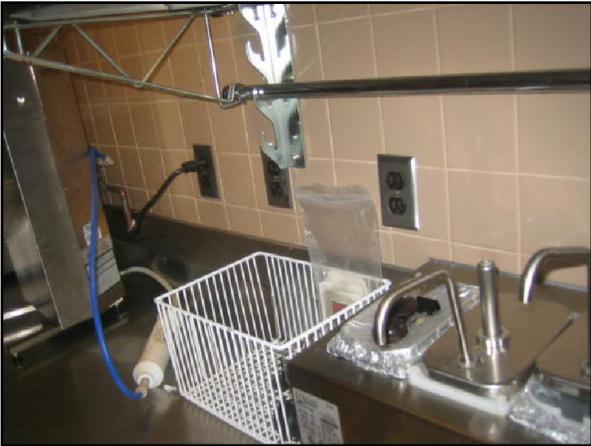
Outlets in the Cafeteria kitchen in the Basement are not GFCI type as required by NFPA 70 (2005) Article 210.8.B (2).

Branch Wiring - Outlets in Kitchen Not GFCI Type  
 Branch Wiring - Outlets in Kitchen Not GFCI Type
