Phase I Environmental Site Assessment

Ainsworth Engineered LLC
Grand Rapids OSB Plant
502 County Road 63
Grand Rapids, MN 55744

Project #20-002

June 1, 2009

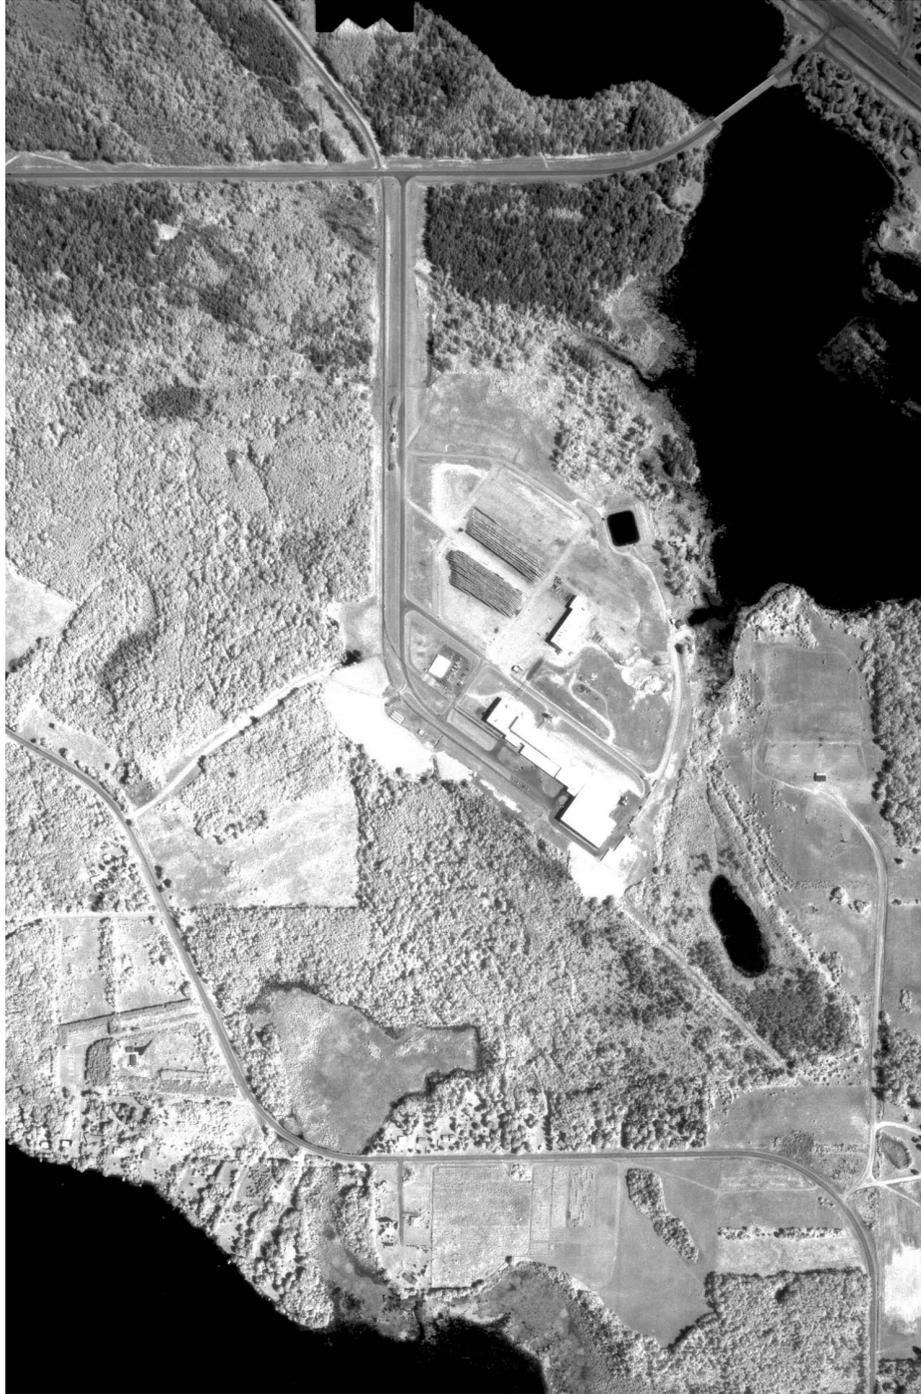
Figure 6: 1975 Aerial Photograph

As noted on the 1975 aerial photograph (Figure 6), a wastewater treatment system was formerly located a few hundred feet north of the current pump house. This was the ozone treatment pond, and was a wastewater treatment system. The system was deemed unnecessary, and closed prior to Potlatch's purchase of the Subject Property in 1990. The 1991 photograph (Figure 7) shows that the impoundment had been filled. The ozone equipment building remains, housing unused electrical equipment.

As noted on the 1975 aerial photograph (Figure 6), a wastewater treatment system including a treatment pond and small building containing ozone producing equipment was located a few hundred feet north of the current pump house. The system was decommissioned prior to Potlatch's purchase of the Subject Property in 1990, although the ozone equipment building remains, housing unused electrical equipment.

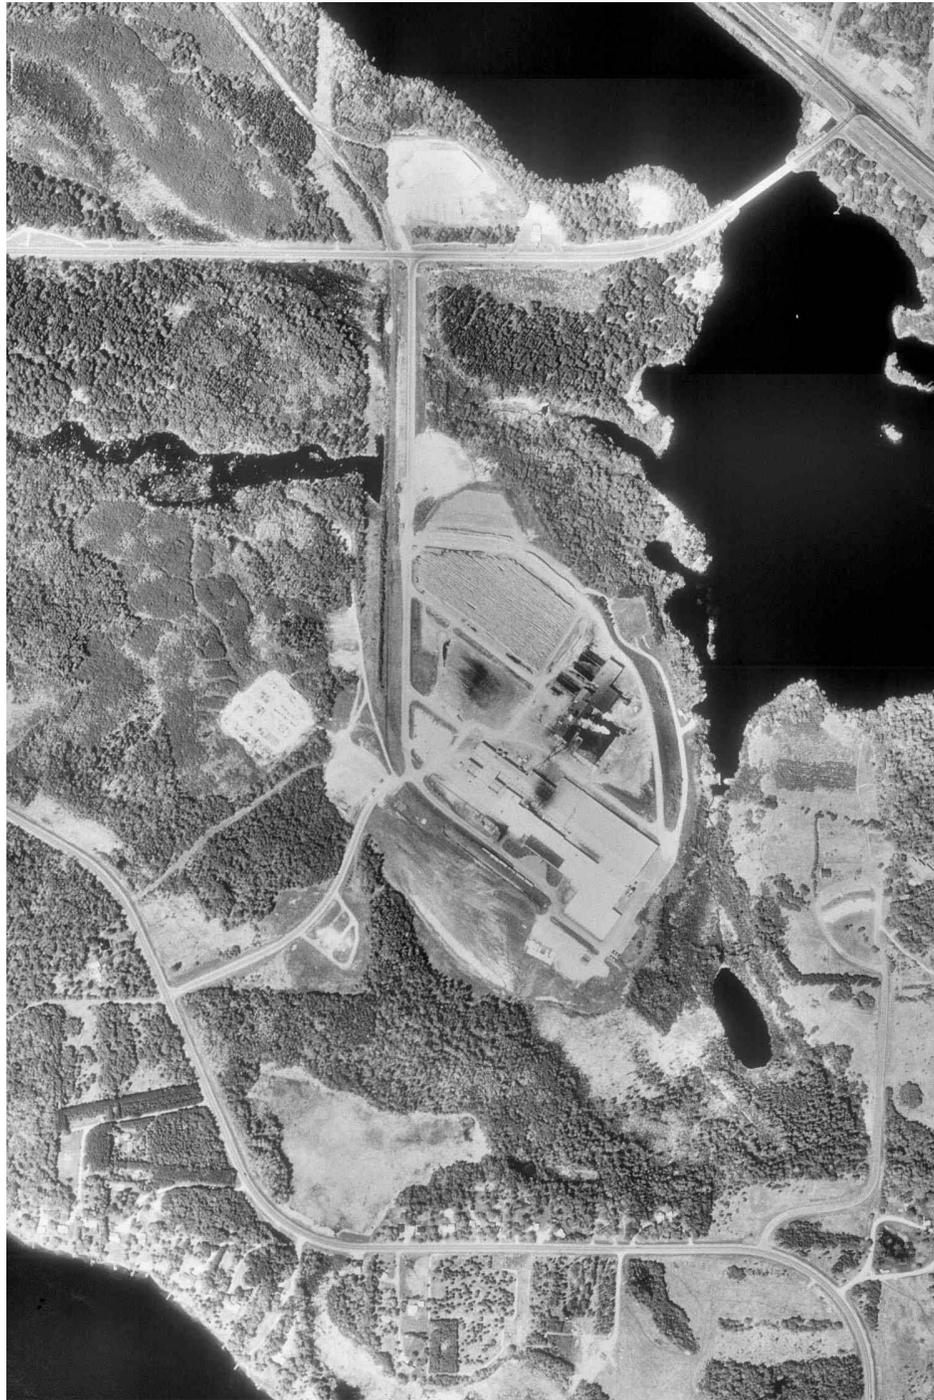
Figure 7: 1991 Aerial Photograph

There is a closed, capped, bark filled landfill (SW-853) on the Subject Property. Located south of the manufacturing buildings, this area is visible by comparing the 1975 and 1991 aerial photographs (Figures 6 and 7 respectively). The landfill cover had typically been mowed once per year to maintain a vegetative cover. This was not completed in 2007, 2008 or yet in 2009. I physically inspected the landfill cap over the summers of 2007, 2008 and as recently as May 15, 2009. The cap appeared to be in adequate condition at the times of inspection (photograph 9).

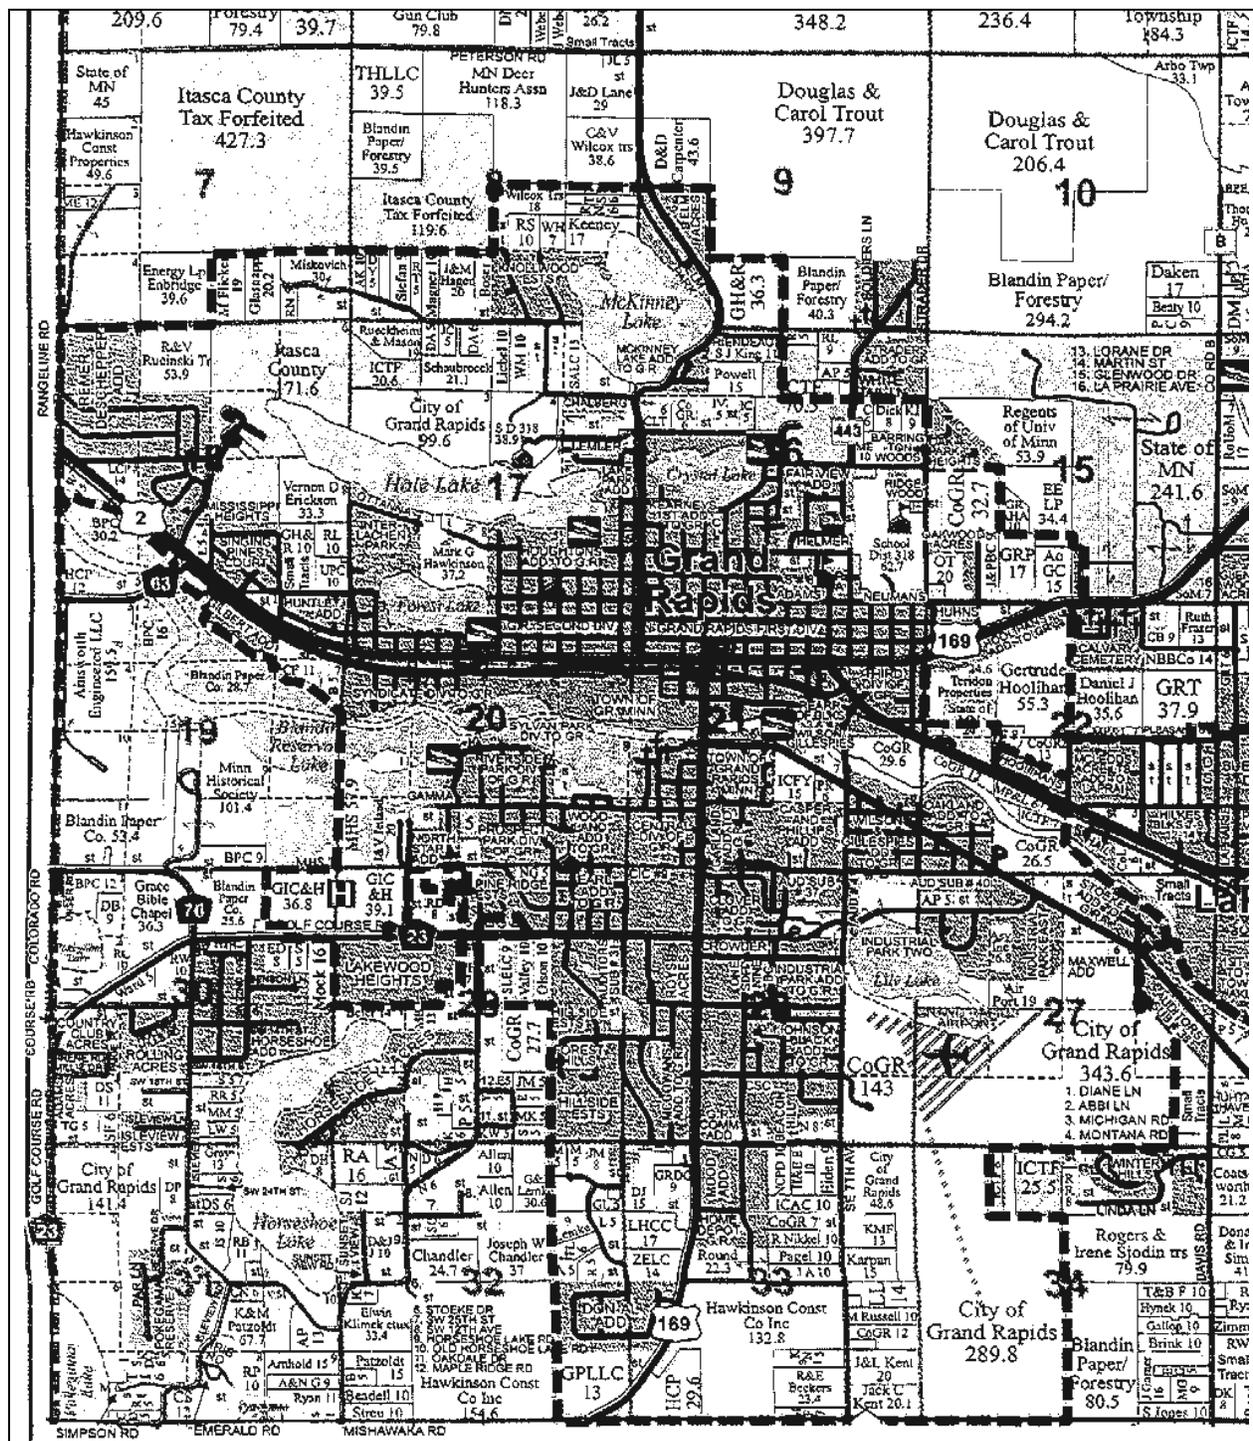
Figure 16: 2007 Plat Map

The 2007 plat map (Figure 16) shows Ainsworth's ownership of the Subject Property within Section 19.

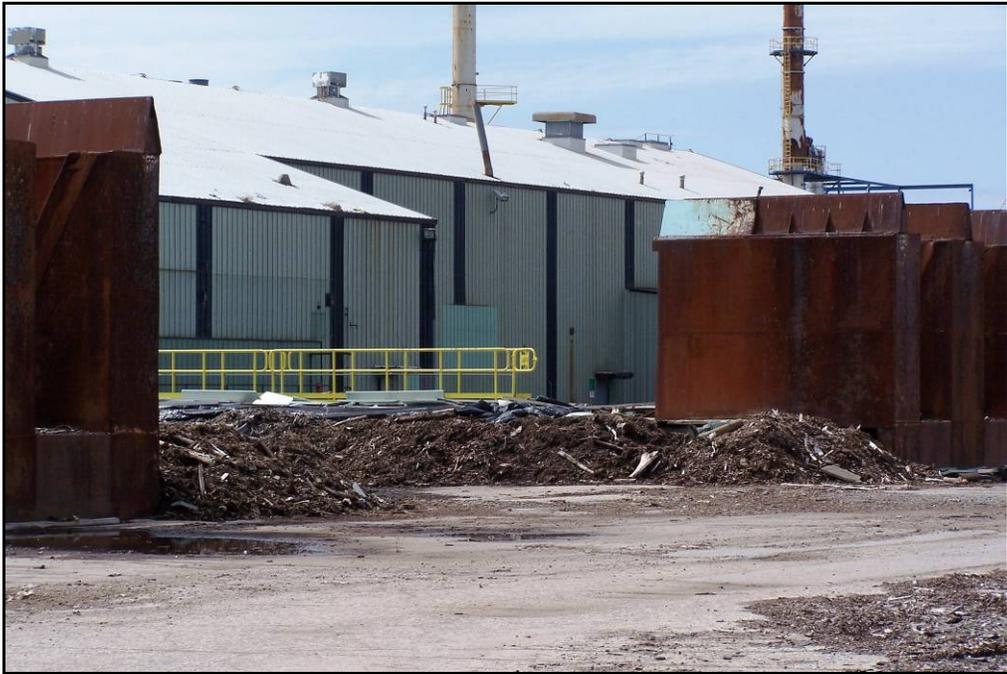
Photograph 1: Wood Bark at Log Ponds (Section 6.1.2.2.)

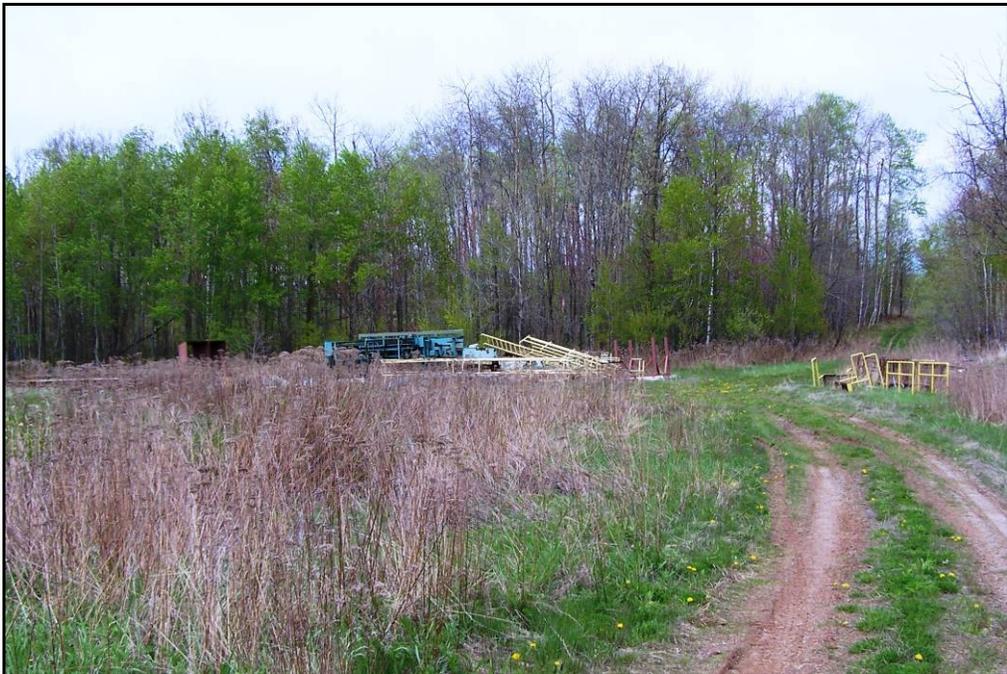
Photograph 2: Scrap metal in "Boneyard" (Section 6.1.3.1.)

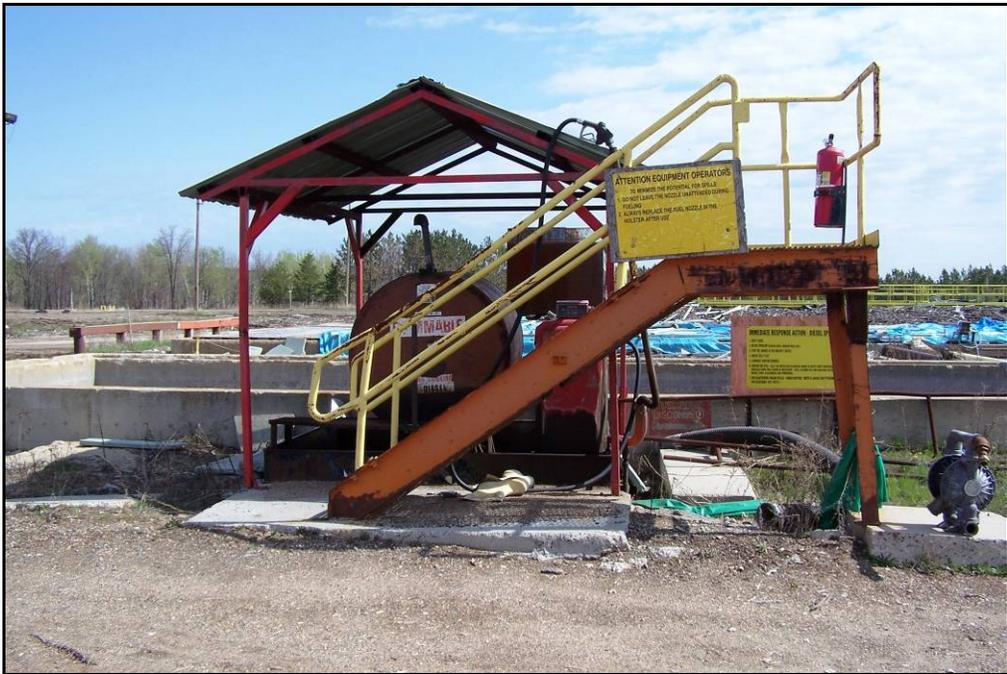
The only storage tank located outside a building is a 585 gallon diesel fuel tank used for weekend filling of logyard mobile equipment. This tank includes steel secondary containment area that is set directly on unpaved soil and a roof to minimize rainwater accumulation within the containment area. The pump and all associated piping is above ground and the area is protected from inadvertent damage by large concrete blocks placed near the containment. Refueling from this diesel tank occurs on an unpaved surface (photograph 6). There was a mixture of water and petroleum in the containment area as of May 2009 (photograph 7).

Photograph 6: Diesel Refueling Station (Section 6.1.4)

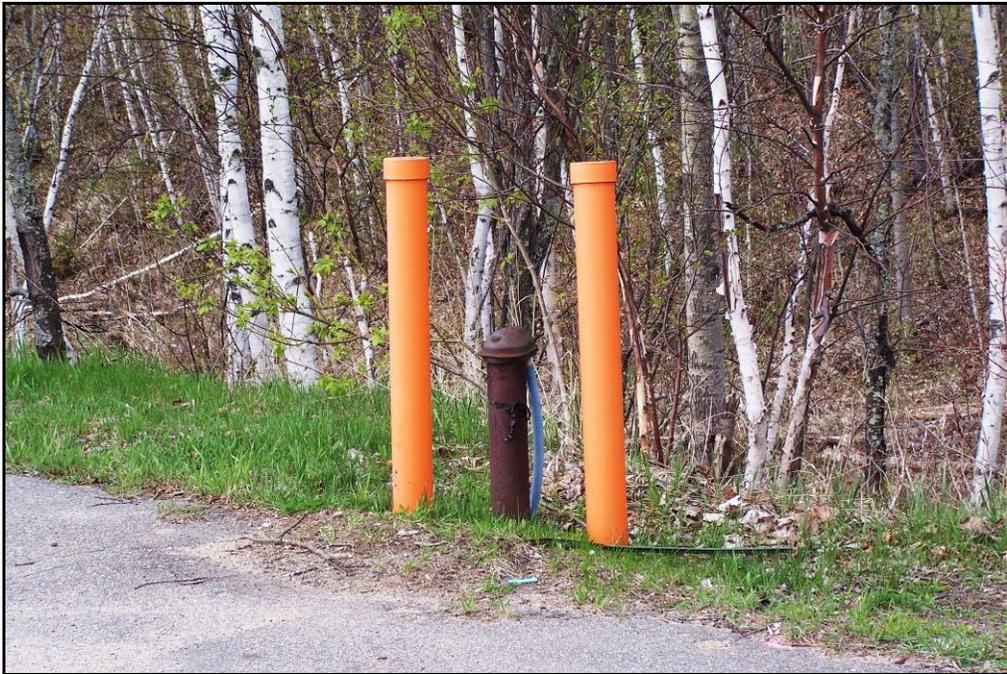
The Subject Property draws water from two sources; the Mississippi River or two groundwater wells located on site. The groundwater wells are used for potable drinking water and bathrooms and the river water is primarily used for fire protection and some process make-up water. The scale house well (photograph 10) serves only a small bathroom in that building. The main facility well is located south of the office (photograph 11) and serves the remainder of the manufacturing facility. The EDR report and MDH web site both refer cite an incomplete well record (Well #304030) located in the undeveloped, wooded portion north of the logyard. The Minnesota Department of Health (MDH) conducts periodic water quality testing on the potable sources and maintains the well boring records; copies of these three boring records are included in Appendix E.

Photograph 10: Scale House Well (Section 6.1.6)

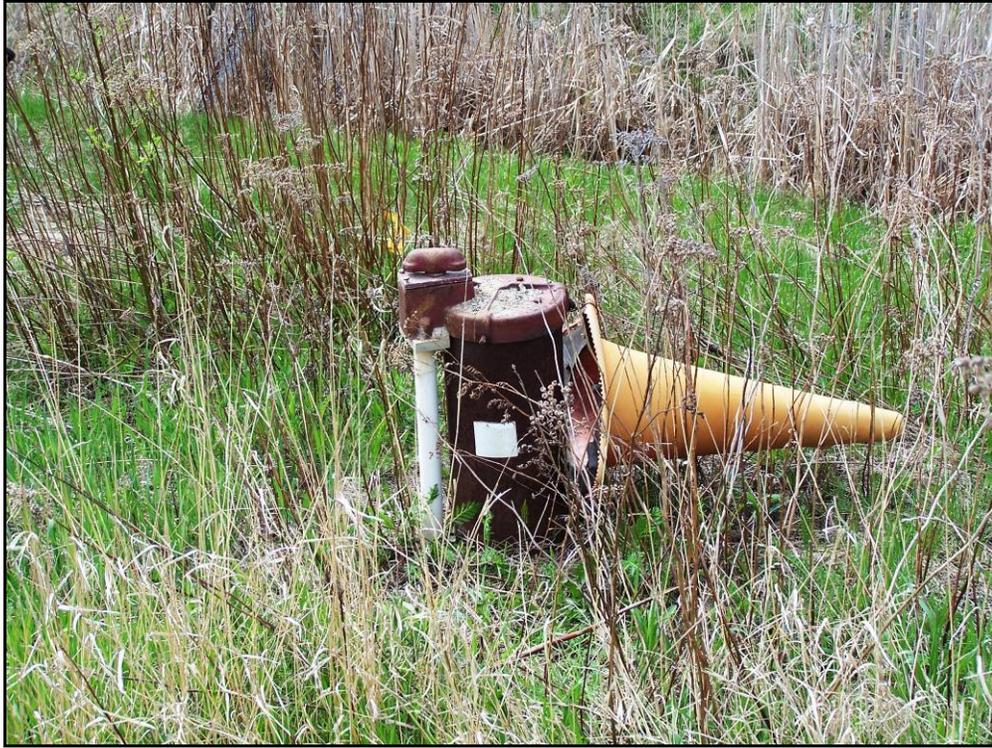
Photograph 11: Main Facility Well (Section 6.1.6)

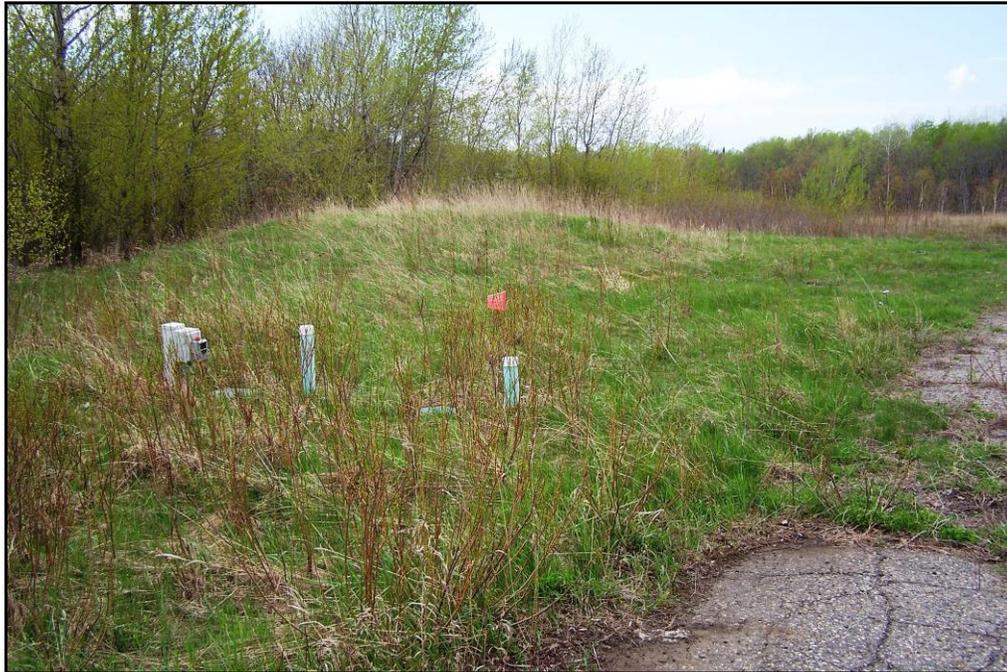
The facility installed three new septic system drain fields in October 2004, as the original drain fields failed performance inspections required at the time of the facility sale from Potlatch to Ainsworth. System #1 is a small system serving a bathroom at the southeast corner of the shipping area (photograph 12). System #2 is another small drain field serving the wood scale house at the north entrance to the Subject Property (photograph 13). Septic system #3 is the main drain field for the facility and is located west of the log truck entrance road between the road and railroad tracks, directly west of the original drain field location (photograph 14).

Photograph 12: Septic Drain field #1 for Shipping Area (Section 6.1.7.1)

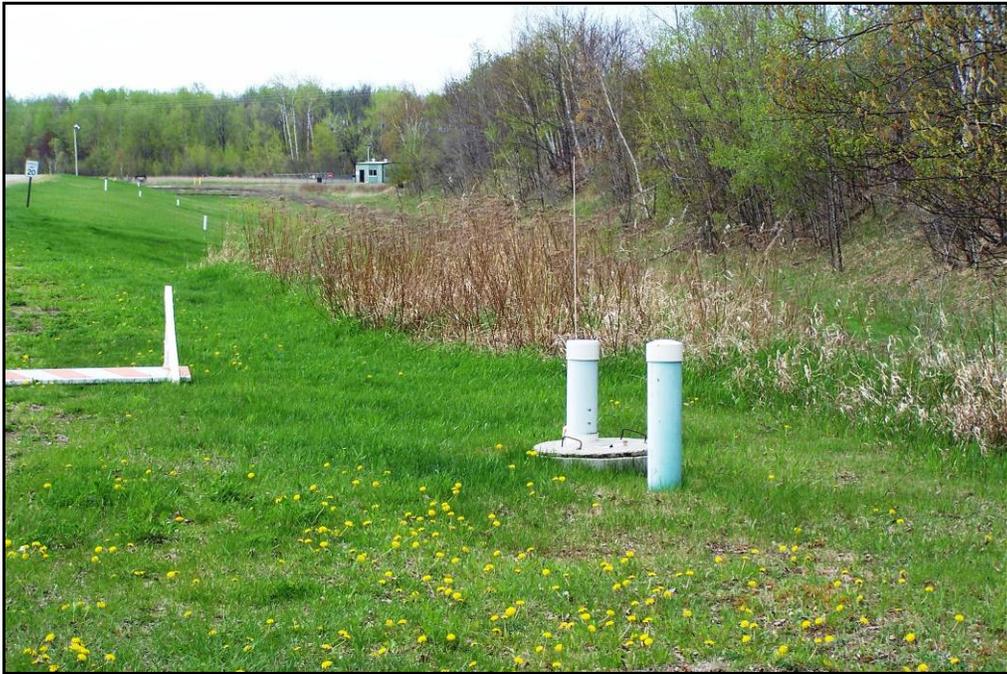
Photograph 13: Septic Drain field #2 for Scale House (Section 6.1.7.1)

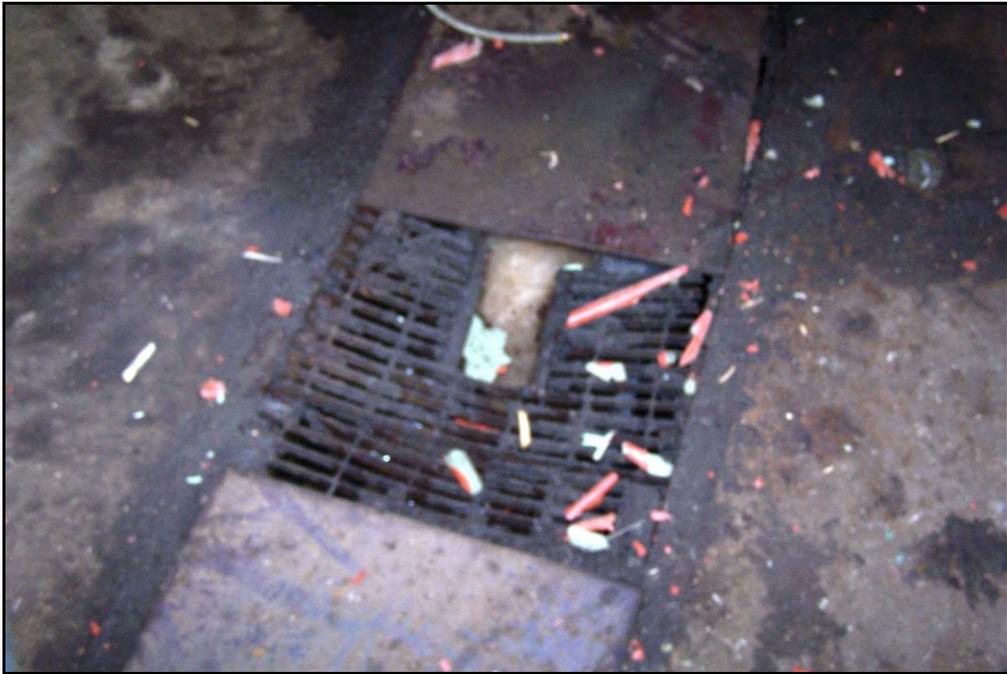
collects any spilled liquids from that location. This drain system collects in a small sump, where it also is pumped back into the pond system (photograph 15).

Photograph 15: Wood room floor trench (Section 6.1.7.2)

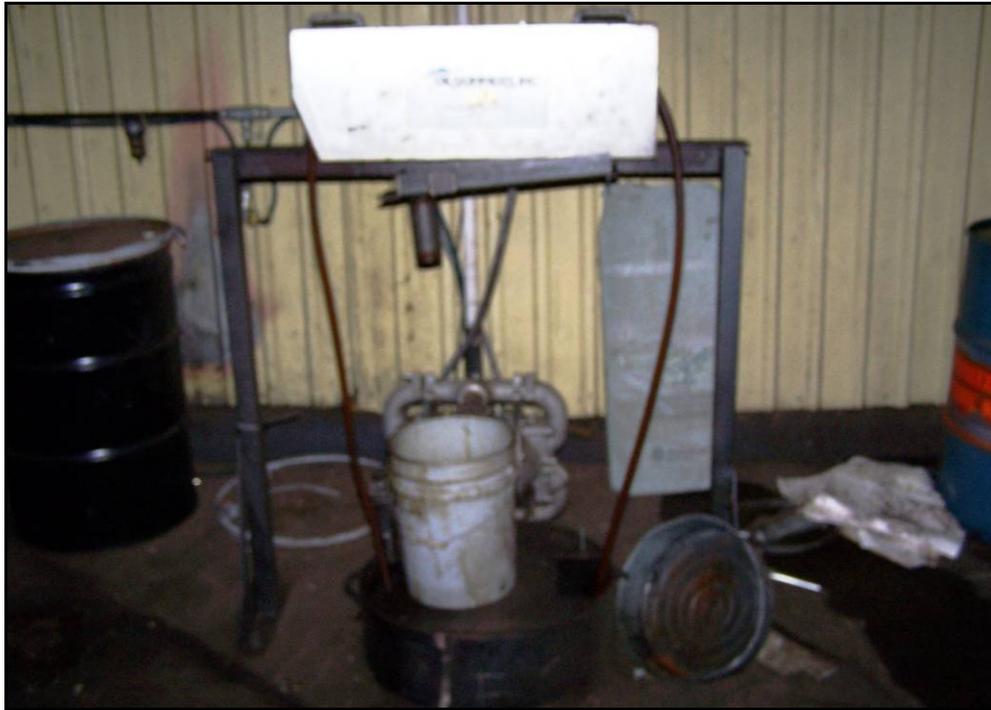
Photograph 17: Oil Skimmer (Section 6.1.7.2)

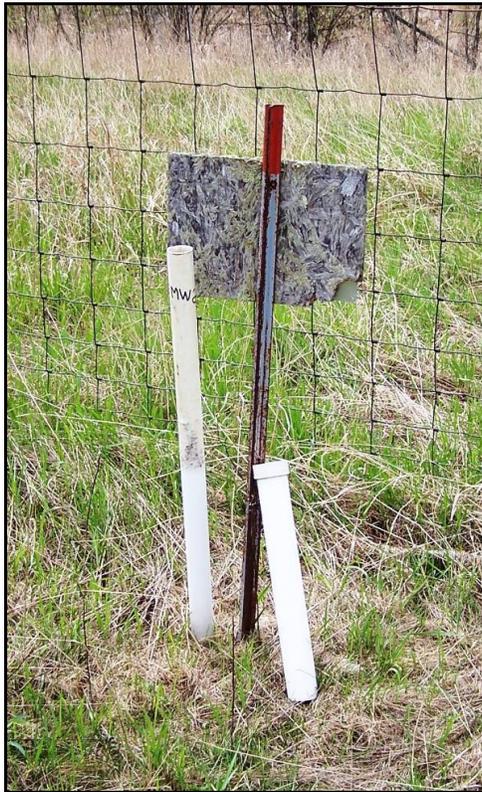
There are two unused monitoring wells on site that were installed as part of the bark landfill closure discussed in Section 6.1.5. MW-2 is located along the SE bank of the landfill (photograph 20) and MW-4 is further to the north, just past the surface stormwater ditch riprap from the southern facility ditch (photograph 21). Both wells are PVC casings with larger PVC covers in place. There is no record of water sampling from these wells since October 1994. The 2006 internal environmental audit (reference B) referred to a third open monitoring well relating to the closed landfill. This well (MW 11) was located towards the east end of the open area between the manufacturing buildings and was sealed (photograph 22). There are no facility records of this closure.

Photograph 20: MW2 (Section 6.1.9)

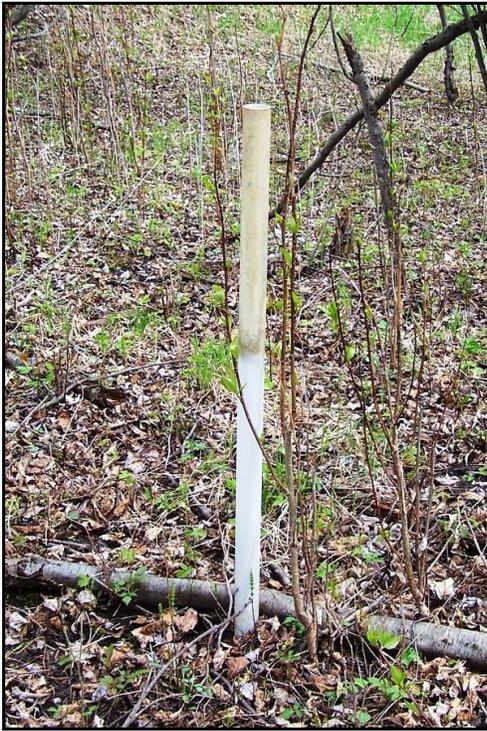
Photograph 21: MW4 (Section 6.1.9)

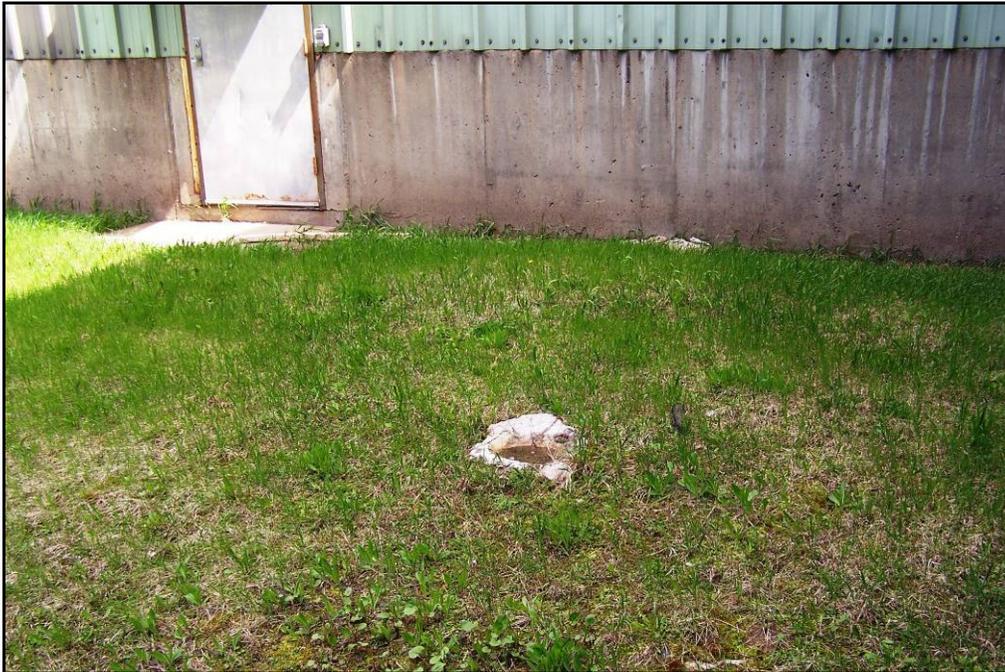
Photograph 22: MW11 (Section 6.1.9)
