MINNESOTA STATE CAPITOL
HISTORIC STRUCTURES REPORT
VOLUME 2.2.3

FIRST FLOOR SPACE INVENTORY AND CONDITIONS

Section 2.2.3
 First Floor Conditions Assessment
 Historic Structures Report

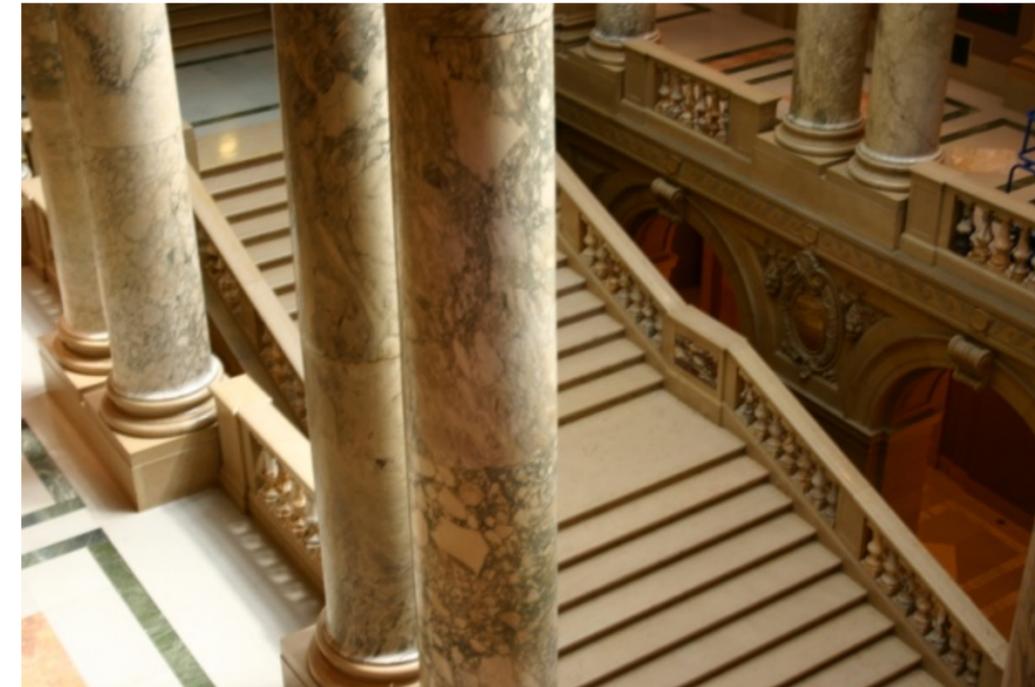
East Stair
 FS01
 Treatment Level: 1

The Grand Stair leading from the Rotunda to the Supreme Court Chambers, and its associated corridors.

Building Element:	Description:	Condition of Material:
Floor	Limestone, marble, Marble treads.	Intact
Walls	Kasota Stone/Plaster	Intact
Ceiling/Cornice	Plaster, skylight	Intact
Doors/Frame:	Wood, see door section	Some removed, covered with plaster.
Hardware	Brass Lever	Original knobs replaced in ADA upgrade.
Light Fixtures	Historic Torcheres, rosettes, uplights	Intact, uplights not original
Artwork	Decorative Plaster painting/Portraits	Restored/Not original
Mechanical	Bronze decorative Grilles	Intact
Trim	Plaster/Stone	Intact

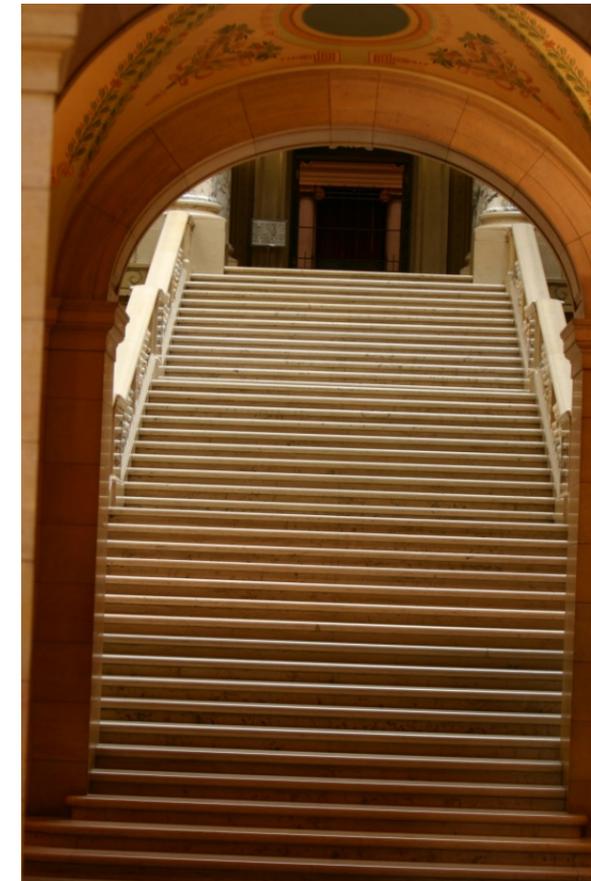
West Stair
 FS02
 Treatment Level: 1

The Grand Stair leading from the Rotunda to the Senate Chambers, and its associated corridors.

Building Element:	Description:	Condition of Material:
Floor	Joliet Limestone, marble, Marble treads.	Intact
Walls	Kasota Stone/Plaster	Intact
Ceiling/Cornice	Plaster, skylight	Intact
Doors/Frame:	Wood, see door section	Some removed, covered with plaster.
Hardware	Brass Lever	Original knobs replaced in ADA upgrade.
Light Fixtures	Historic Torchères, uplights	See lighting assessment
Artwork	Decorative Plaster painting/Portraits	Restored/Not original
Mechanical	Bronze decorative grilles	Intact
Trim	Plaster/Stone	Intact

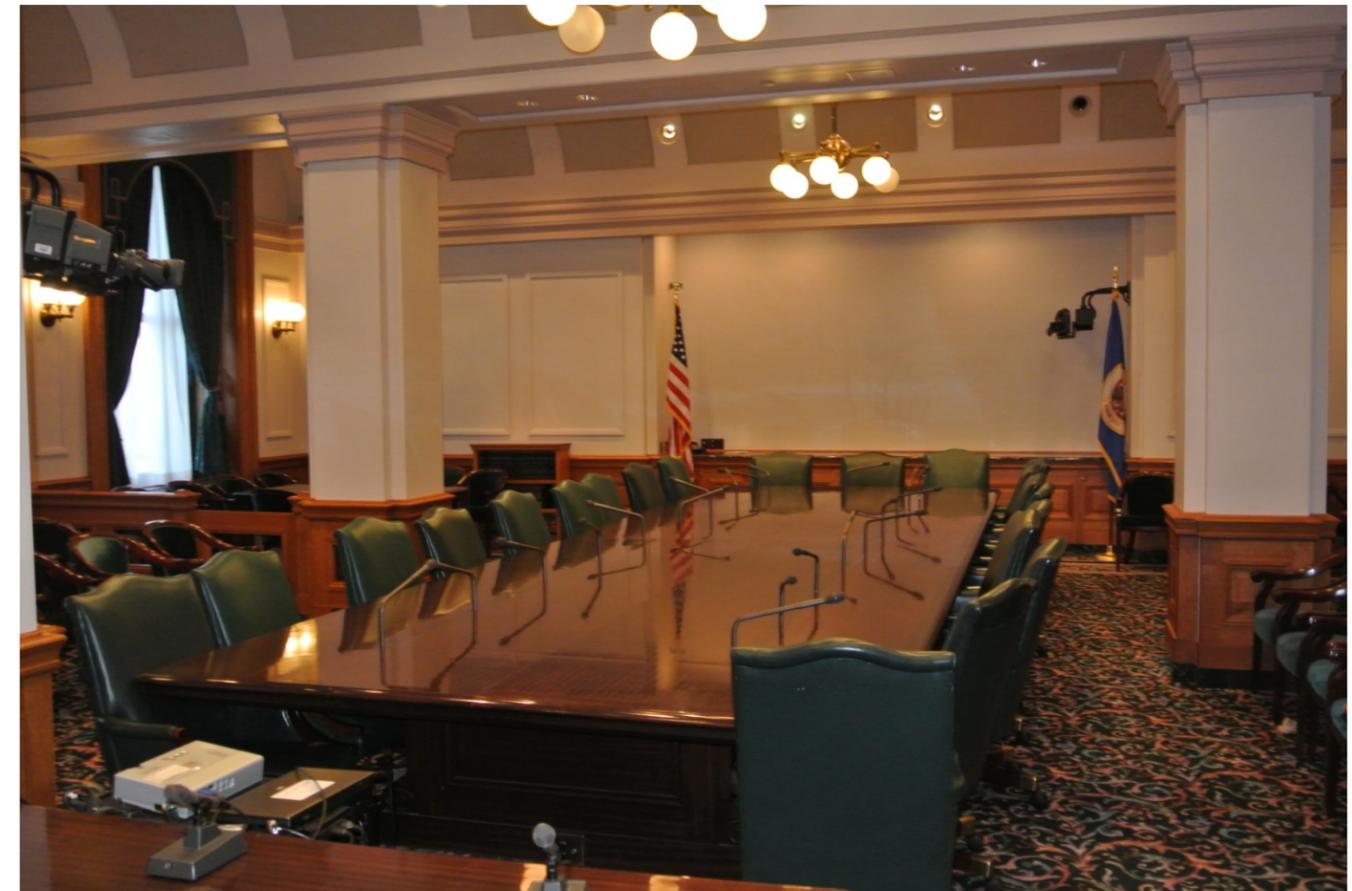
These hearing rooms were added in the Second Renovation (1968-73), replacing miscellaneous government offices. They are poorly suited for this function with columns in the center of the spaces. Associated offices are standard for the time.

Building Element:	Description:	Condition of Material:
Floor	Concrete/carpet	Wood destroyed. condition of stone unknown
Walls	Plaster/Vinyl Wall covering	Unknown/not original
Ceiling/Cornice	ACT over plaster/none	Hearing rooms have non original plaster ceilings with decorative elements. Offices have ACT.
Doors/Frame:	Wood, see door section	Intact/ Not Original
Hardware	Original knobs and ADA levers	See door section
Light Fixtures	Lay in/wall mounted	Not original
Artwork	Portrait	Not original
Mechanical	Ceiling Distribution	Not original
Trim	Wood	Original trim remains around original doors and windows. Wood wainscot and other not original.

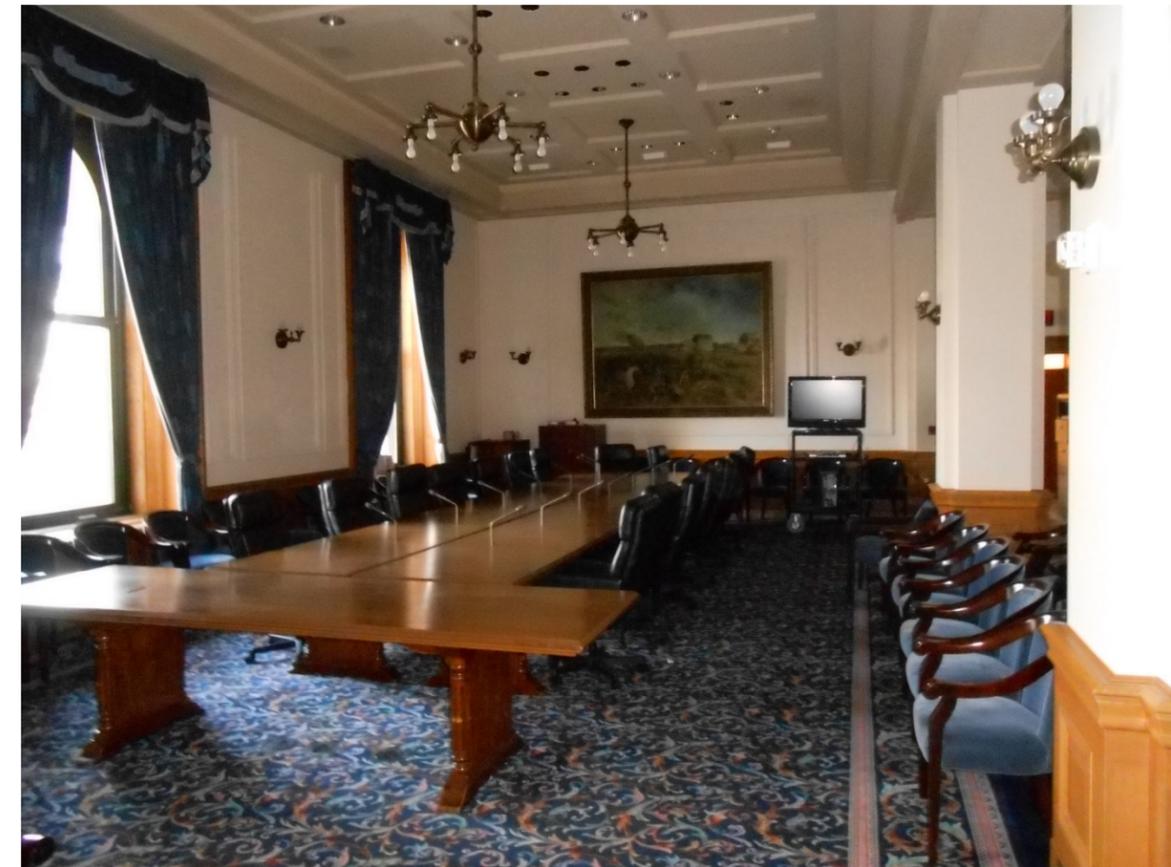
Floor	Concrete/carpet	Wood destroyed. condition of stone unknown
Walls	Plaster/Vinyl Wall covering	Unknown/not original
Ceiling/Cornice	ACT over plaster/none	Hearing rooms have non original plaster ceilings with decorative elements. Offices have ACT.
Doors/Frame:	Wood, see door section	Intact/Not Original
Hardware	Original knobs and ADA levers	See door section
Light Fixtures	Lay in/wall mounted	Not original
Artwork	Painting	Not original
Mechanical	Ceiling Distribution	Not original
Trim	Wood	Original trim remains around original doors and windows. Wood wainscot and other not original.

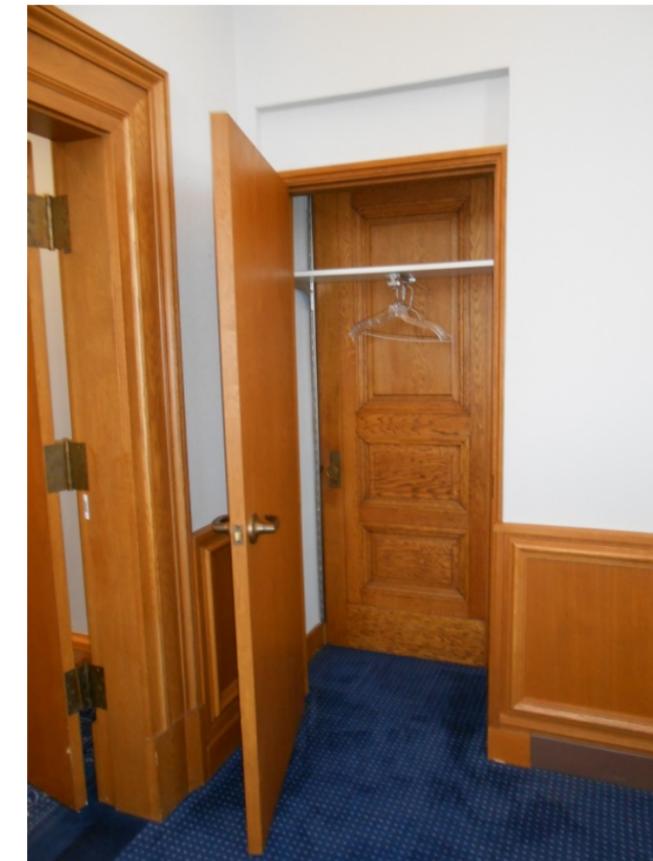
121-121B

This small office suite was accessed off the Railroad Commissioner’s hallway originally. Stairs were added during the second renovation. Two original doors with original hardware remain in the offices in addition to the vestibule door, but they lead only to closets.

Building Element:	Description:	Condition of Material:
Floor	Concrete/carpet	Wood destroyed. condition of stone unknown
Walls	Plaster/Vinyl Wall covering	Modified/not original
Ceiling/Cornice	ACT over plaster/none	Unknown
Doors/Frame:	Wood, see door section	Intact/Not Original
Hardware	Original knobs and ADA levers	See photo: original closet doors have original knobs. Original room doors have replica levers. Other doors have non matching hardware.
Light Fixtures	Lay in/wall mounted	Not original
Artwork	None	None
Mechanical	Ceiling Distribution	Not original
Trim	Wood	Original trim remains around original doors and windows. Wood wainscot and other not original.

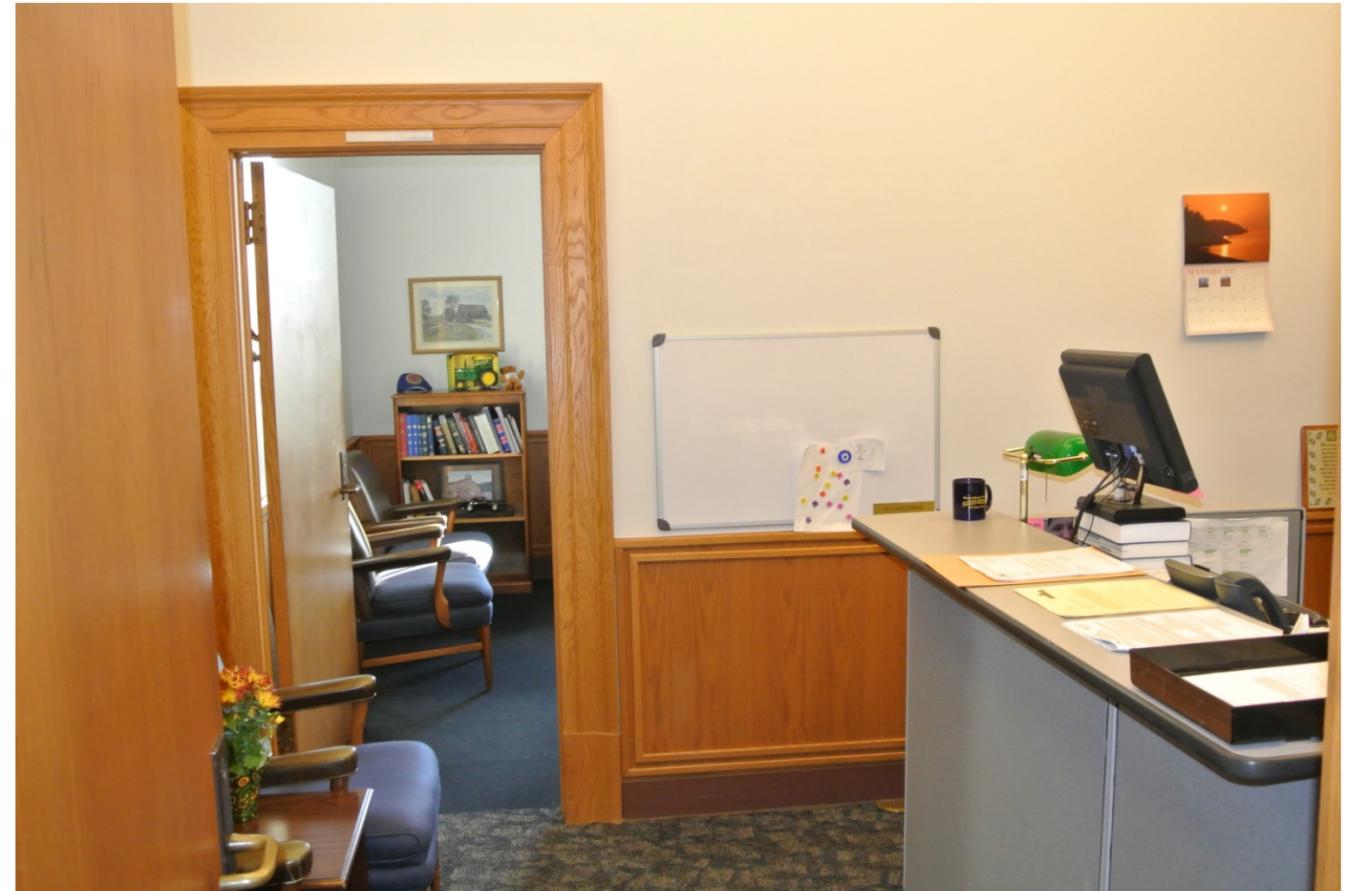
Original Counter was removed.

Building Element:	Description:	Condition of Material:
Floor	Concrete/carpet	Wood destroyed. condition of stone unknown
Walls	Plaster/Vinyl Wall covering	Unknown/not original
Ceiling/Cornice	ACT over plaster/none	Unknown
Doors/Frame:	Wood, see door section	Intact/Not Original
Hardware	Original knobs and ADA levers	See door section
Light Fixtures	Lay in/wall mounted	Not original
Artwork	None	None
Mechanical	Ceiling Distribution	Not original
Trim	Wood	Original trim remains around original doors and windows. Wood wainscot and other not original.

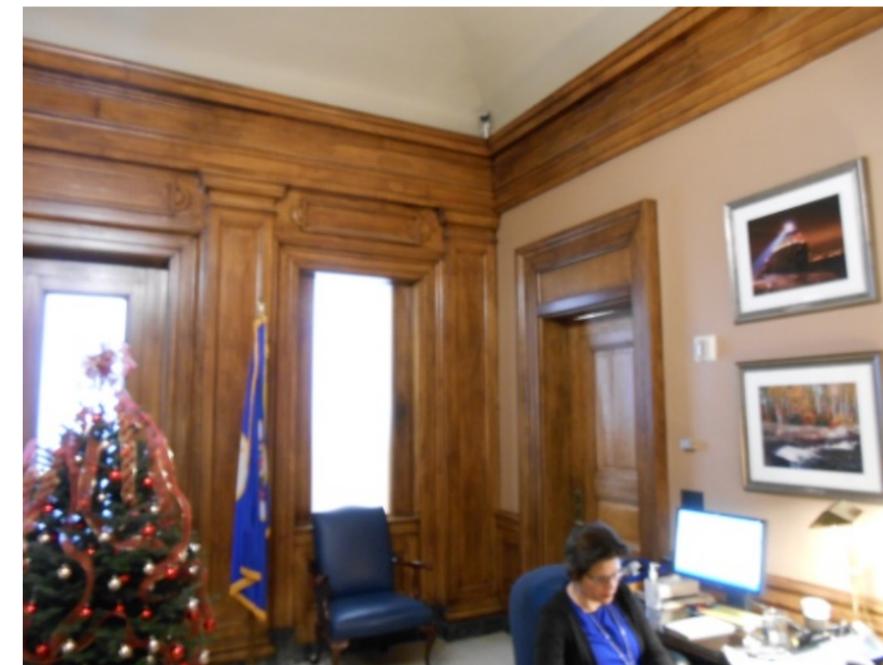
Waiting Room

The floor plan has been altered from the original by the addition of a corridor running behind the waiting room, with the space beyond being divided up into offices.

Building Element:	Description:	Condition of Material:
Floor	Wood/carpet, Marble	Wood floor original, Carpet replicated. Condition of marble floor beneath carpet unknown.
Walls	Plaster/wd wainscot	Restored, see description
Ceiling/Cornice	Painted and gilded plaster	Replicated, see below
Doors/Frame:	Ornate door at entry, not original Two original interior doors, remainder newer	Intact, Type
Hardware	Brass Lever	Original knobs replaced in ADA upgrade.
Light Fixtures	Chandeliers and wall mounted fixtures	Not original
Artwork	Hung paintings	Not original
Mechanical	Cast iron decorative Grilles	Intact
Trim	Oak	Intact

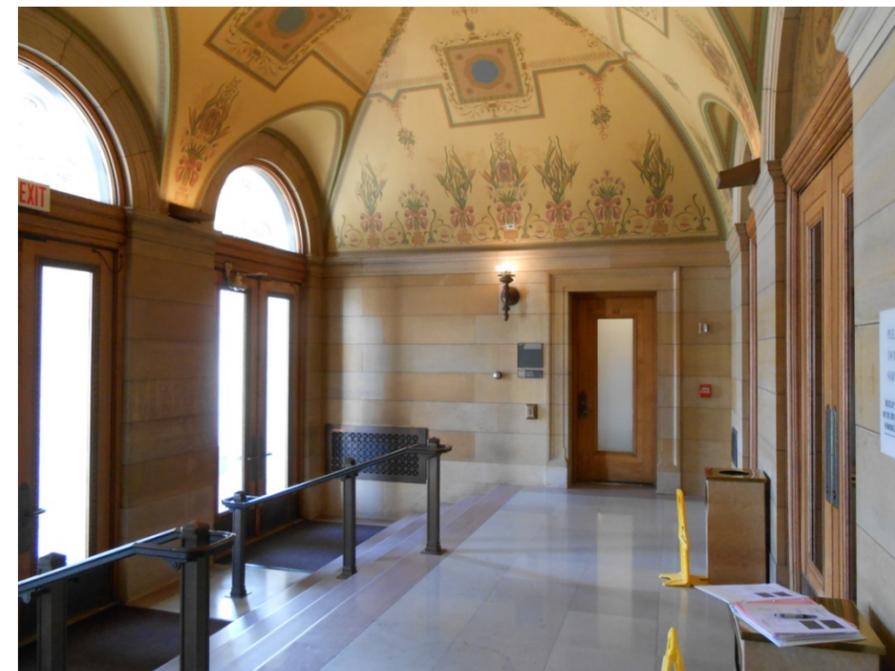
Building Element:	Description:	Condition of Material:
Floor	Marble	Intact
Walls	Kasota Stone/Plaster	Stone intact, Plaster damaged
Ceiling/Cornice	Plaster with decorative painting	Decorative painting damaged
Doors/Frame:	Glass and wood door with stone frames	Intact, Type
Hardware	Brass Lever	Original knobs replaced in ADA upgrade.
Light Fixtures	Historic Torchers and non historic wall mounted uplights	Original/Not original
Artwork	Decorative plaster painting	Restored
Mechanical	Cast iron decorative Grilles	Intact
Trim	Oak, stone	Intact

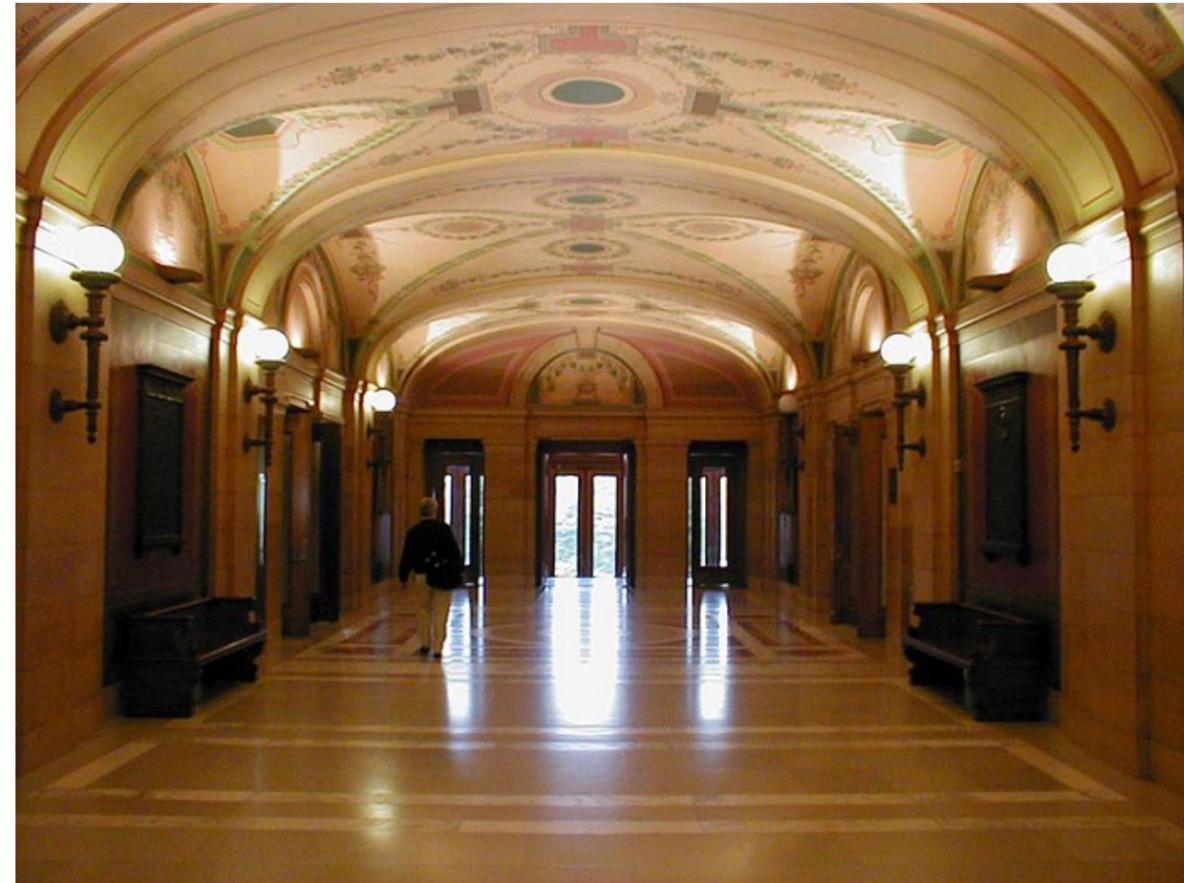
Description: Same as East Entry Corridor

Building Element:	Description:	Condition of Material:
Floor	Marble	Intact
Walls	Kasota Stone/Plaster	Stone intact, Plaster damaged
Ceiling/Cornice	Plaster with decorative painting	Decorative painting damaged
Doors/Frame:	Glass and wood door with stone frames	Intact, Type
Hardware	Brass Lever	Original knobs replaced in ADA upgrade.
Light Fixtures	Historic Torcheres and non historic wall mounted uplights	Original/Not original
Artwork	Decorative plaster painting	Repainted
Mechanical	Cast iron decorative Grilles	Intact
Trim	Oak, stone	Intact

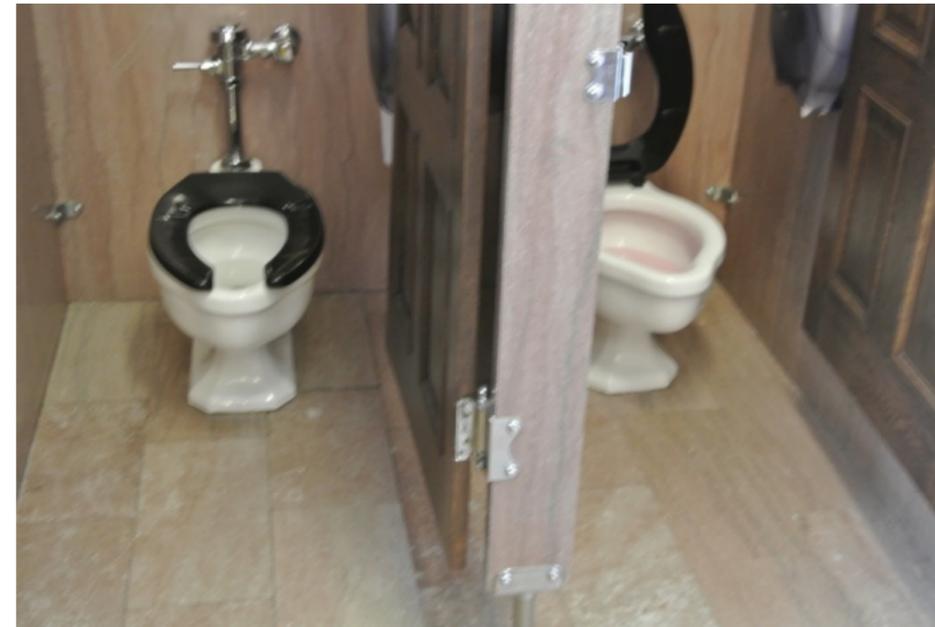
Typical Marble Stalls and Wood Doors

The Men’s restroom 117 is located next to the Oval Stair. The Women’s restroom 110A is located off the North Entry Vestibule. They are both largely intact, with an enlarged stall added in the men’s room by removing an adjacent stall. Neither room complies with current ADA standards. Of the remaining small restrooms, 124A has been heavily altered, reduced to a single fixture. 119 has what may be an original WC fixture, but has had at least one sink removed.

Building Element:	Description	Condition
Floor:	Tennessee Pink Marble	Intact
Walls:	Tennessee Pink Marble	Intact
Ceiling/Cornice:	Plaster	Intact
Doors/Frame:	Orig Wood with louver/Wood	Intact
Light Fixtures:	Original light fixtures	Intact
Artwork:	None	None
Mechanical:	Cast iron decorative grilles	Intact
Trim:	Original oak, stone	Intact

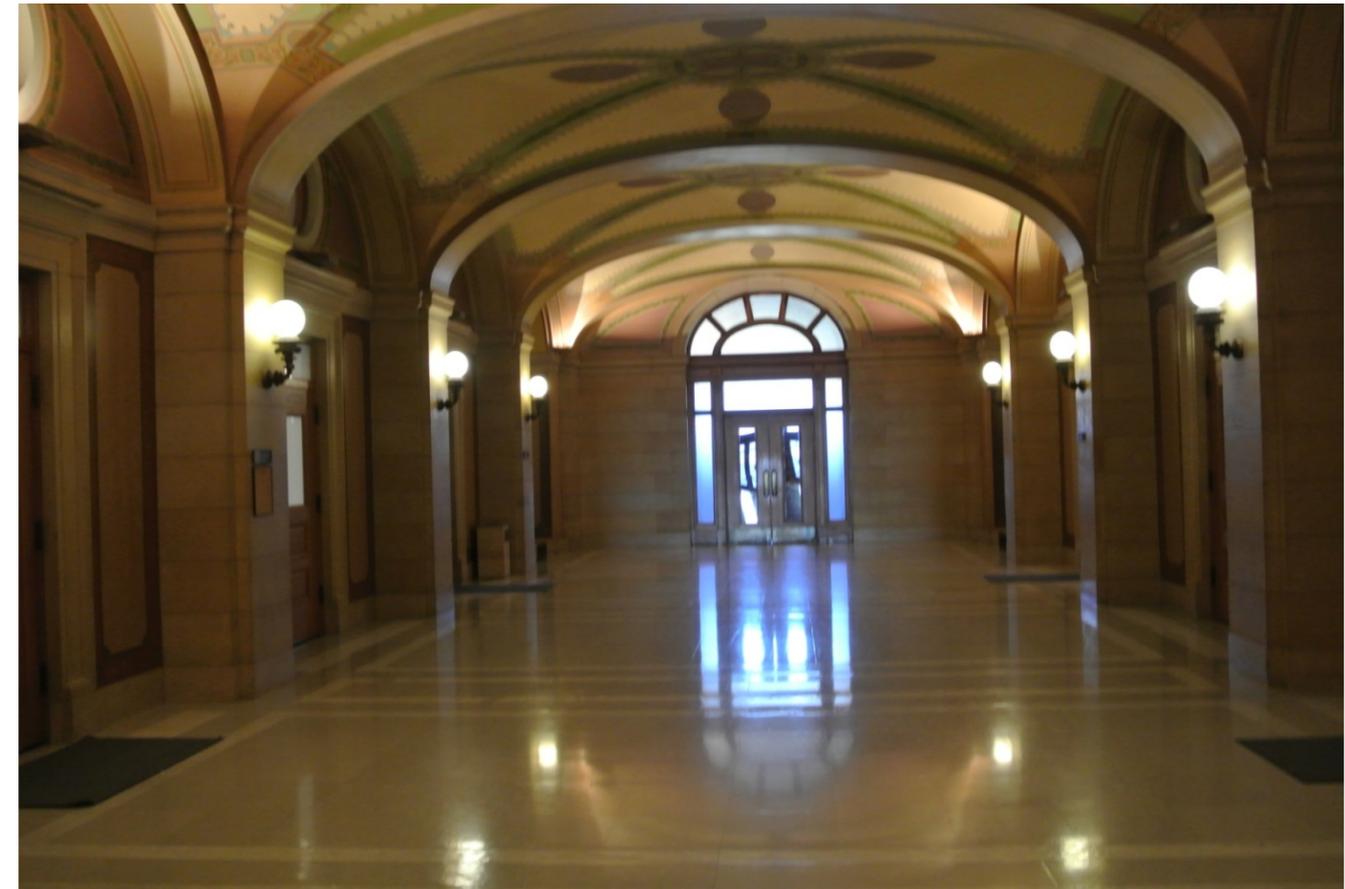
Floor	Marble	Intact
Walls	Kasota Stone/Plaster	Stone intact, Plaster damaged
Ceiling/Cornice	Plaster with decorative painting	Decorative painting damaged
Doors/Frame:	Glass and wood door with stone frames	Intact, Type
Hardware	Brass Lever	Original knobs replaced in ADA upgrade.
Light Fixtures	Historic Torchers and non historic wall	Original/Not original

mounted uplights	
Artwork	Decorative plaster painting	Repainted
Mechanical	Cast iron decorative Grilles	Intact
Trim	Oak, stone	Intact

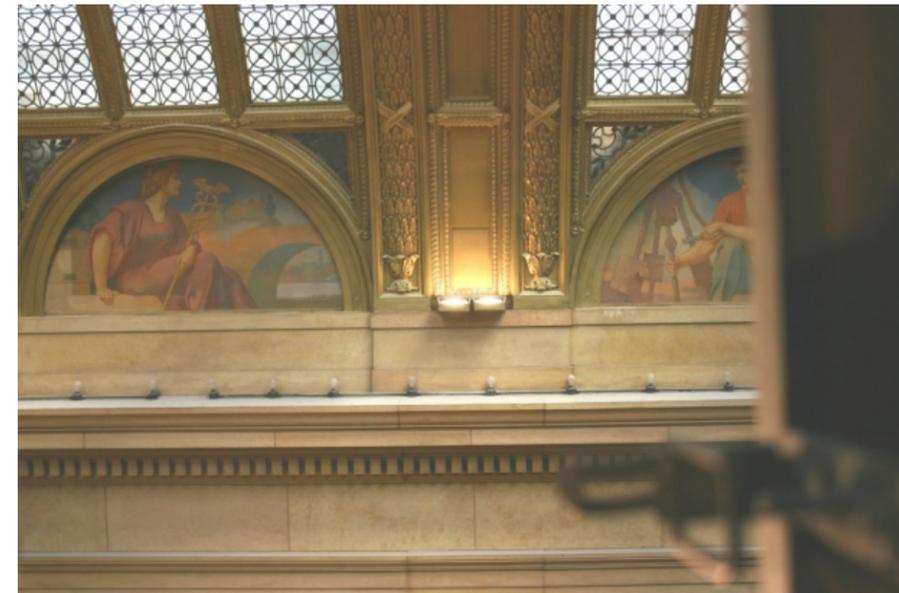
Above the stair are the skylights, and there is visual evidence of water damage to the murals and associated plaster.

Skylight, murals, and light fixtures above stair

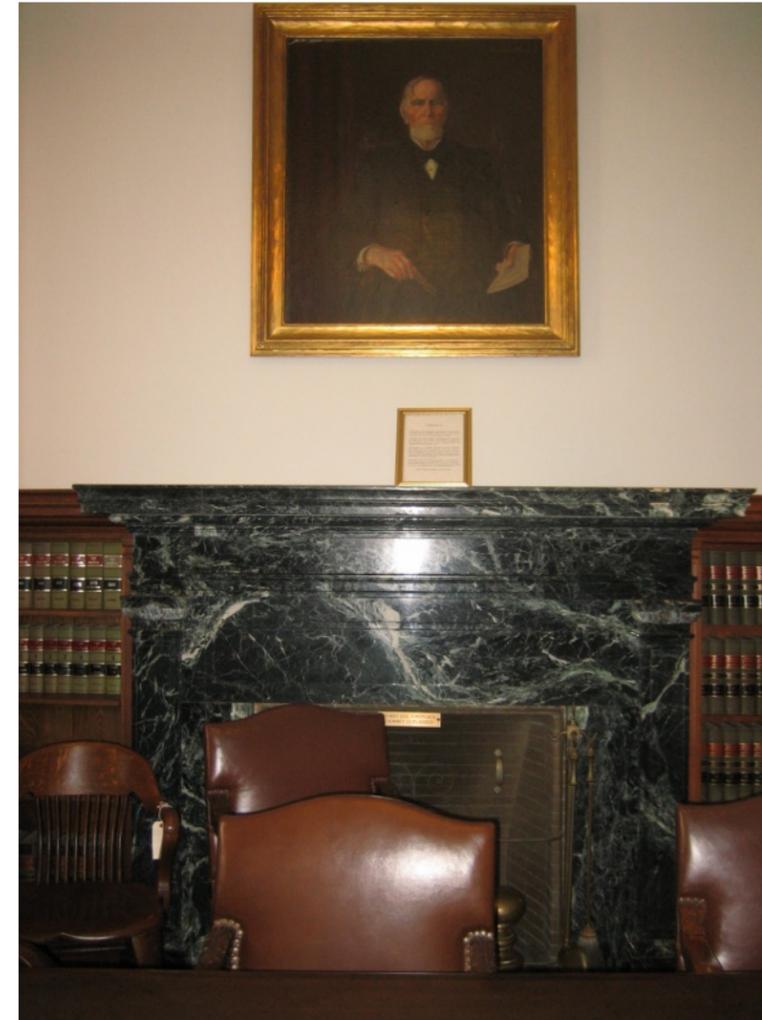
Fireplace and portrait

The former Chief Justice's Office is largely intact and is now used as a conference room and library.
