# Minnesota State Capitol Preservation

Presentation to the Capitol Preservation Commission

December 8, 2011

# **UPDATE ON MECHANICAL & ELECTRICAL ASSESSMENT**

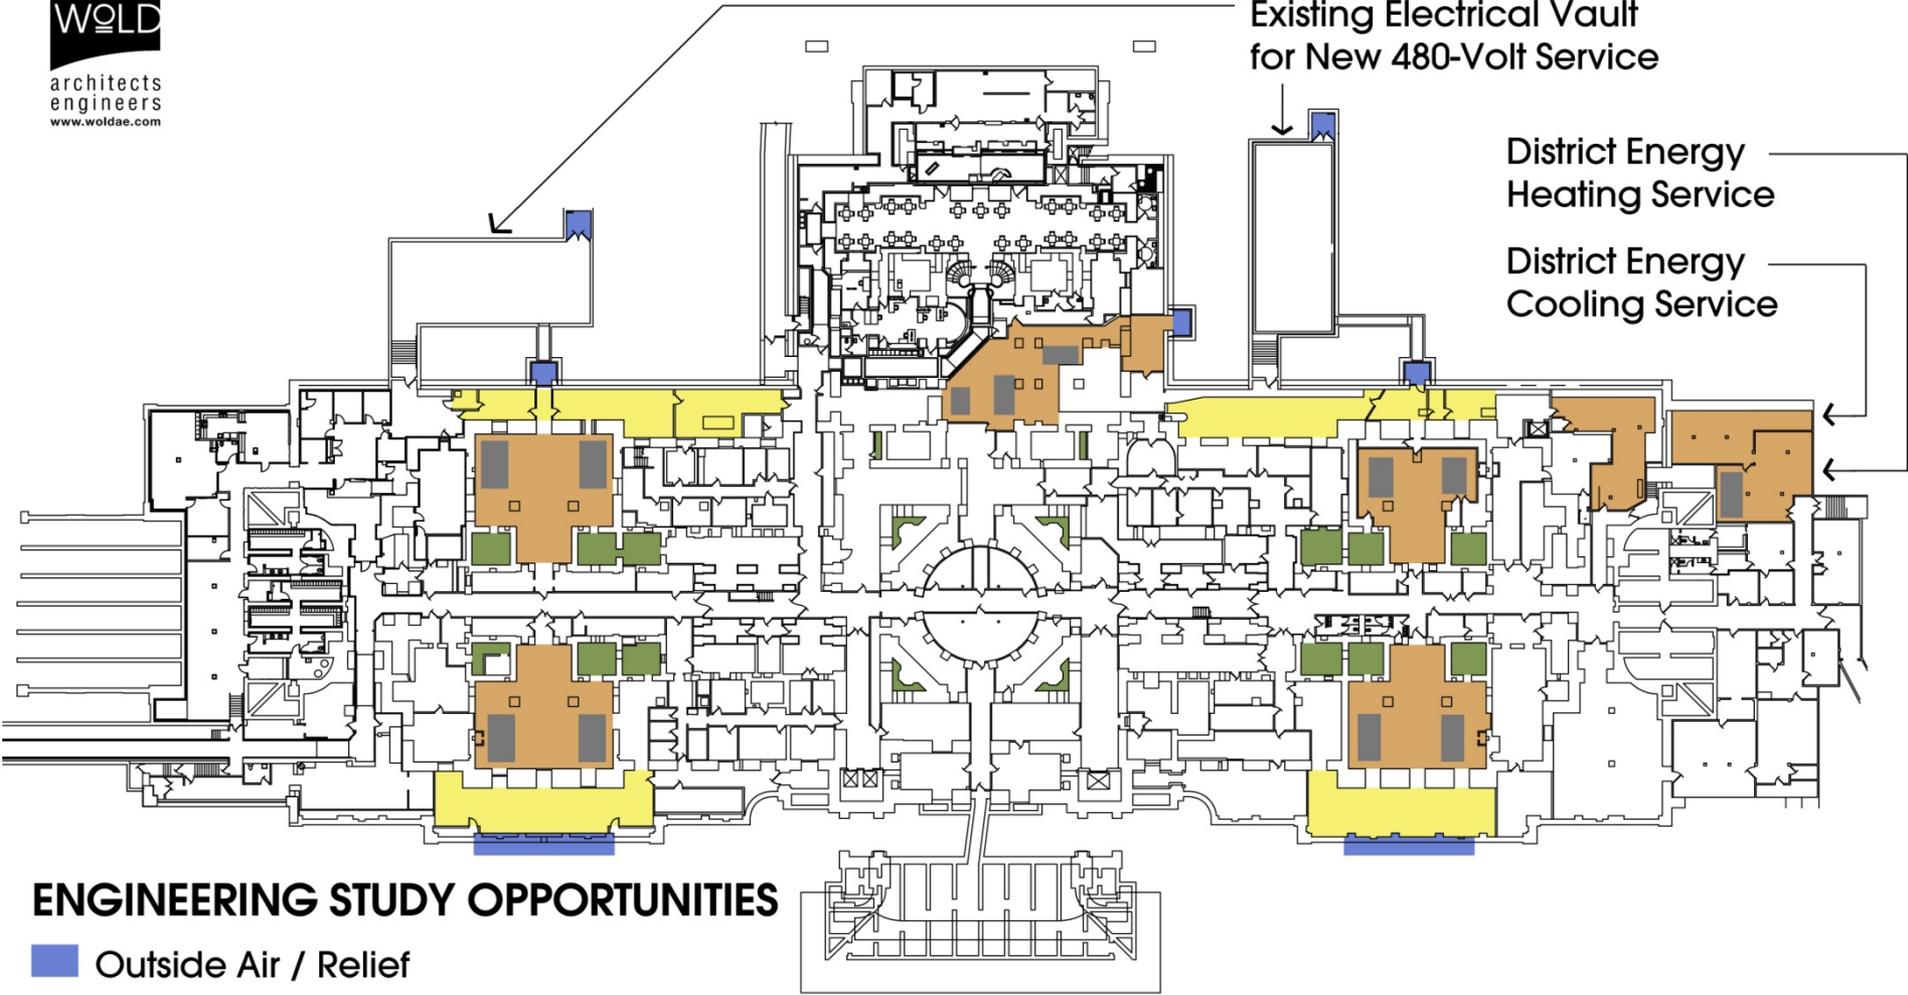
Existing Electrical Vault  
for New 480-Volt Service

District Energy  
Heating Service

District Energy  
Cooling Service

- **District Energy Service** – the building heating and cooling is provided by St. Paul District Energy. Service piping enters the building in the northwest corner of the building. Currently there is a project underway to improve the hot water service entrance and distribution piping.

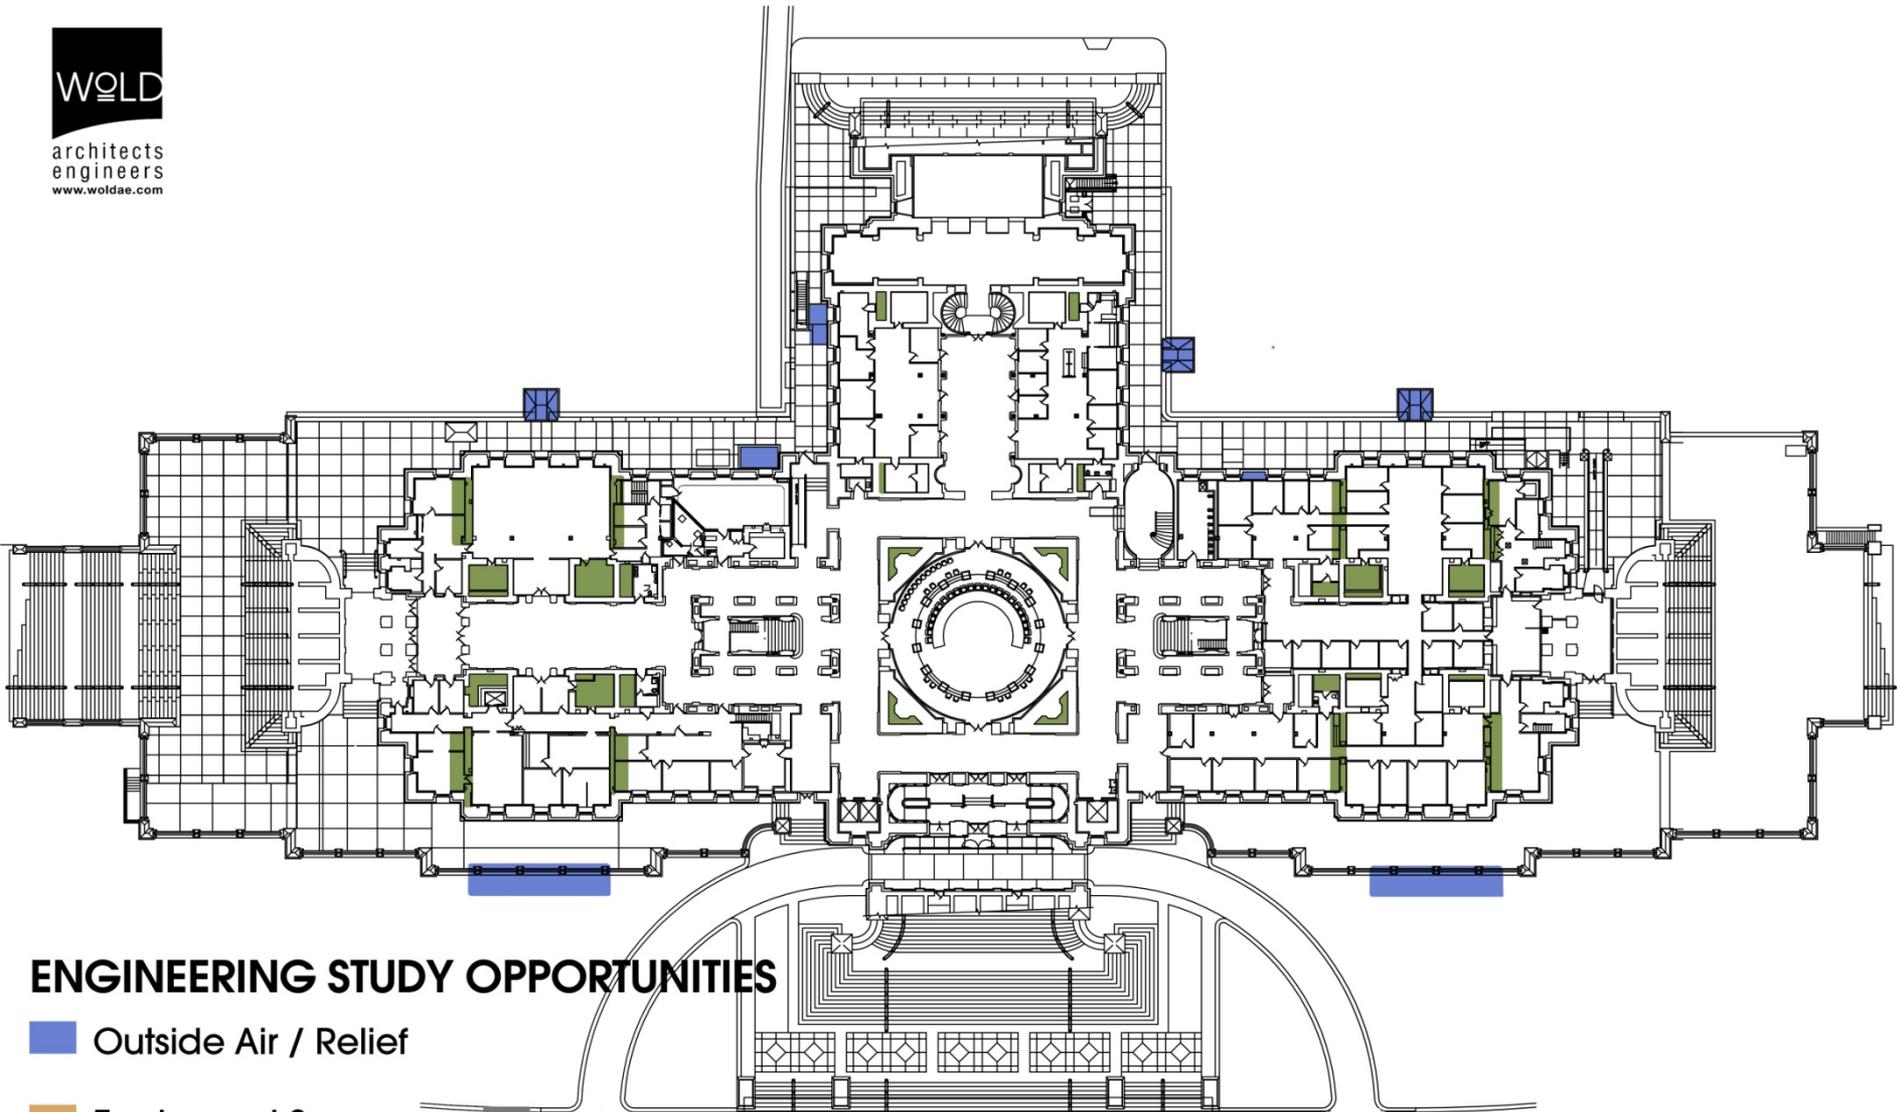
# BASEMENT

## ENGINEERING STUDY OPPORTUNITIES

Blue square: Outside Air / Relief

Orange square: Equipment Space

Grey square: Air Handling Units

Yellow square: Horizontal Distribution

Green square: Vertical Distribution

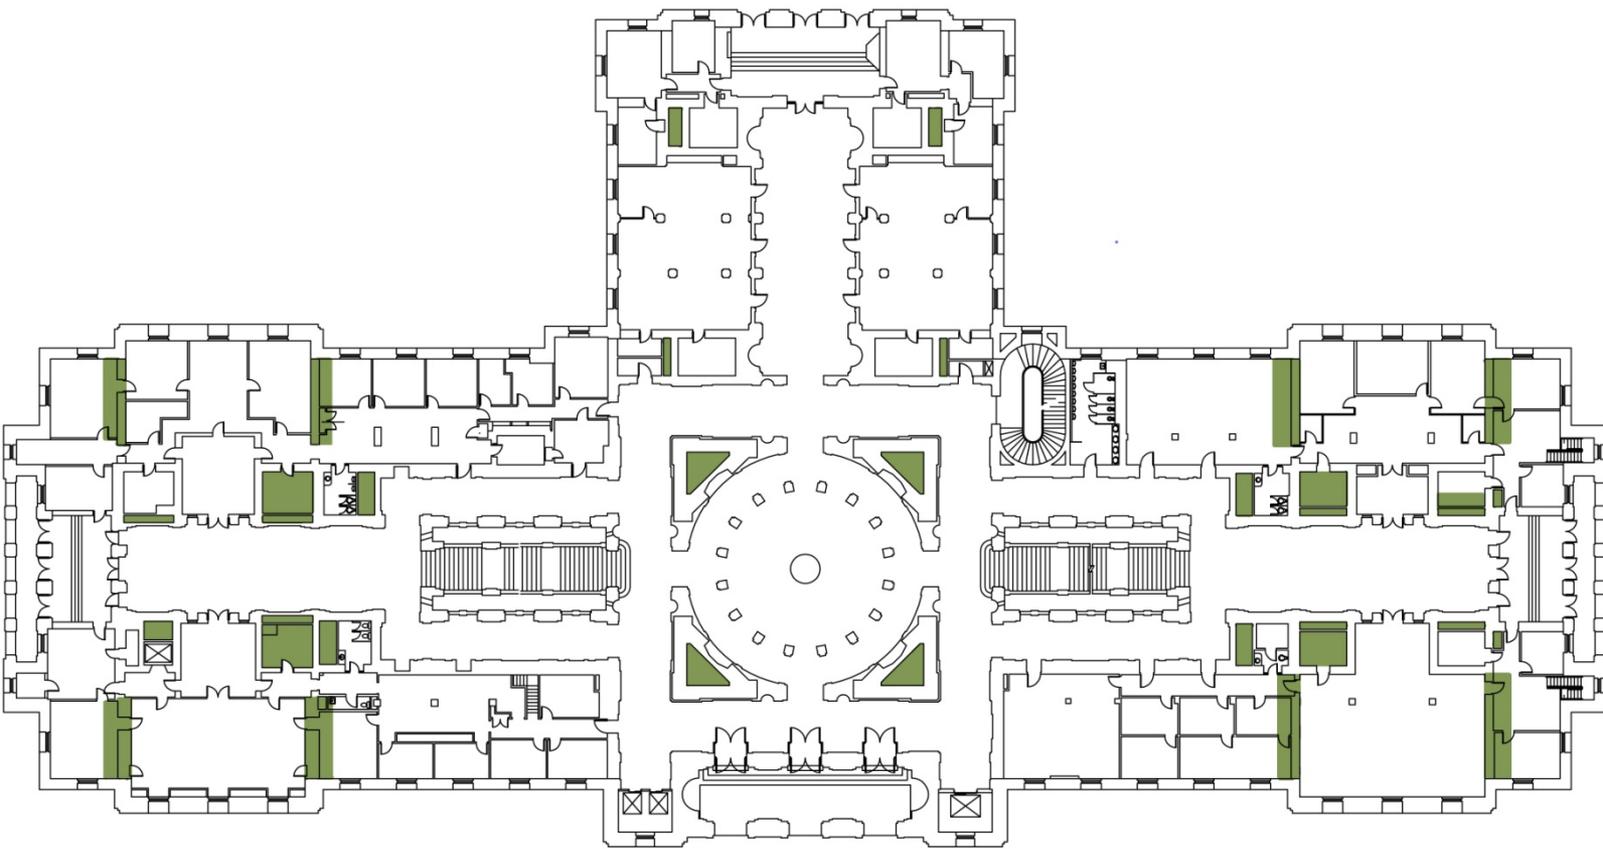
**GROUND FLOOR**

**ENGINEERING STUDY OPPORTUNITIES**

- Blue square: Outside Air / Relief
- Orange rectangle: Equipment Space
- Yellow rectangle: Horizontal Distribution
- Green rectangle: Vertical Distribution
- Grey rectangle: Air Handling Units

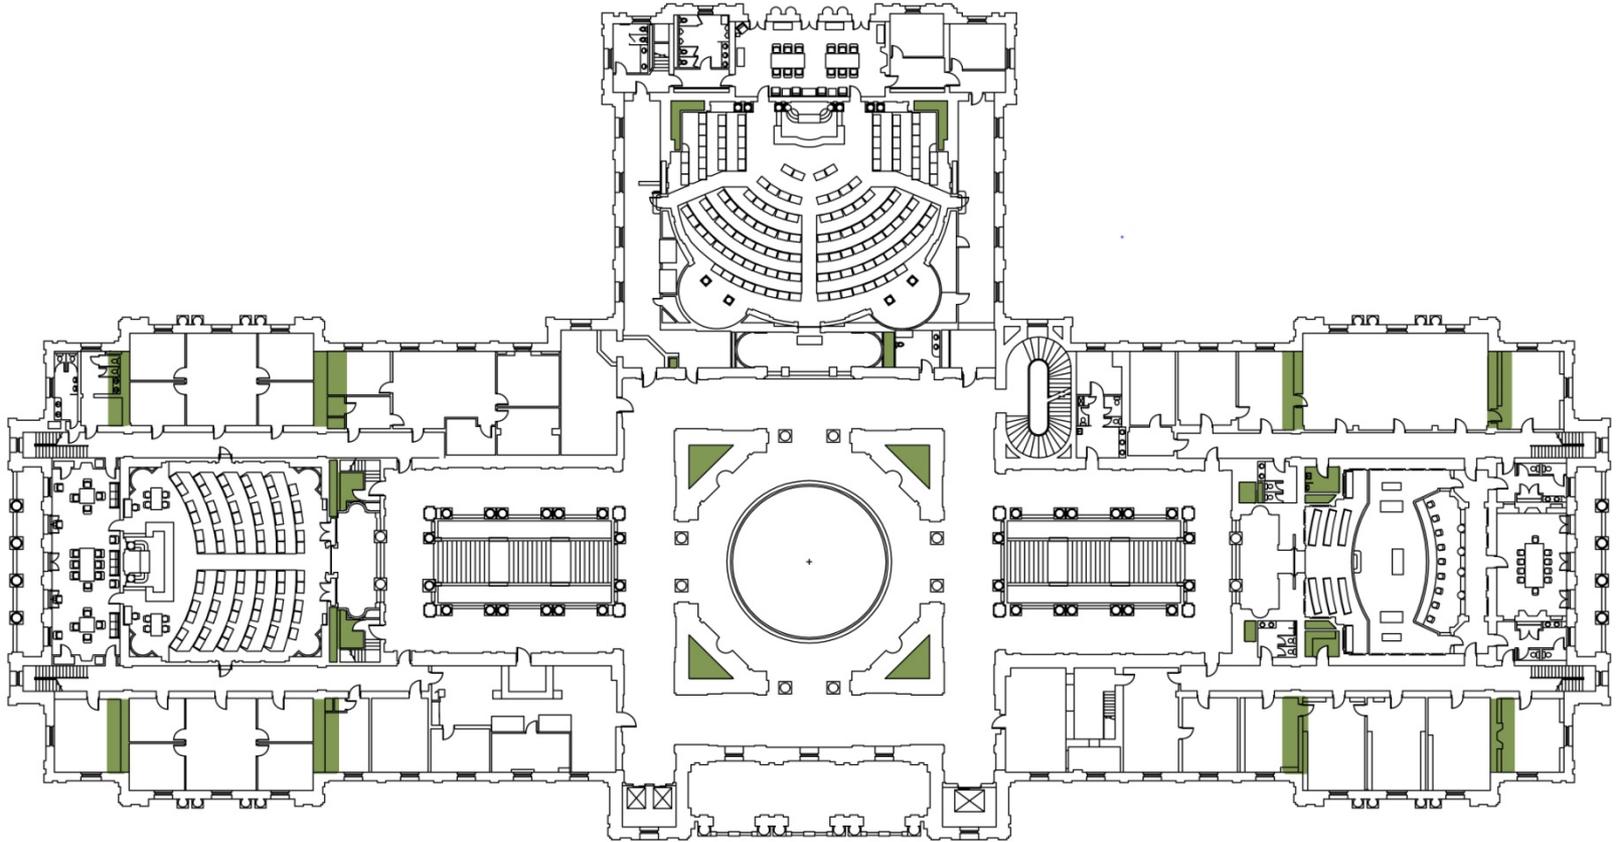
# 1ST FLOOR

### ENGINEERING STUDY OPPORTUNITIES

- Blue square: Outside Air / Relief
- Orange square: Equipment Space
- Yellow square: Horizontal Distribution
- Grey square: Air Handling Units
- Green square: Vertical Distribution

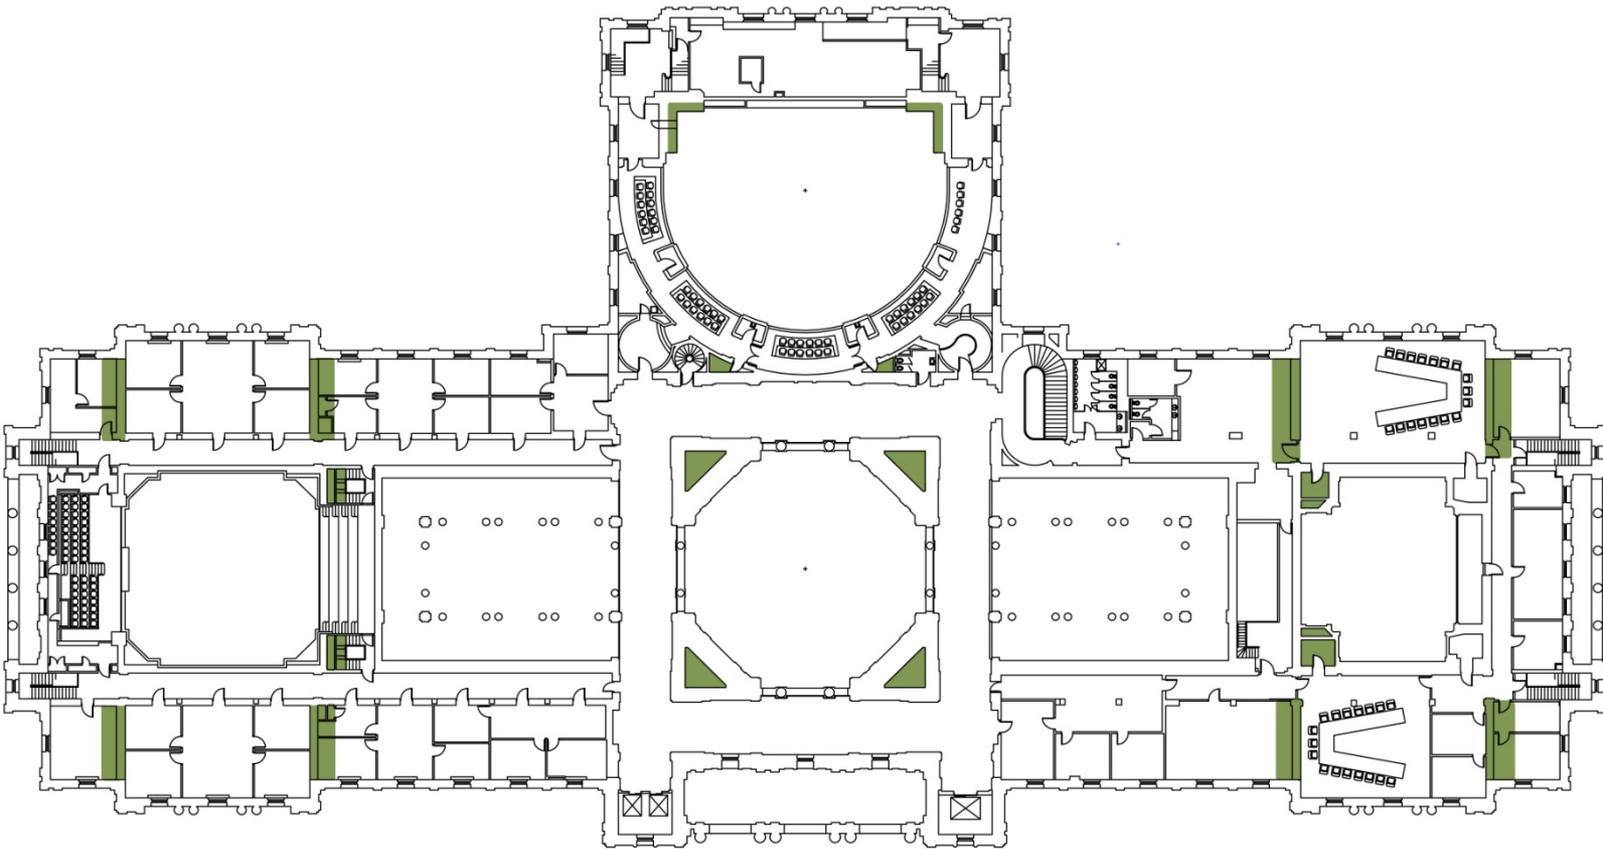
# 2ND FLOOR

## ENGINEERING STUDY OPPORTUNITIES

- Outside Air / Relief
- Equipment Space
- Horizontal Distribution
- Air Handling Units
- Vertical Distribution

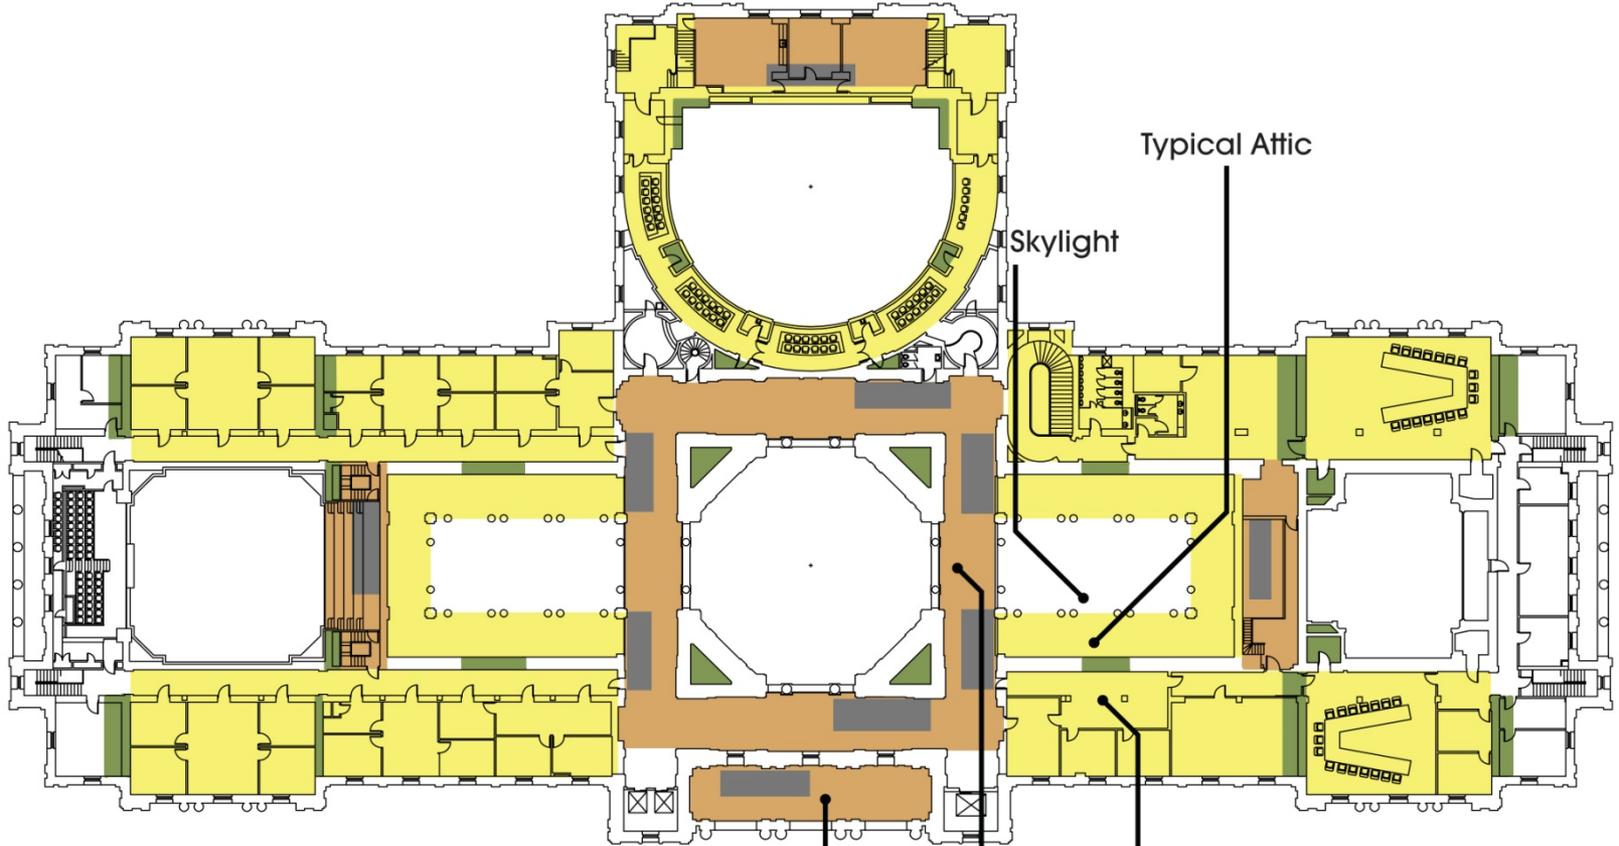
# 3RD FLOOR

### ENGINEERING STUDY OPPORTUNITIES

- Outside Air / Relief
- Equipment Space
- Horizontal Distribution
- Air Handling Units
- Vertical Distribution

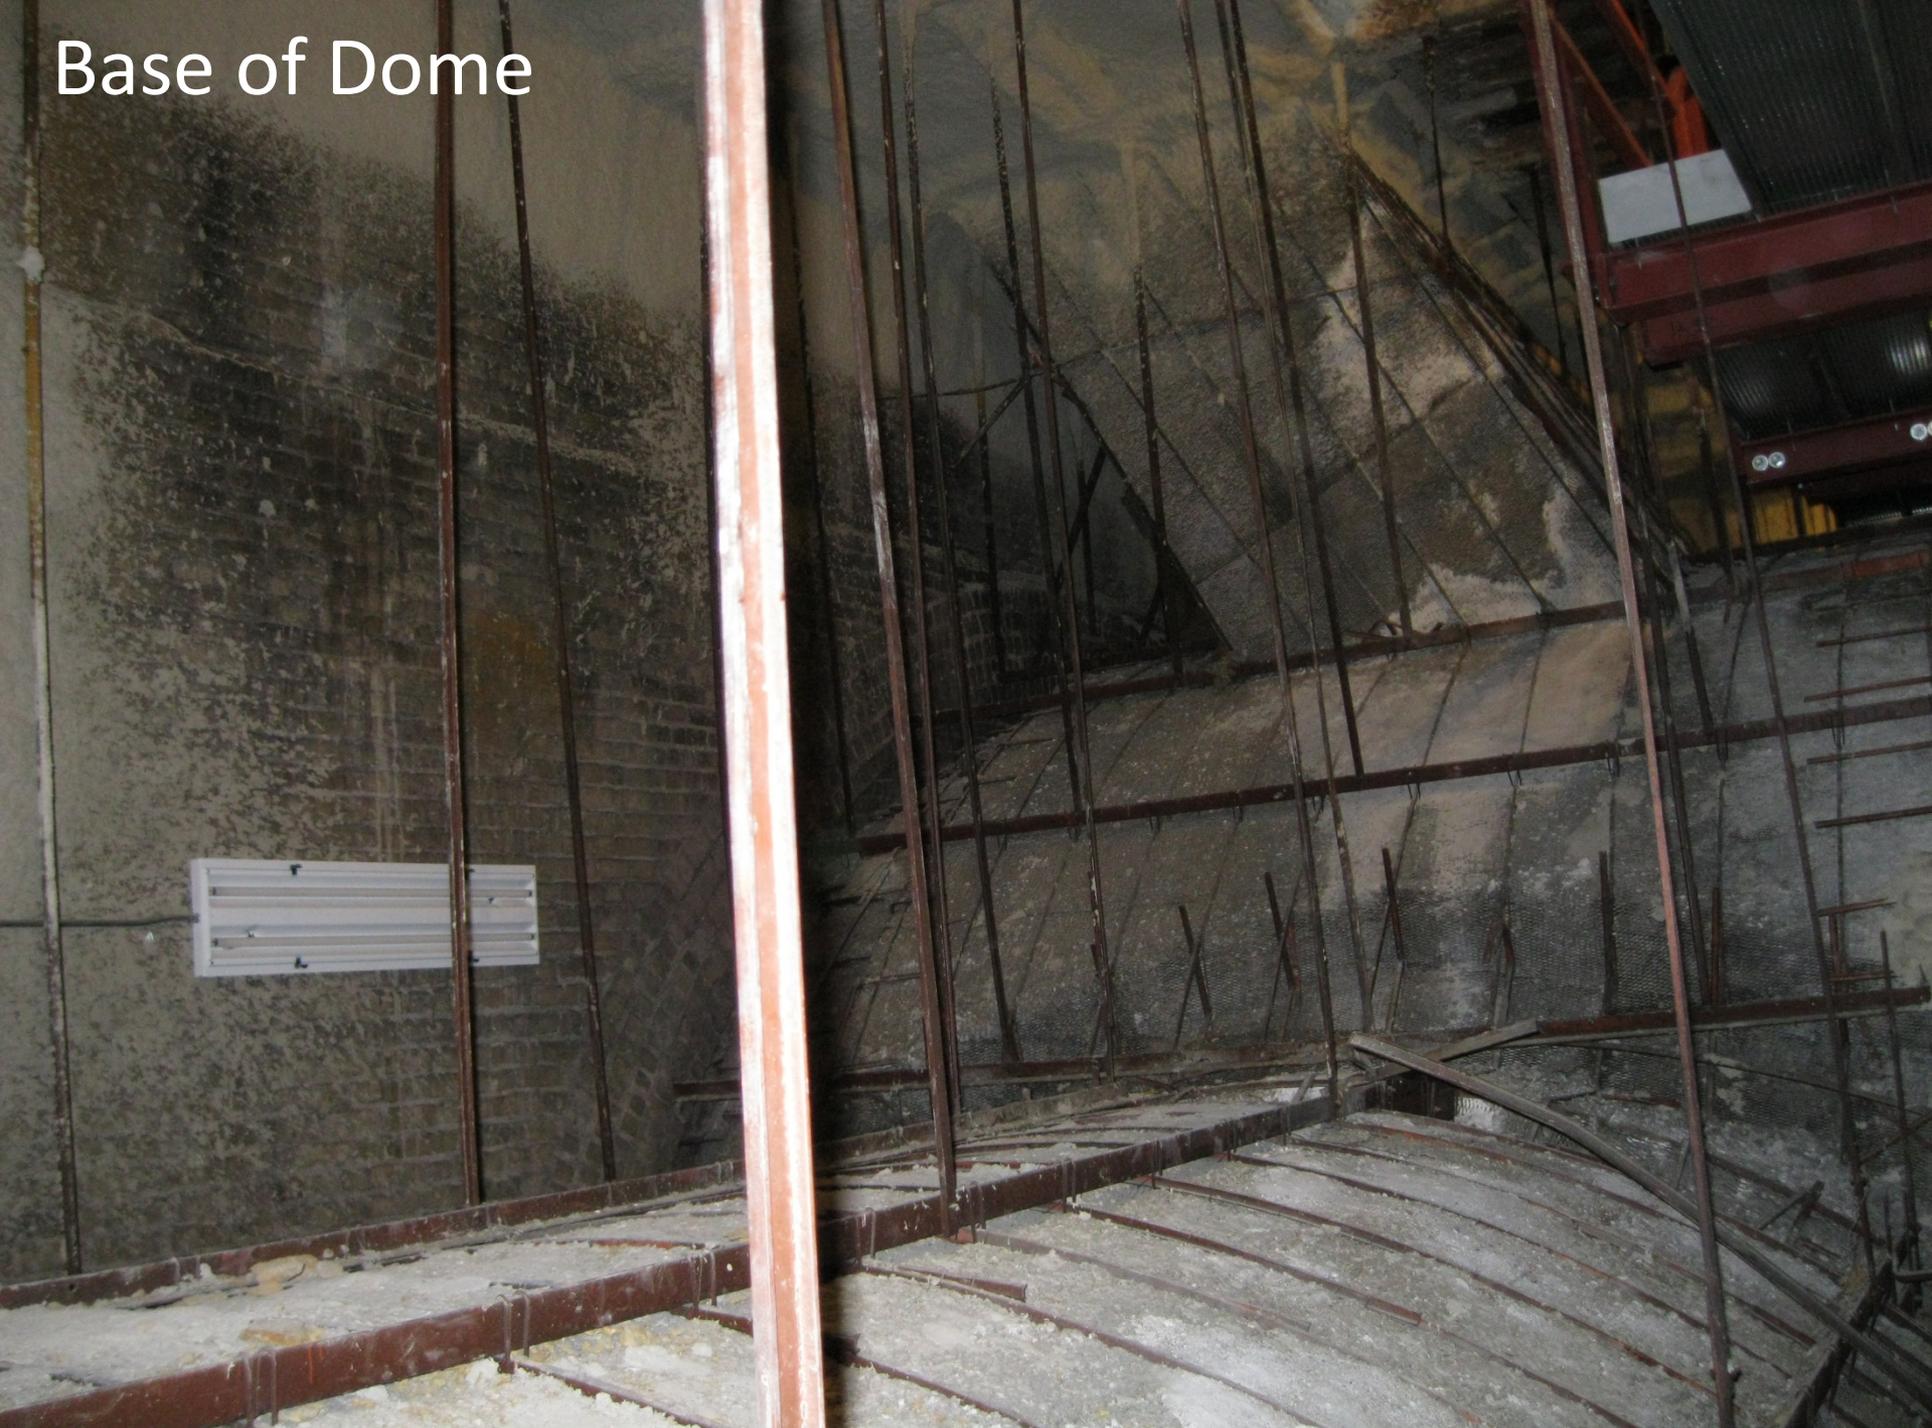
# Base of Dome

## ENGINEERING STUDY OPPORTUNITIES

- Outside Air / Relief
- Equipment Space
- Air Handling Units
- Horizontal Distribution
- Vertical Distribution

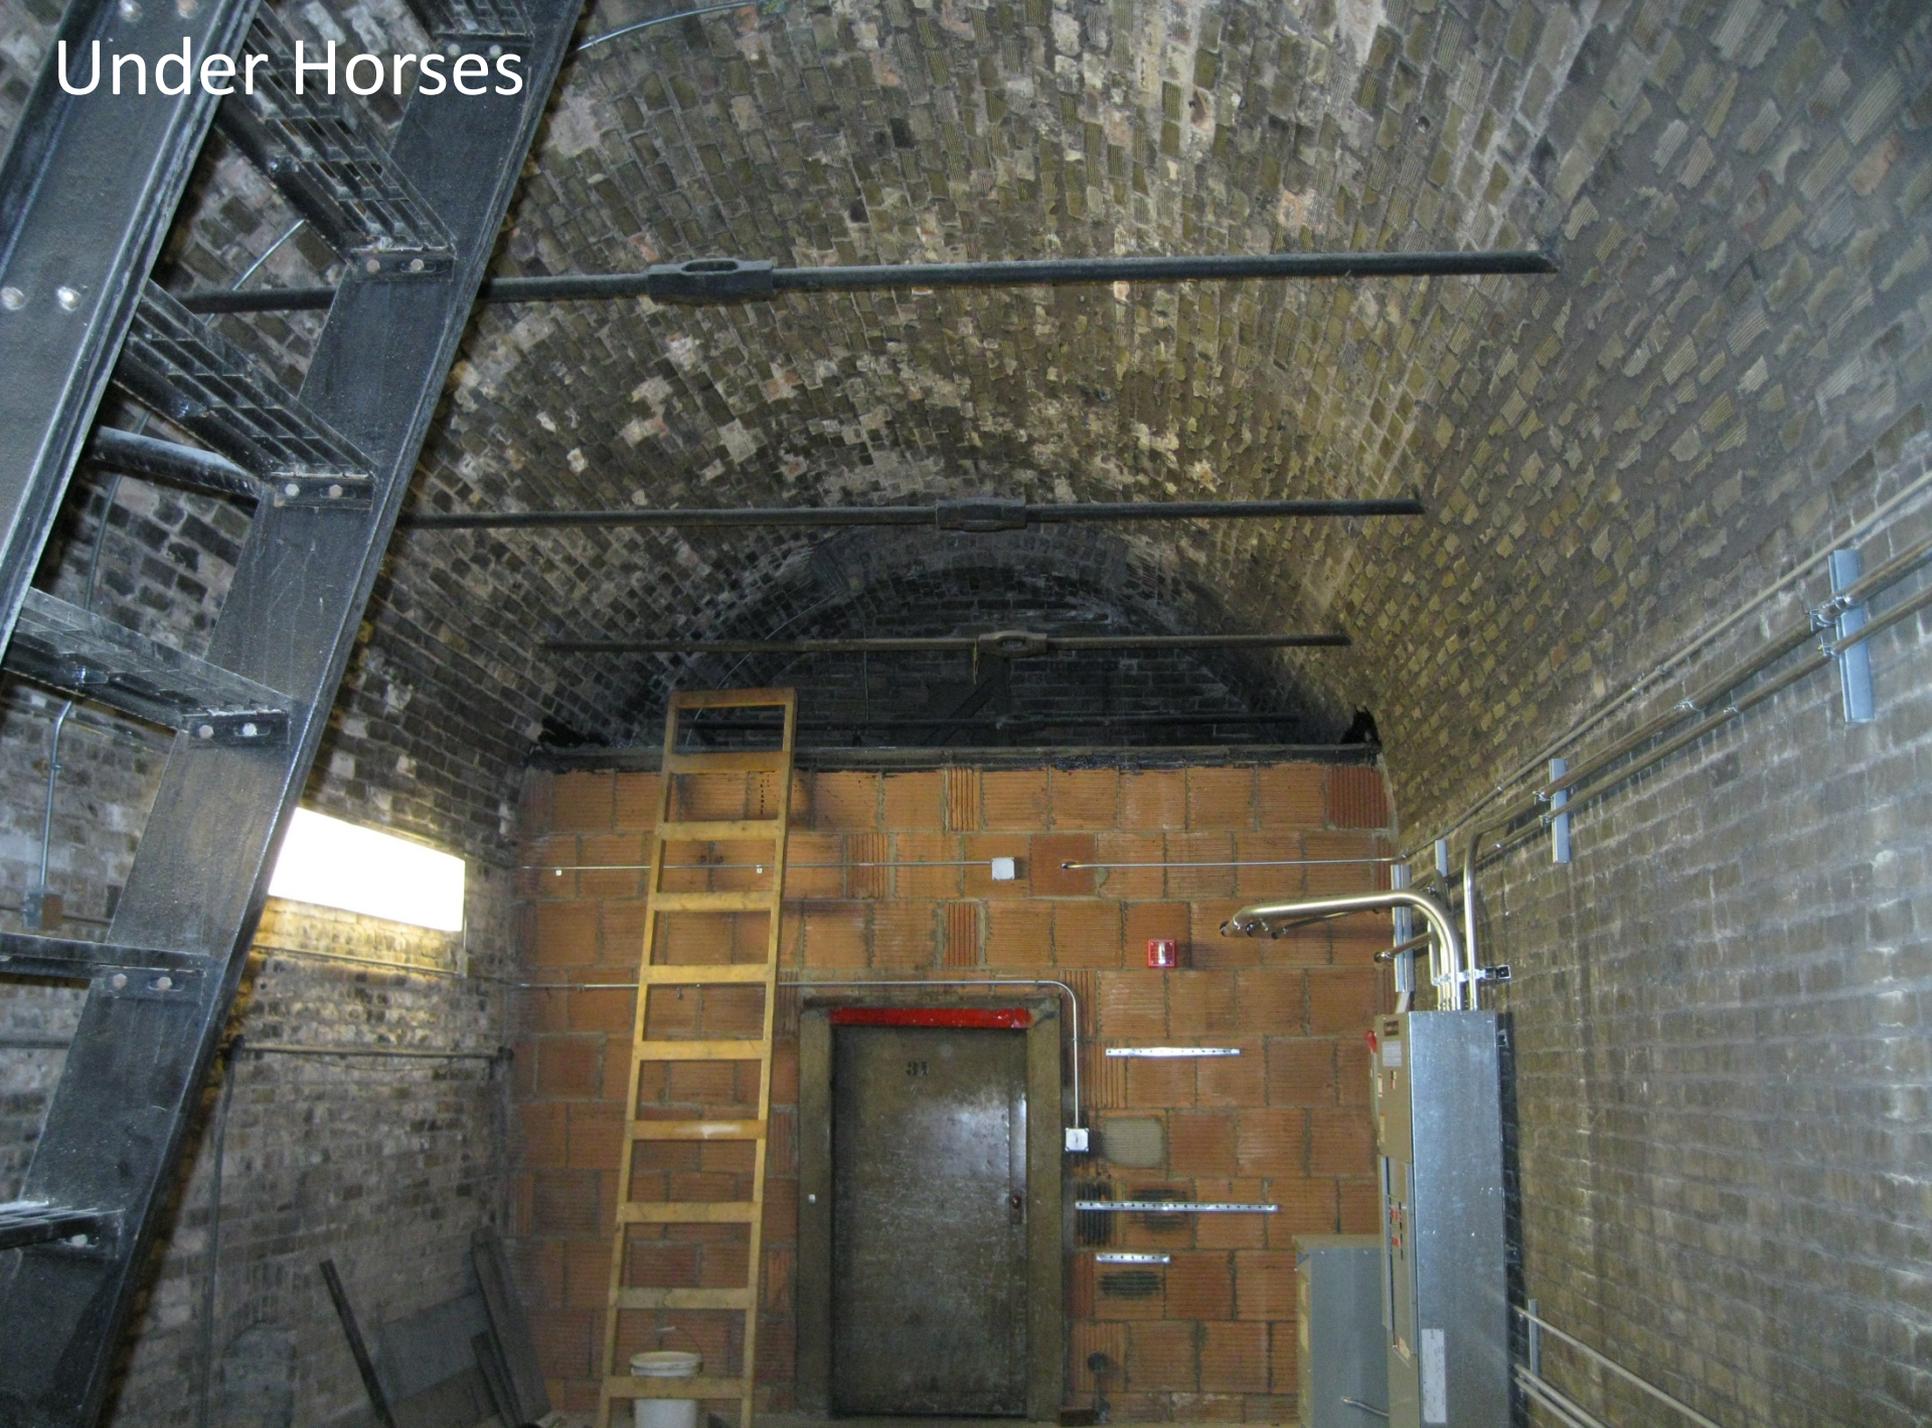
# Under Horses

## ENGINEERING STUDY OPPORTUNITIES

- Outside Air / Relief
- Equipment Space
- Horizontal Distribution
- Air Handling Units
- Vertical Distribution

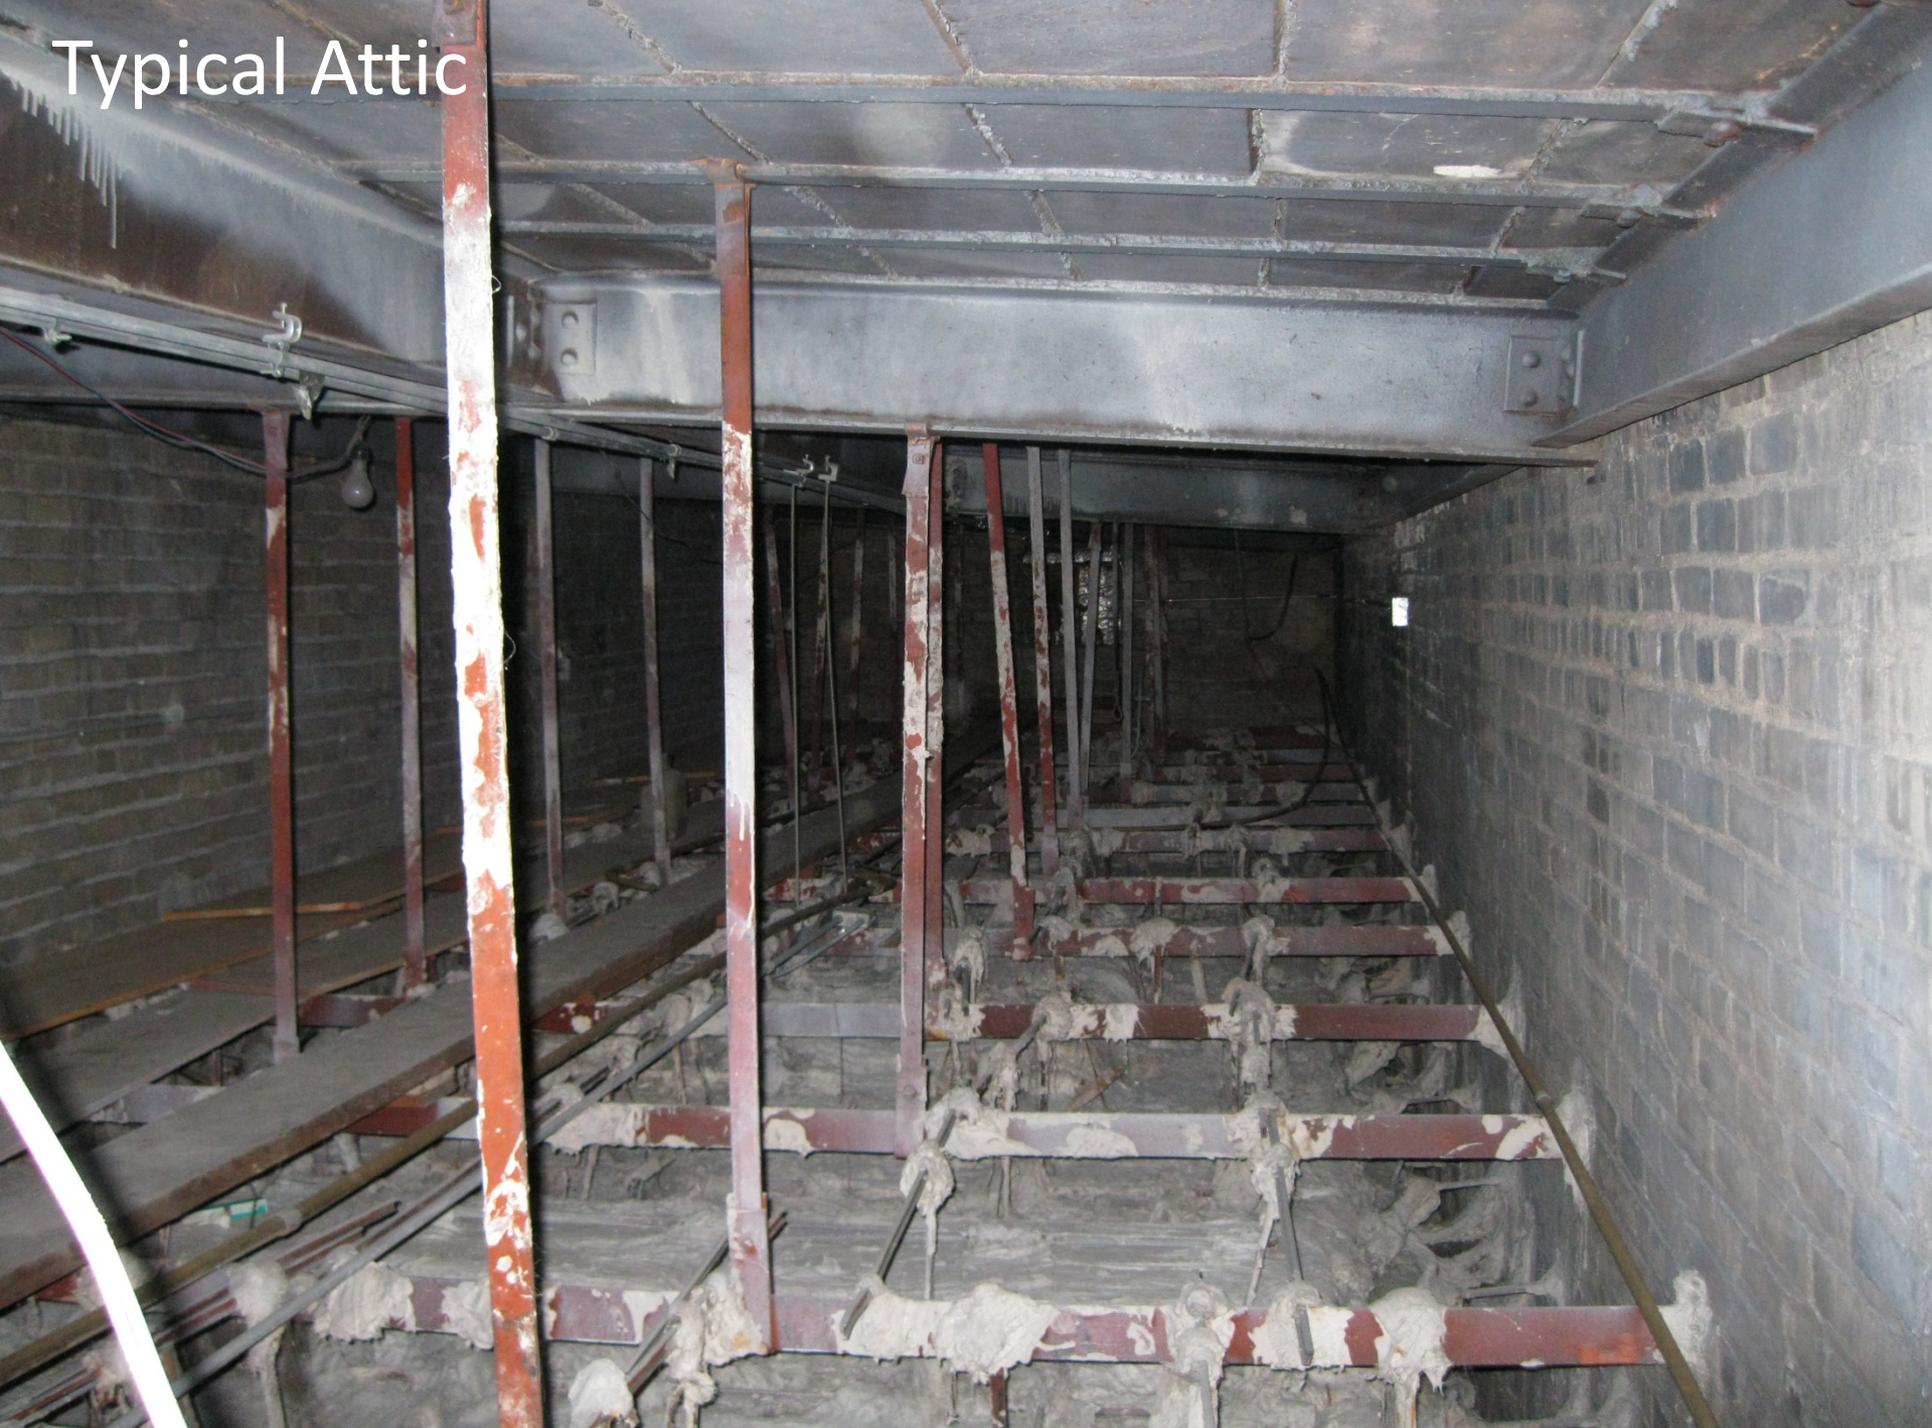
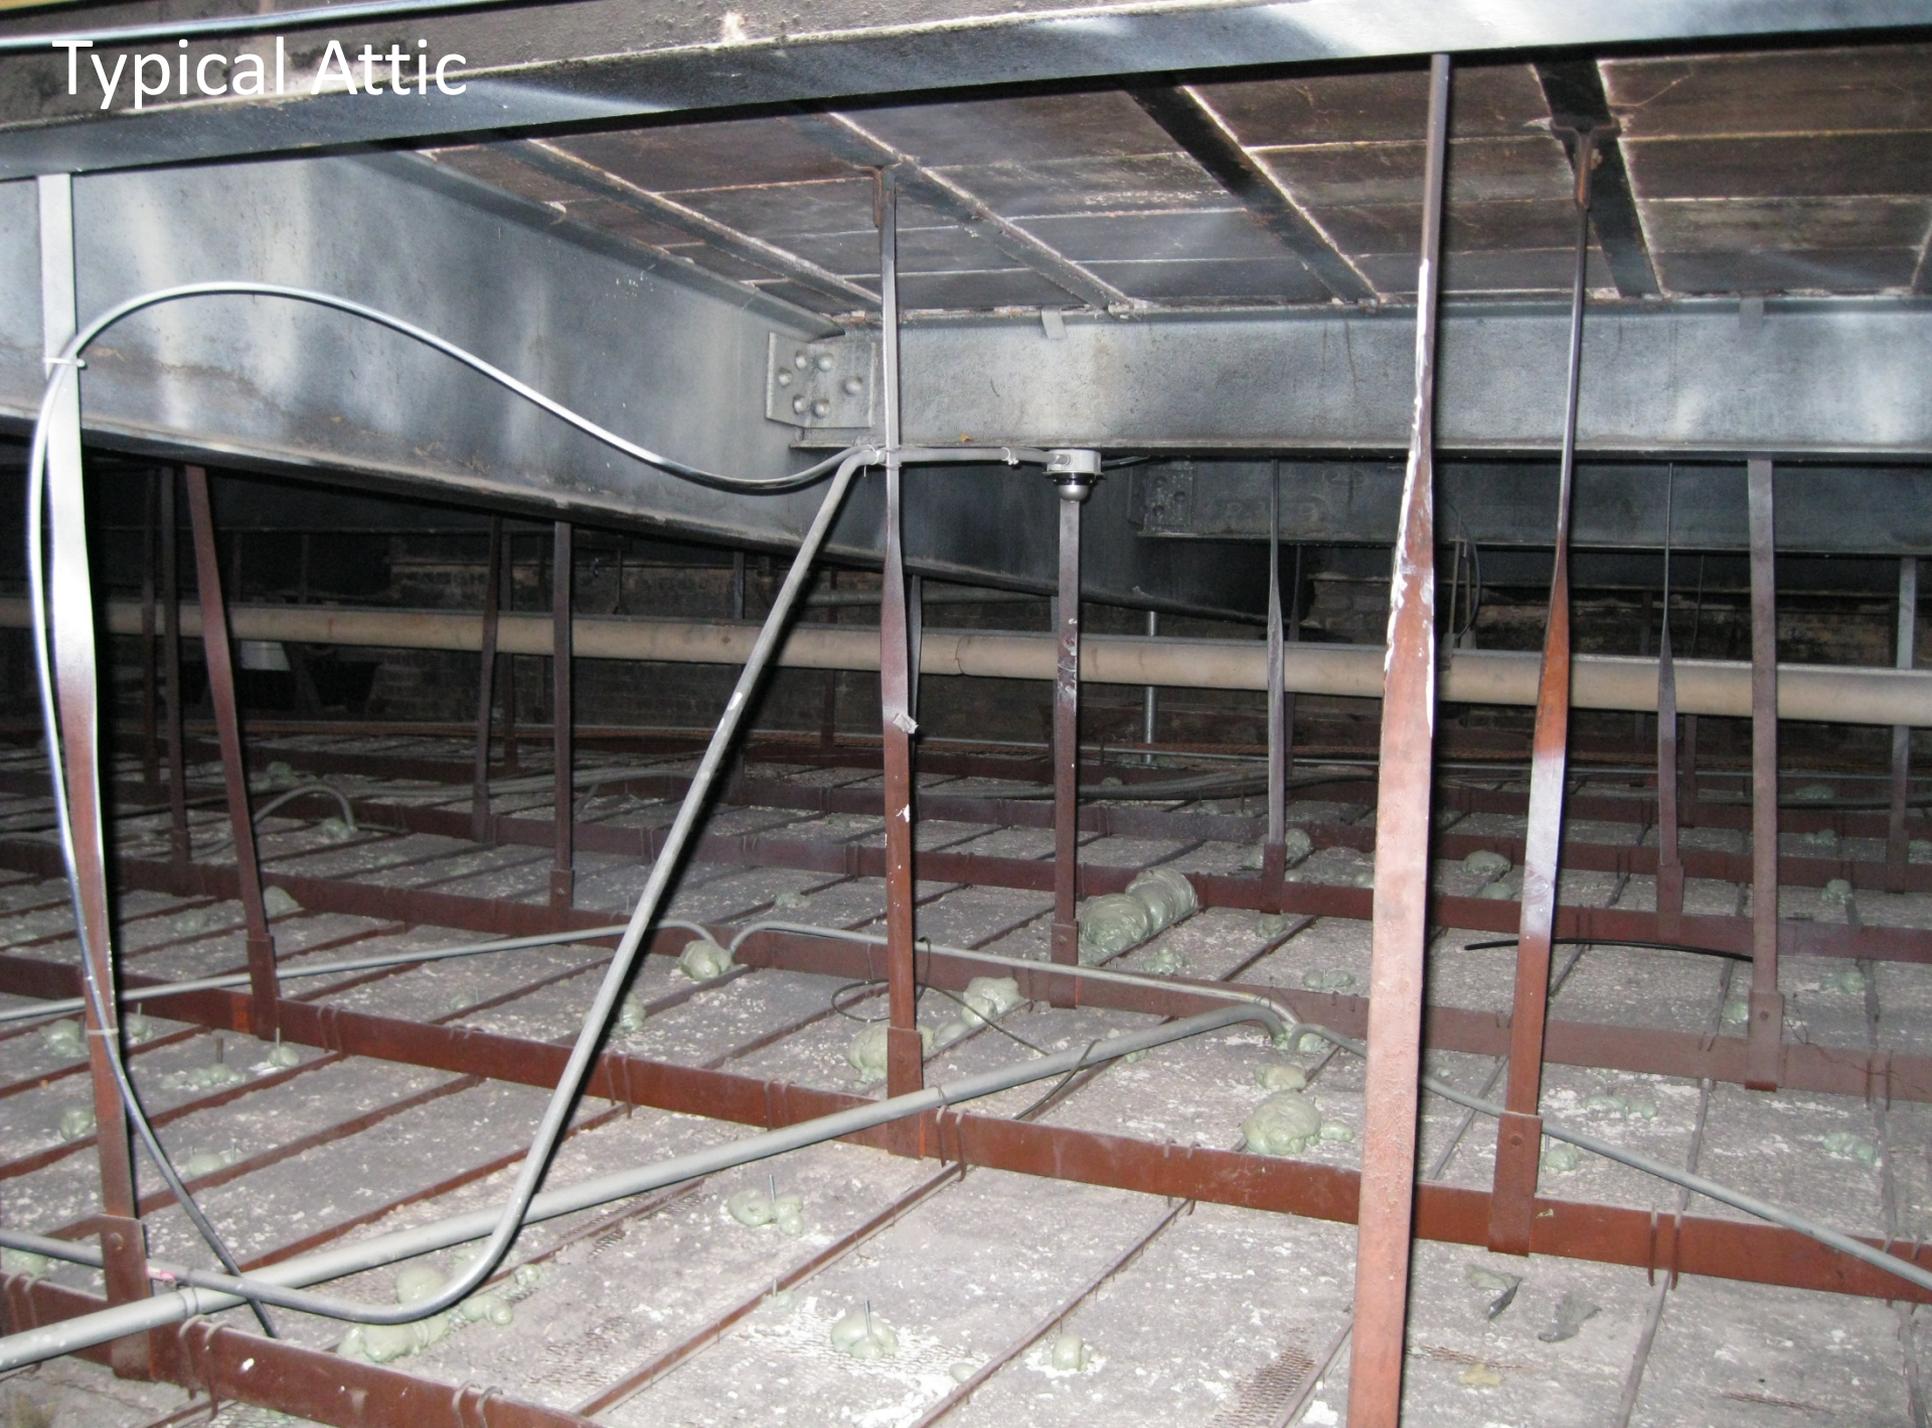
# Typical Attic

## ENGINEERING STUDY OPPORTUNITIES

- Outside Air / Relief
- Equipment Space
- Horizontal Distribution
- Air Handling Units
- Vertical Distribution
