# Minnesota State Capitol Preservation

Presentation to the Capitol Preservation Commission

December 8, 2011

# **UPDATE ON MECHANICAL & ELECTRICAL ASSESSMENT**

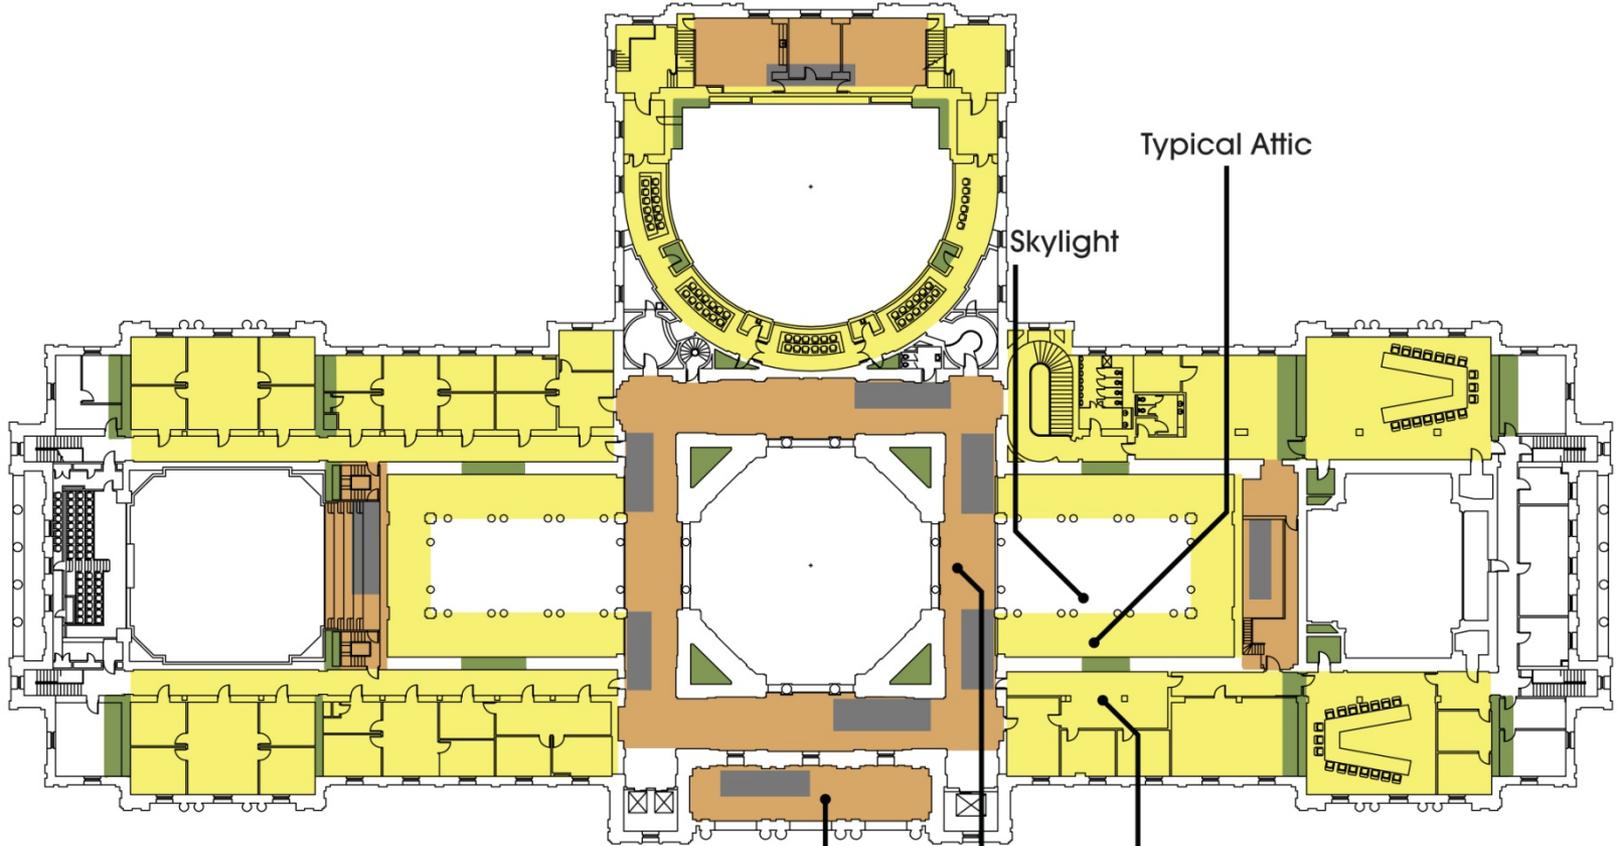
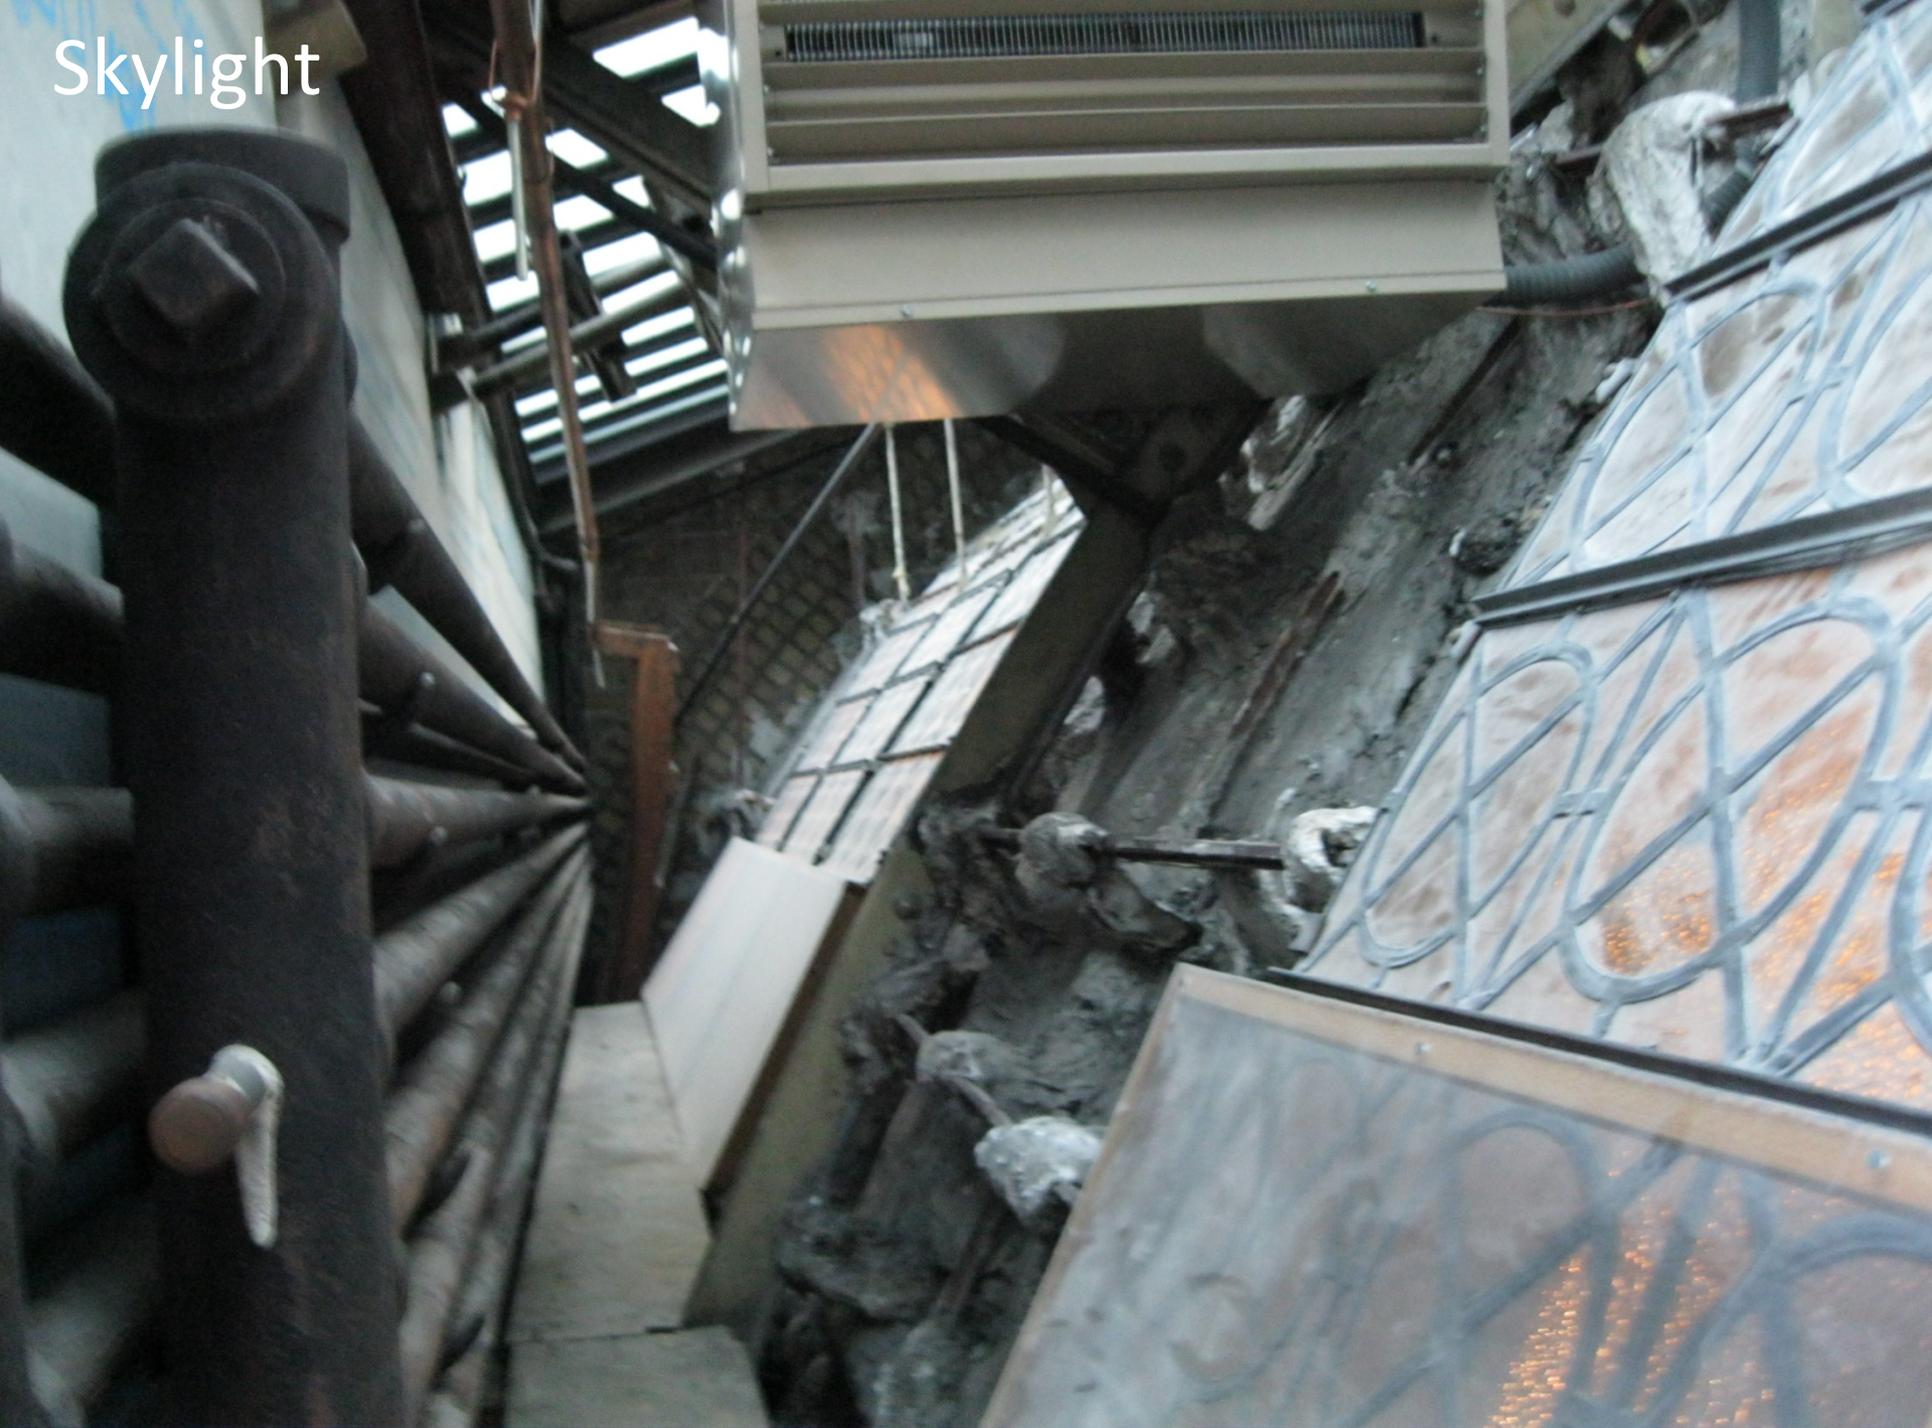
Skylight

## ENGINEERING STUDY OPPORTUNITIES

- Outside Air / Relief
- Equipment Space
- Air Handling Units
- Horizontal Distribution
- Vertical Distribution

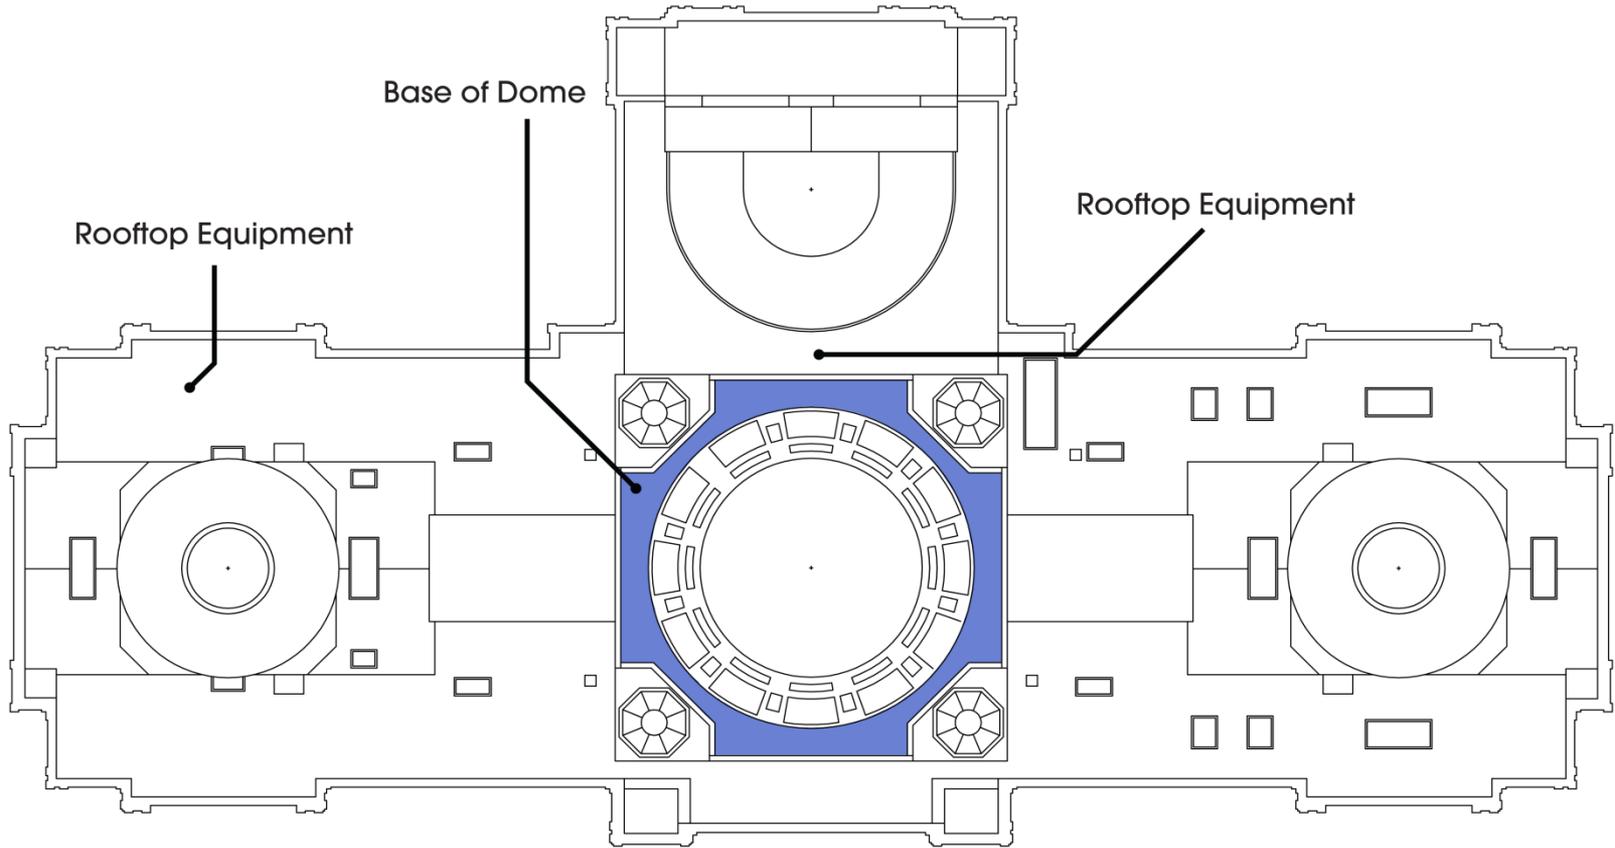
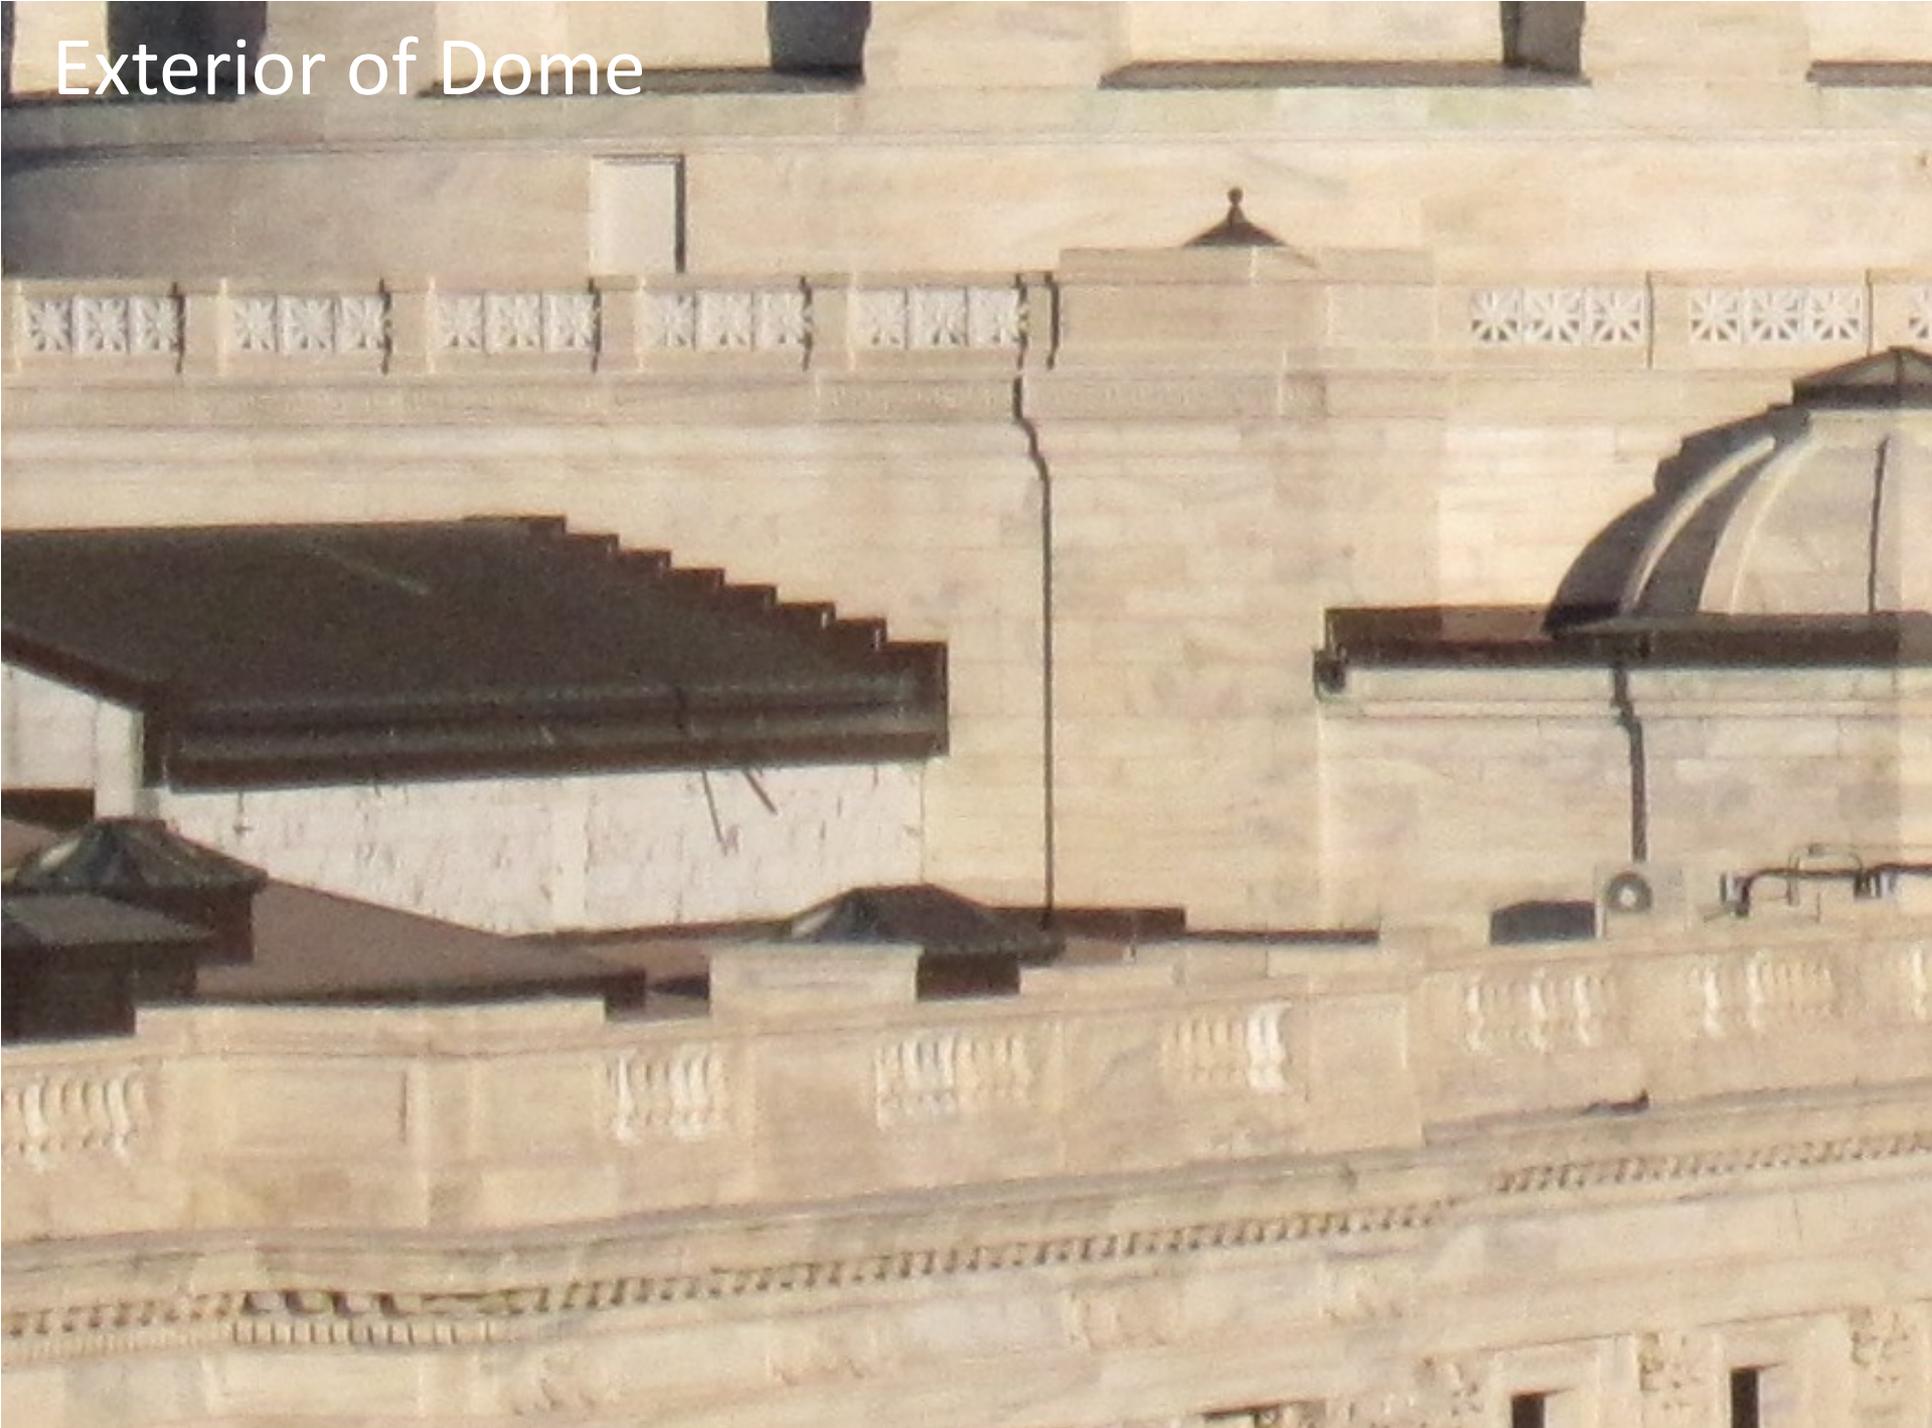
Exterior of Dome

## ENGINEERING STUDY OPPORTUNITIES

- Outside Air / Relief
- Equipment Space
- Air Handling Units
- Horizontal Distribution
- Vertical Distribution

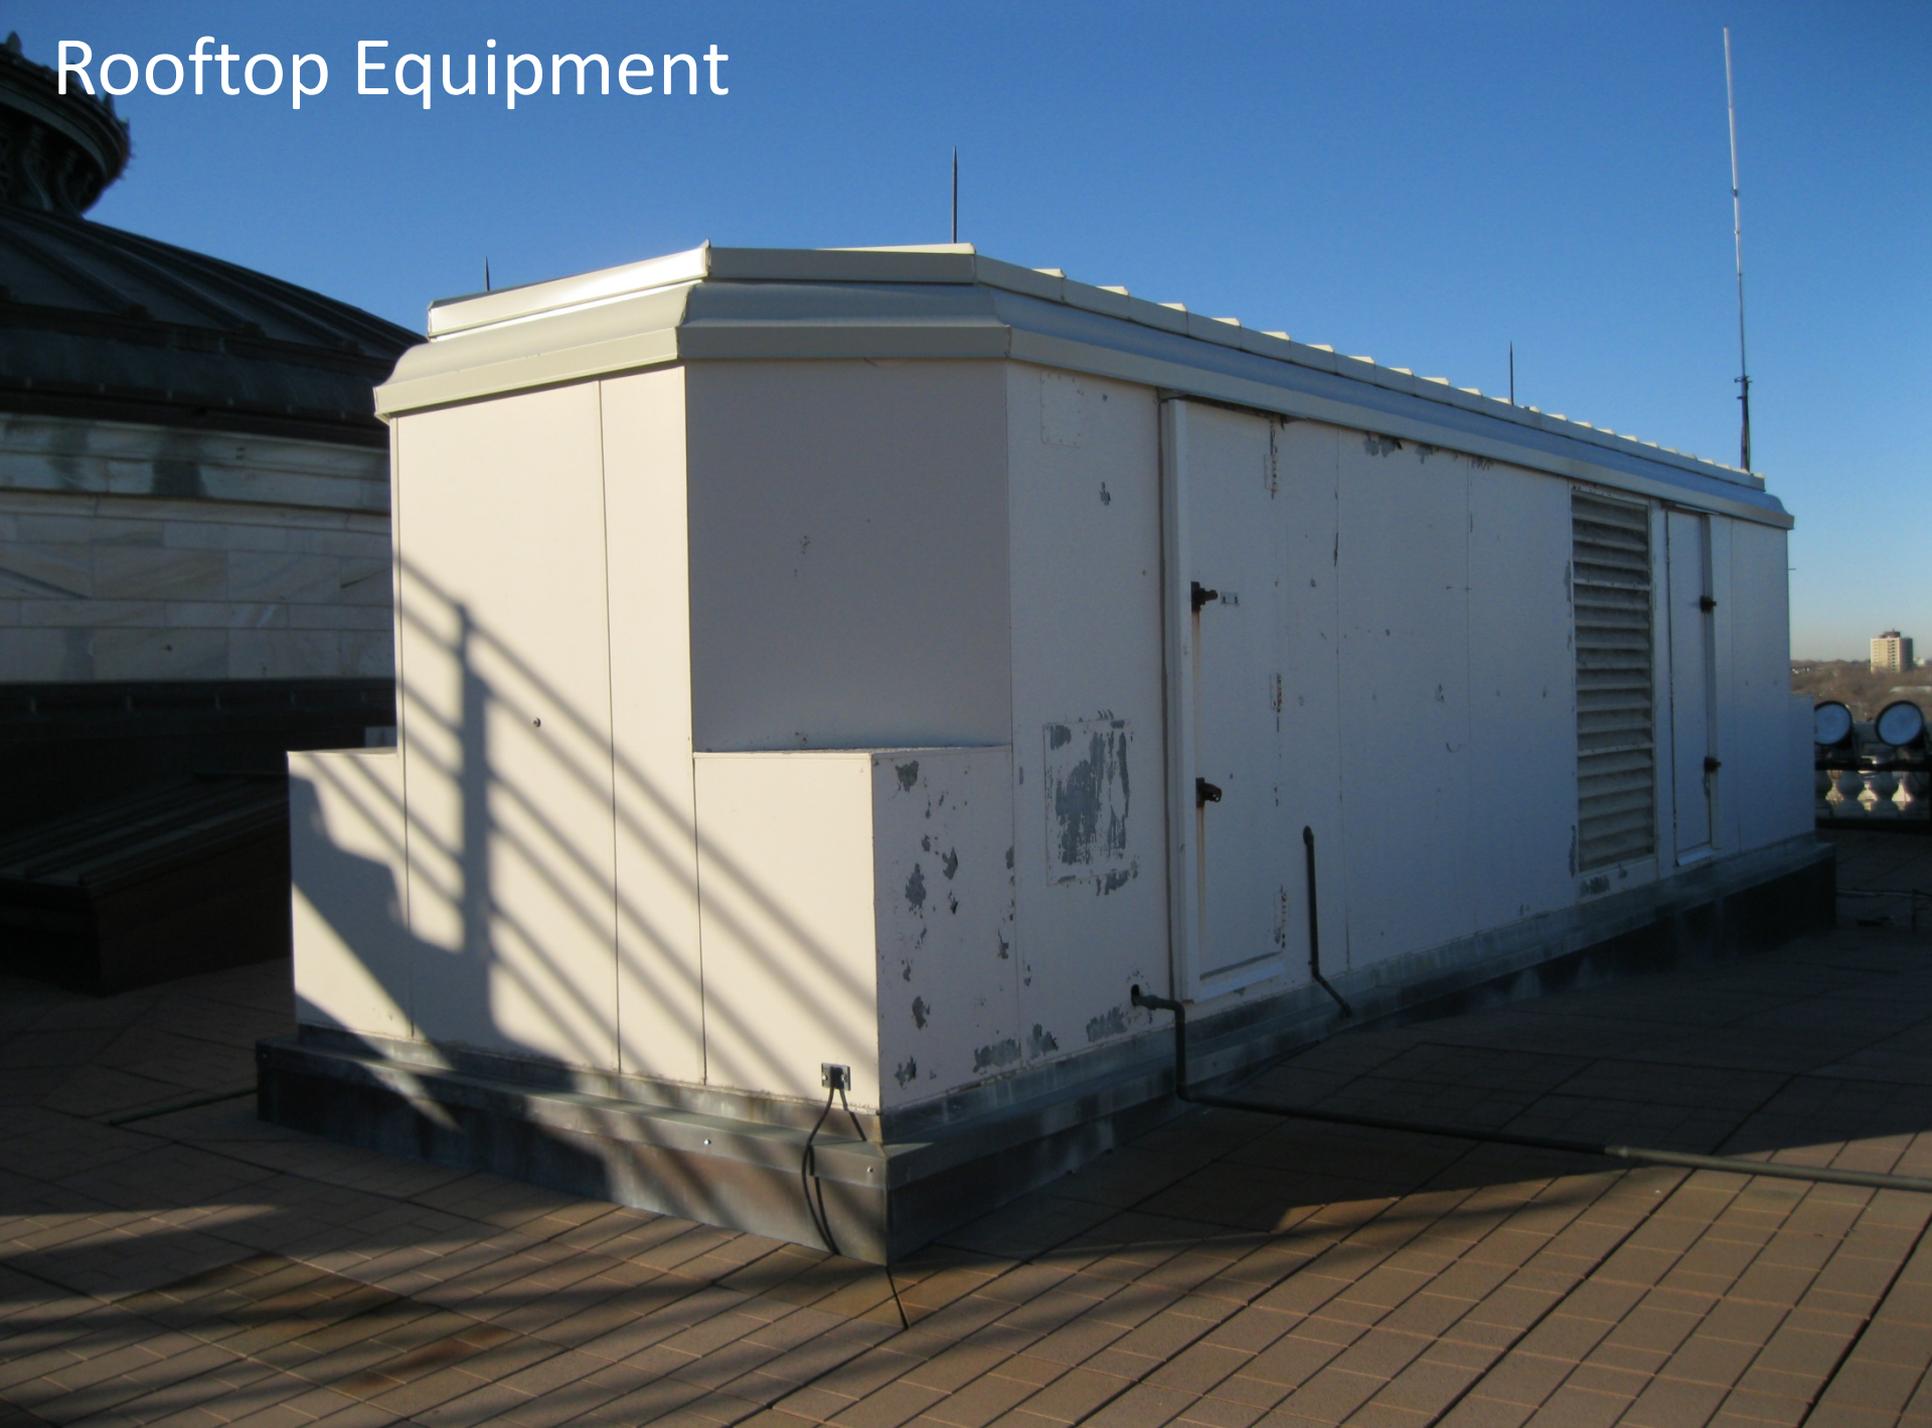
# Rooftop Equipment

## ENGINEERING STUDY OPPORTUNITIES

- Outside Air / Relief
- Equipment Space
- Air Handling Units
- Horizontal Distribution
- Vertical Distribution

- **Ventilation Systems** – The building has been retrofitted over the years to where today it has 32 air handling units. These units are primarily located in the basement. Two units have been installed on the roof to serve the House and Supreme Court assembly areas. The systems serving the rotunda and the grand stairs areas do not have a direct source of outside air ventilation and originally relied on natural air flow through the building.

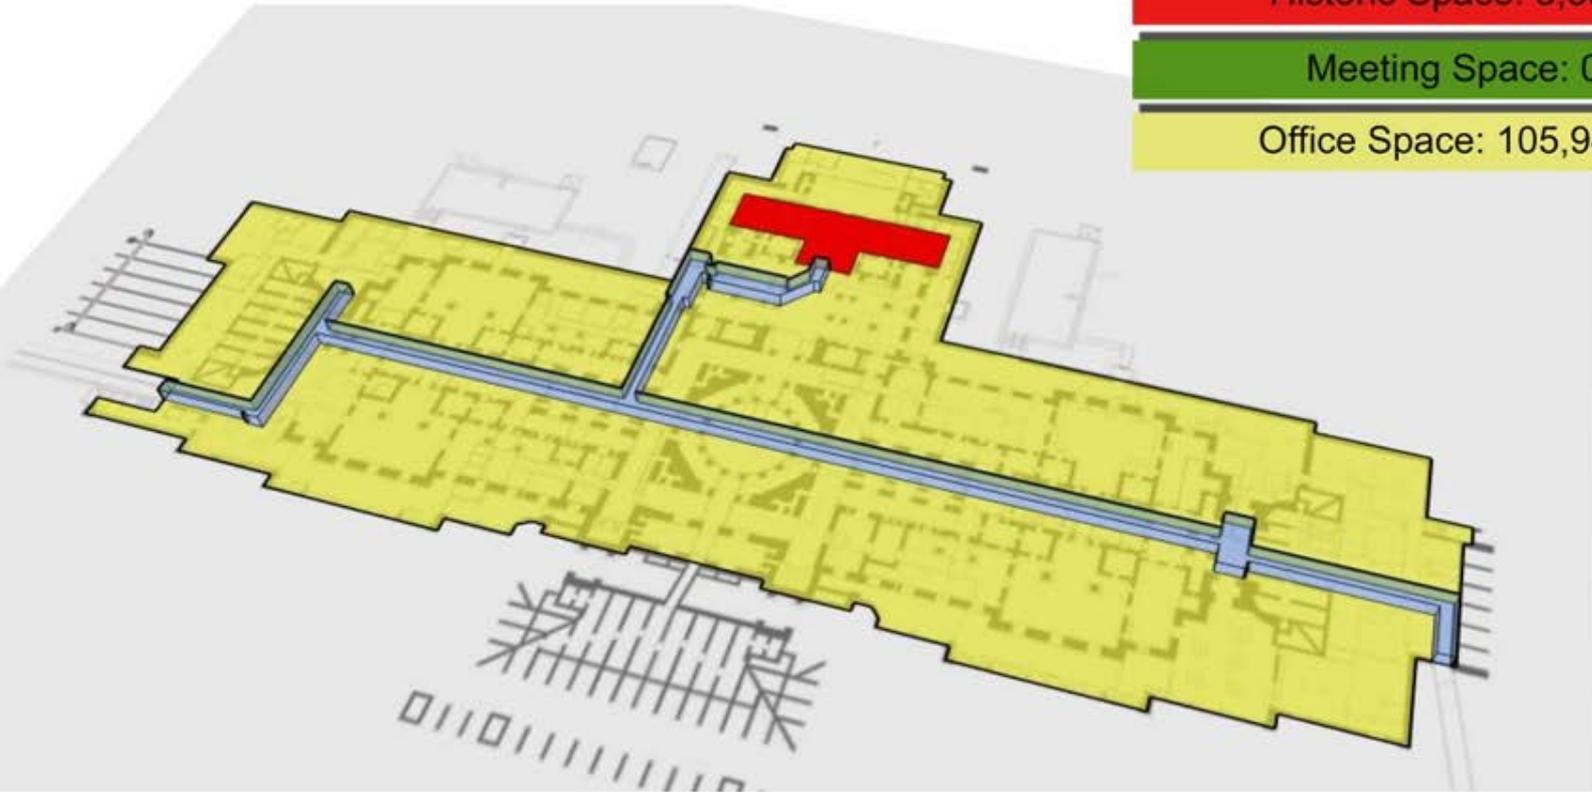
Minnesota State Capitol - Basement Floor  
Restoration Space Definition

Meeting Space: 0 sf

Office Space: 105,946 sf

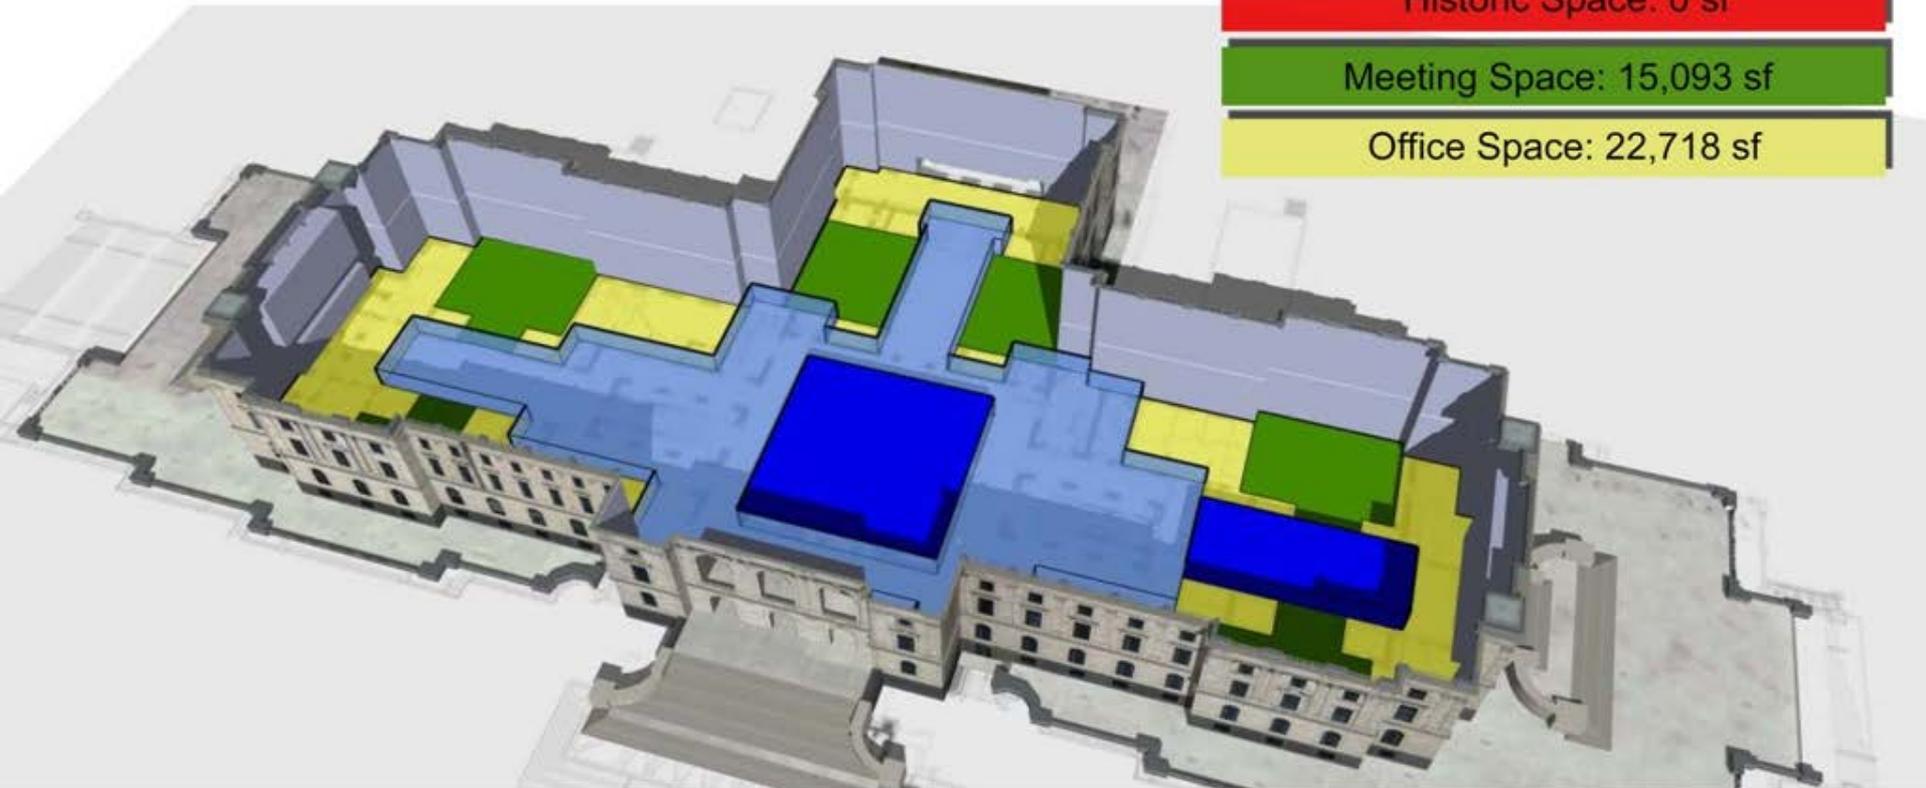
Minnesota State Capitol - Ground Floor  
Restoration Space Definition

Meeting Space: 15,093 sf

Office Space: 22,718 sf

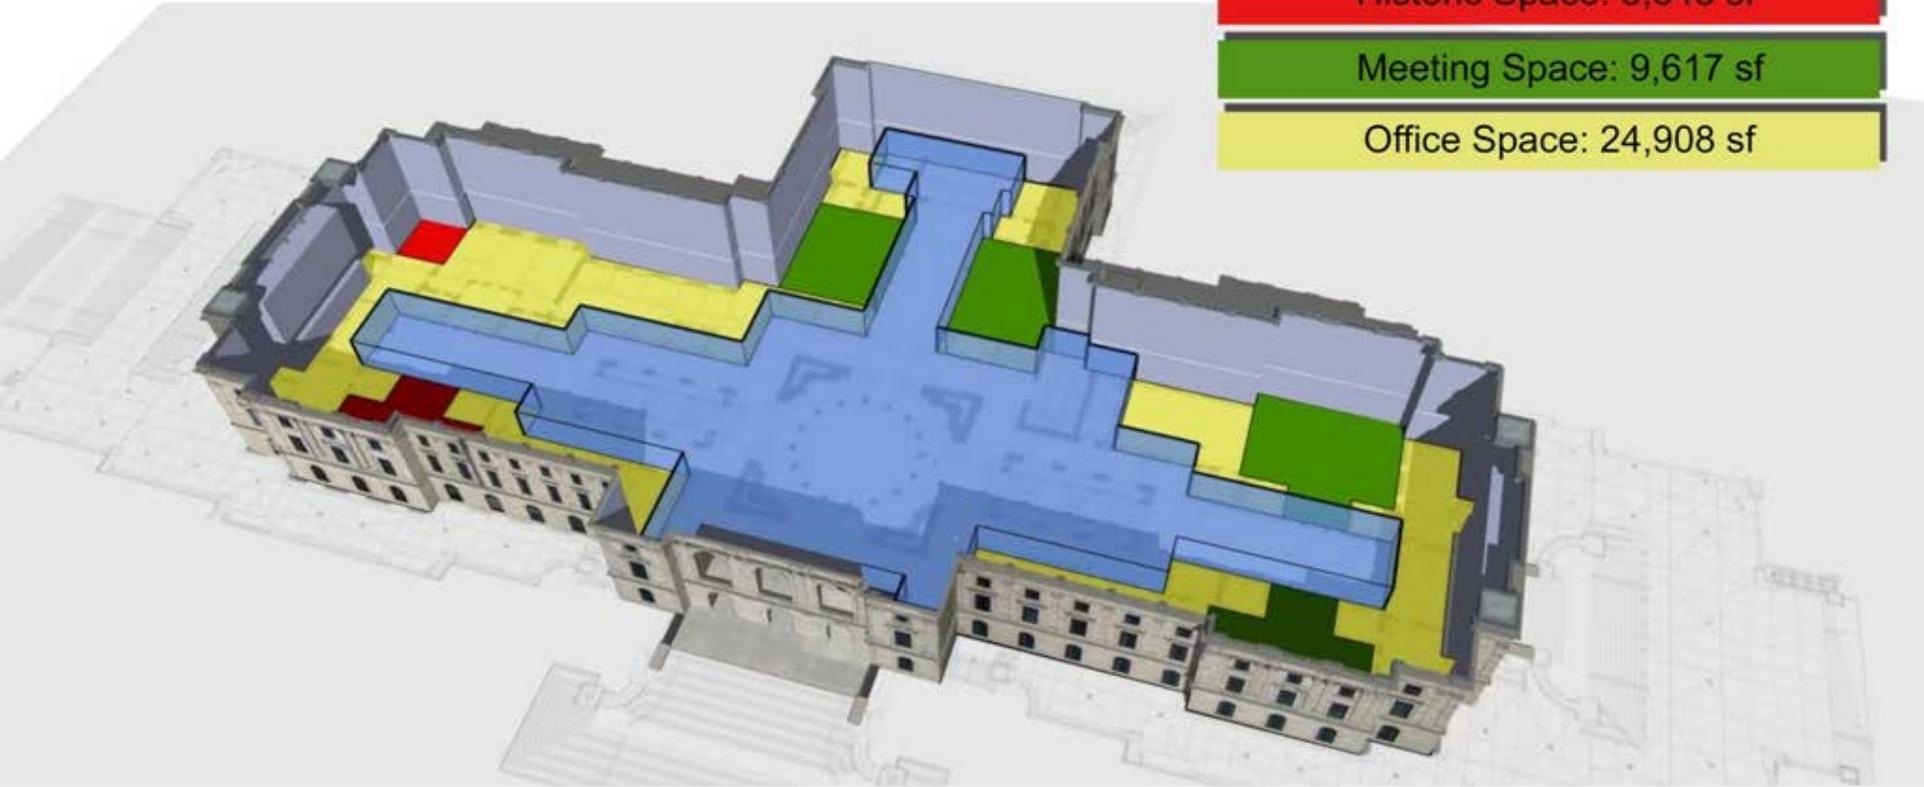
Minnesota State Capitol - First Floor  
Restoration Space Definition

Meeting Space: 9,617 sf

Office Space: 24,908 sf

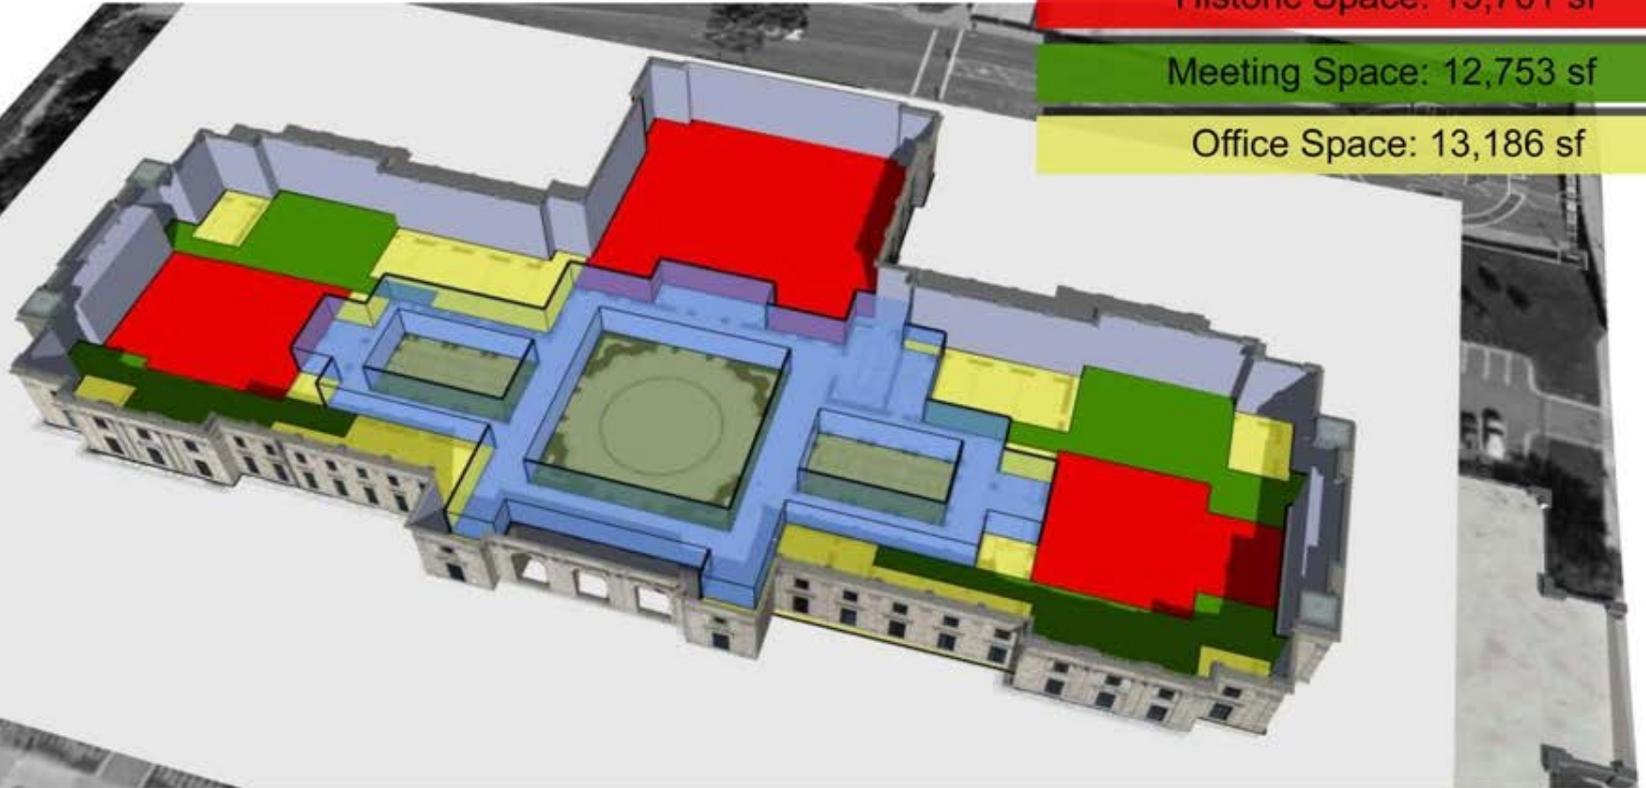
Minnesota State Capitol - Second Floor  
Restoration Space Definition

Meeting Space: 12,753 sf

Office Space: 13,186 sf

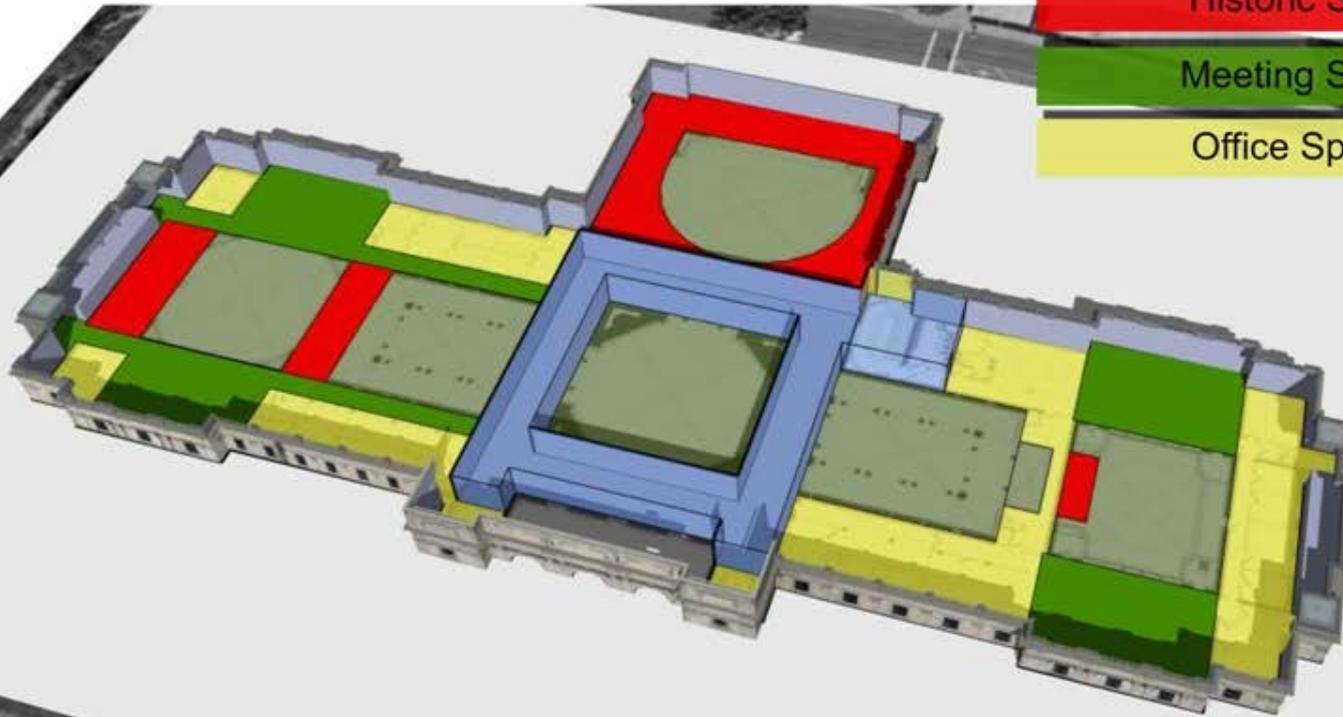
Minnesota State Capitol - Third Floor  
Restoration Space Definition

Approximately 43,778 sf Total

- Public Space: 8,088 sf
- Historic Space: 9,706 sf
- Meeting Space: 11,319 sf
- Office Space: 14,665 sf
